# Buckinghamshire County Council

## Flood Investigation Report

Oxford Road New Denham February 2014

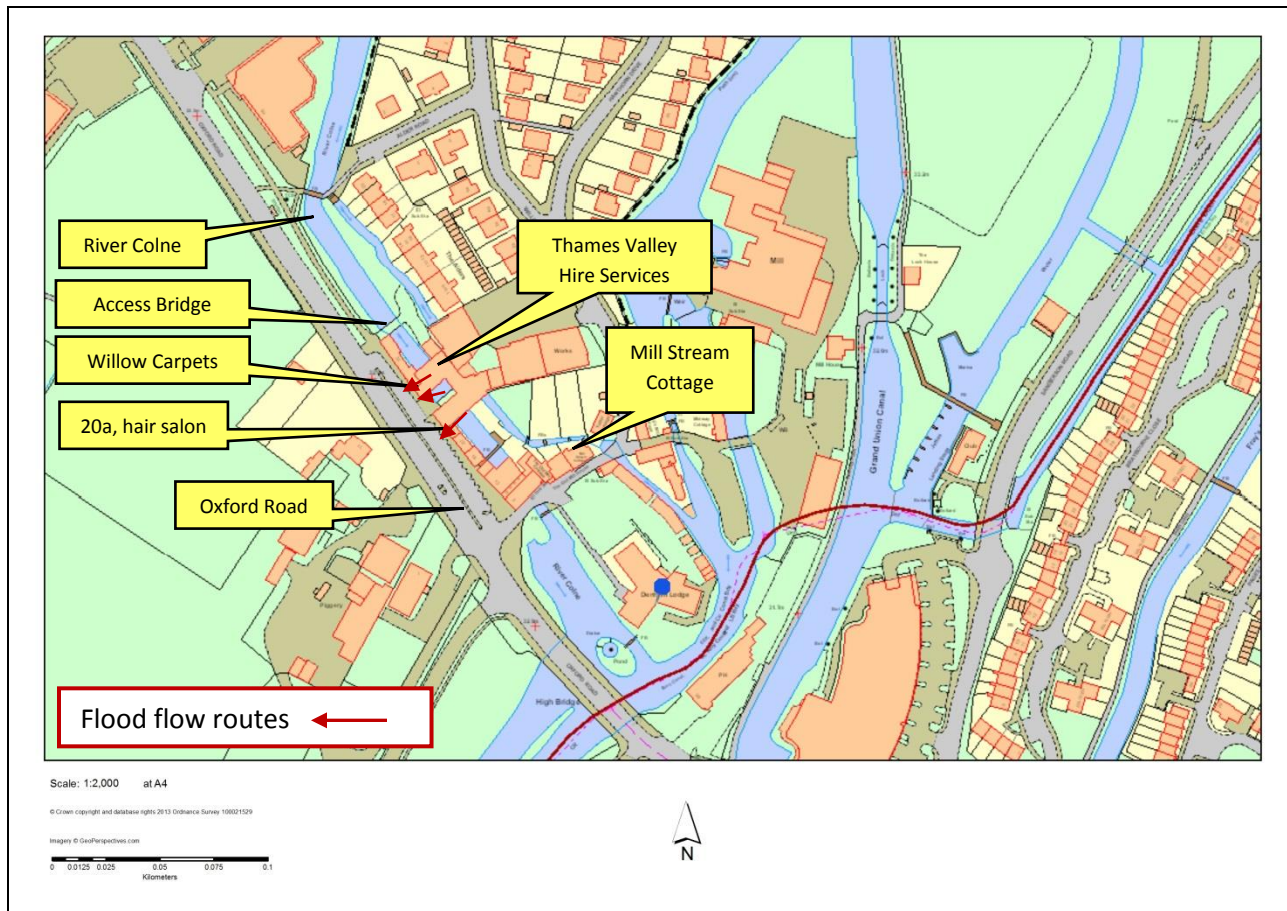
**Figure 7 Location of flooding and features around the Oxford Road.**

Figure 7 shows flood routes around the Oxford Road area. There were reports of some flooding at the parade of shops on the Oxford Road. The newsagent in the parade of shops advised that the hair salon and carpet shop had been flooded internally.

On investigation the Environment Agency staff found that there was a gap between the hair salon, Hair by Debbie, and adjacent building (northern side), and that the right bank height on the shop side was significantly lower than the opposite left bank. There was also evidence of gravels being washed out of the gap on to the pavement. The hair salon was closed. On hearing of further rainfall forecast in the coming days, the low point in the bank was reported to the FIDO the following day and an Environment Agency Operations Team asked to raise the bank in the gap with sandbags, which they did the same day (12th February 2014).

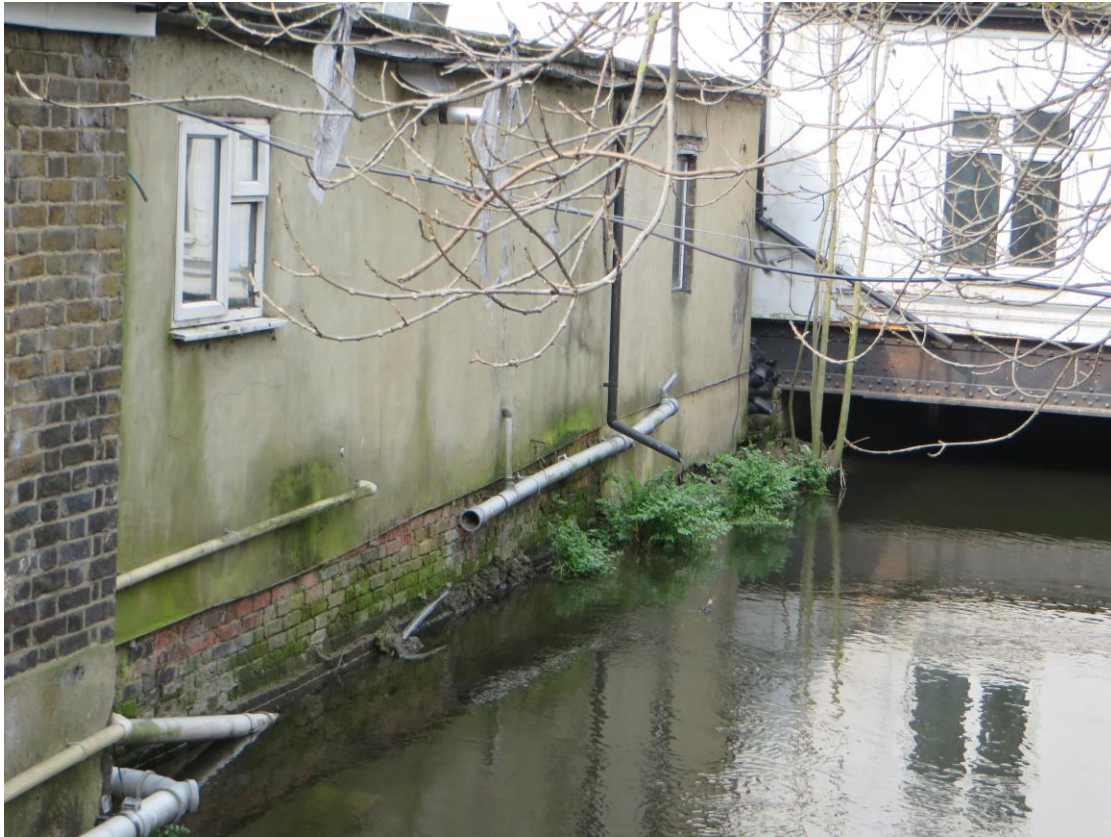
area and easily becomes blocked. The soil vent pipes and outlets from surface water pipes flowing into the channel were likely to have been surcharged and under water which would have created backing up into the properties. Some of the pipes are broken and in need of repair – see photo.

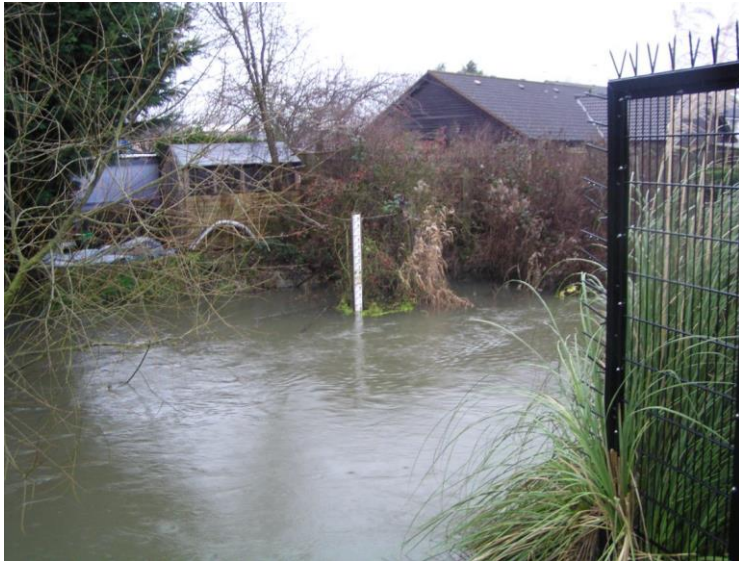
P1010098 TQ0501385015 Gauge Board  
Opposite Poplar Road, reading 32.61mAOD

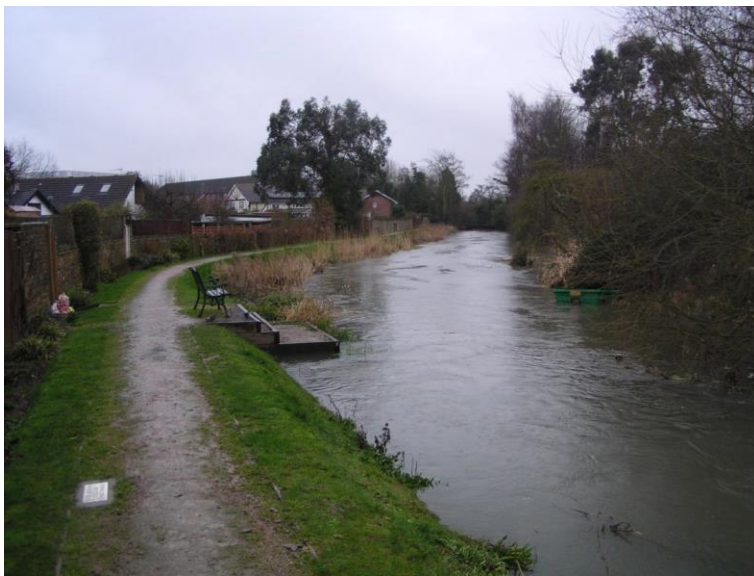
P1010099 TQ0501385015 Looking S d-s  
Rebuilt flood defence between Poplar Road and Alder Road. Maximum water level reported by residents as to just below the middle step of the fishing platform.

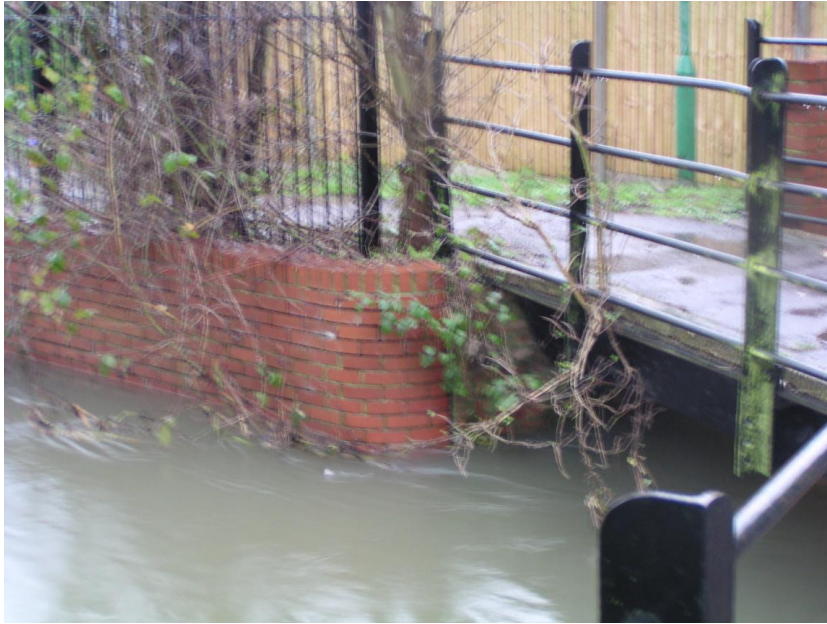
P1010104 TQ0497484861 looking E channel w-l  
Water level at the footbridge by Alder Road, 11 courses of bricks from the top of the wall.

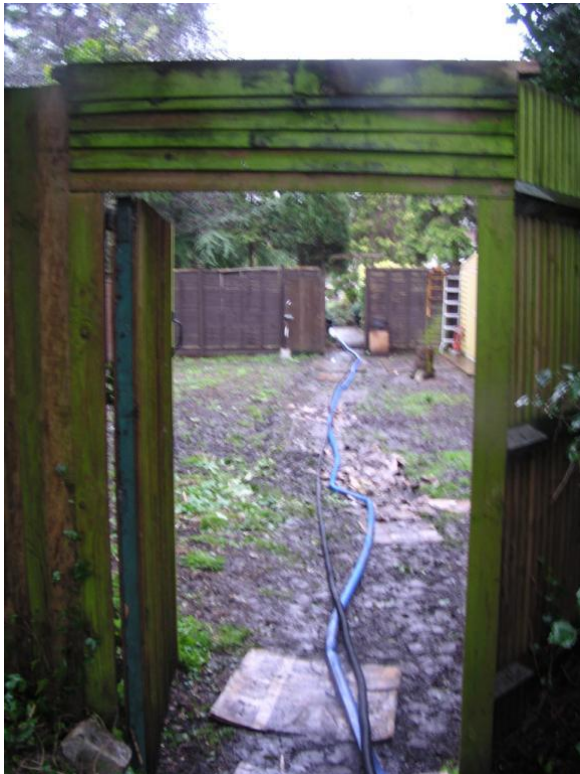
P1010105 TQ0499185074 16 Willow Av  
Pumping

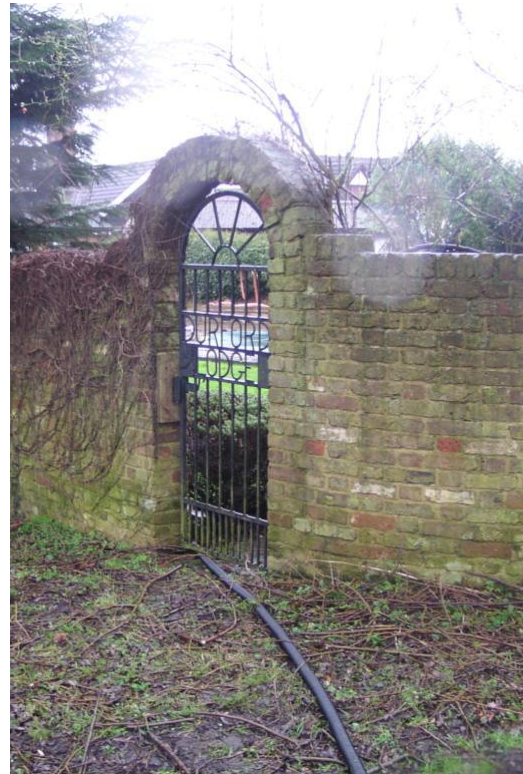
P1010107 TQ0500185118 79 Willow  
Cres W pumping

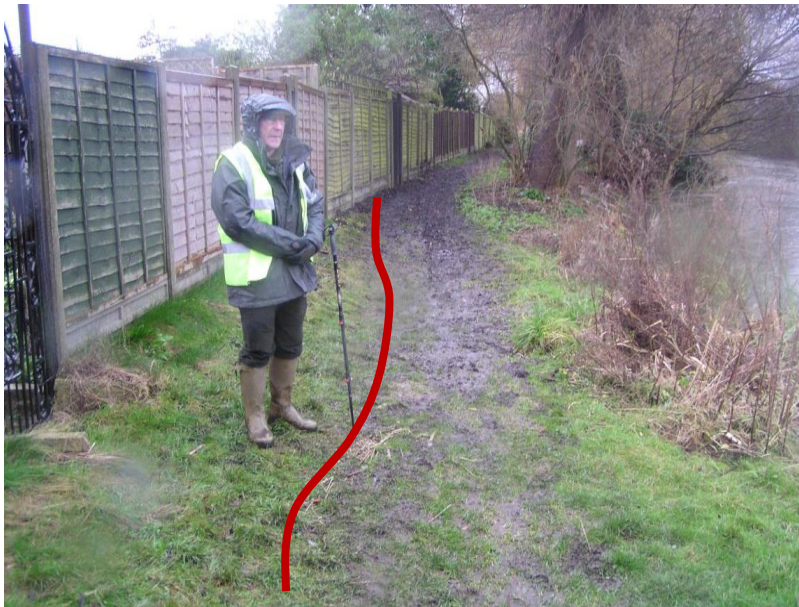
P1010118 TQ0518485546 Looking SSW trash line

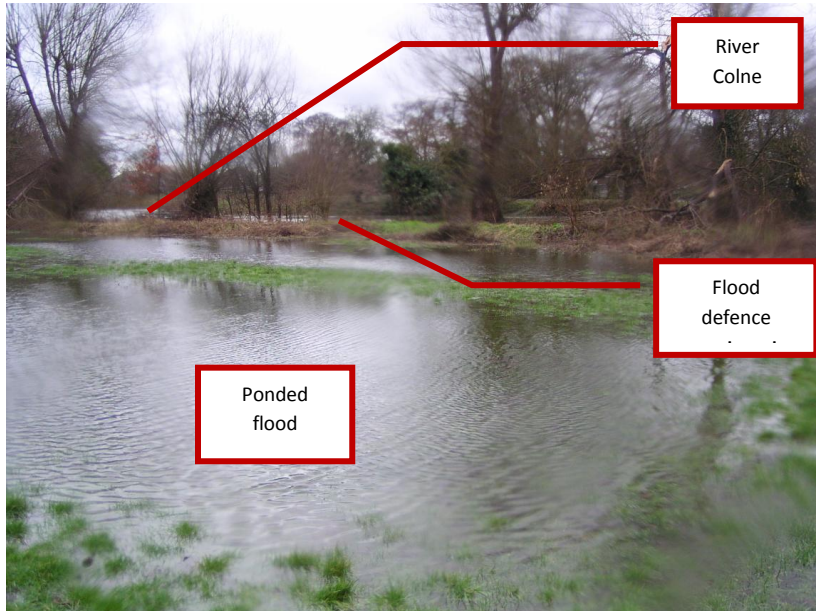
observed at the northern end of the recreation ground where a section of flood defence kerb exposed and accumulated vegetation from out of bank ponding of water. The water level at the gauge board on the western channel of the gauging station was noted as 32.90m AoD.

P1010120 TQ0500885306 Looking SW Rec Grnd ponding  
In front of the flood defence, with the river behind.

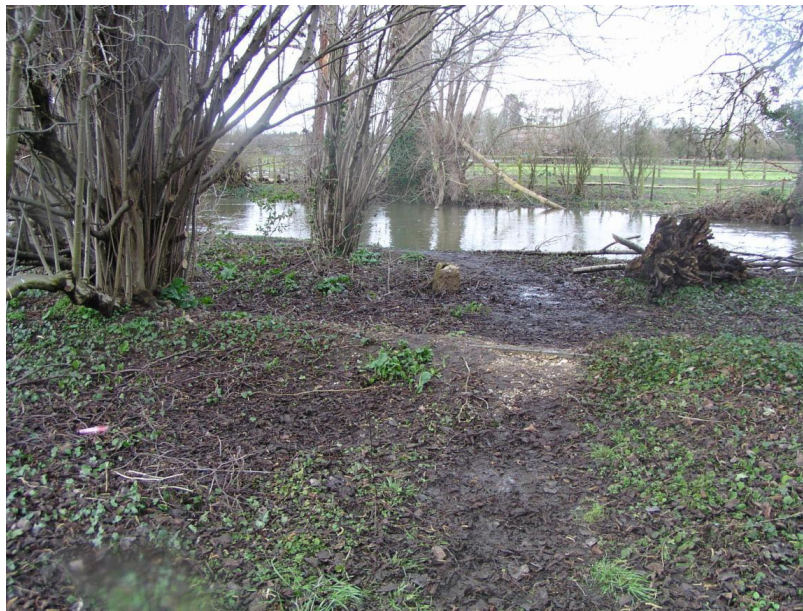
Residents reported that the flood defence at the northern end of the recreation ground had been over-topped, and showed the Environment Agency the place where this had happened. The flood kerbs of the defence were exposed with the normal 100-150mm of topsoil having been eroded. This over-topping was reported to the Environment Agency.

P1010123 TQ0499285317 Looking W defence overtopping point  
With flood kerb exposed.

Following forecasts on the evening of the 11th February for further heavy rain in the coming days an Ops Team from the Environment Agency was sent to build up the low points of the defence with sandbags, which was carried out on the 12th February 2014.

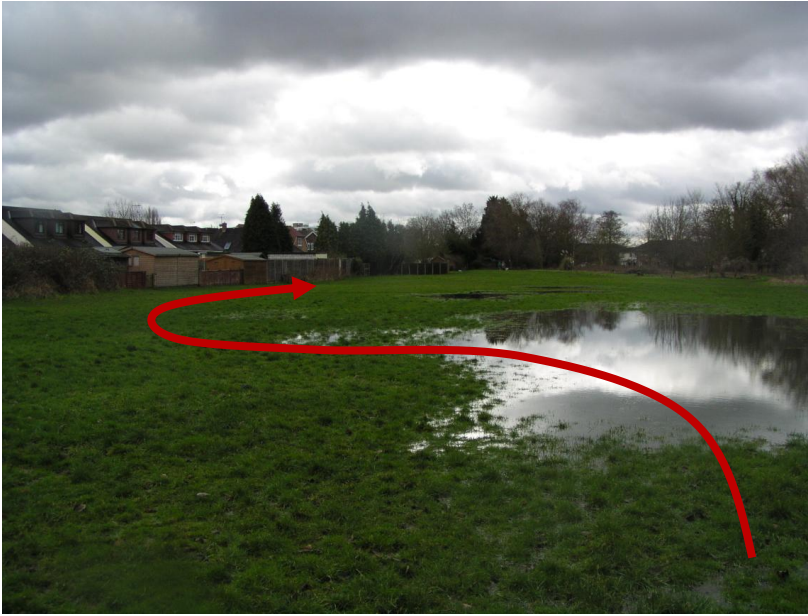
P1010126 TQ0498785308 Looking S Rec Grnd ponding-flow route

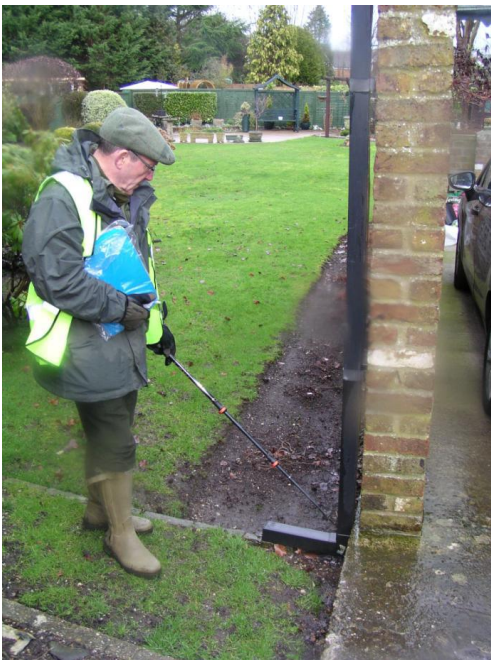
P1010122 TQ0501585023 2 Poplar Rd water-level

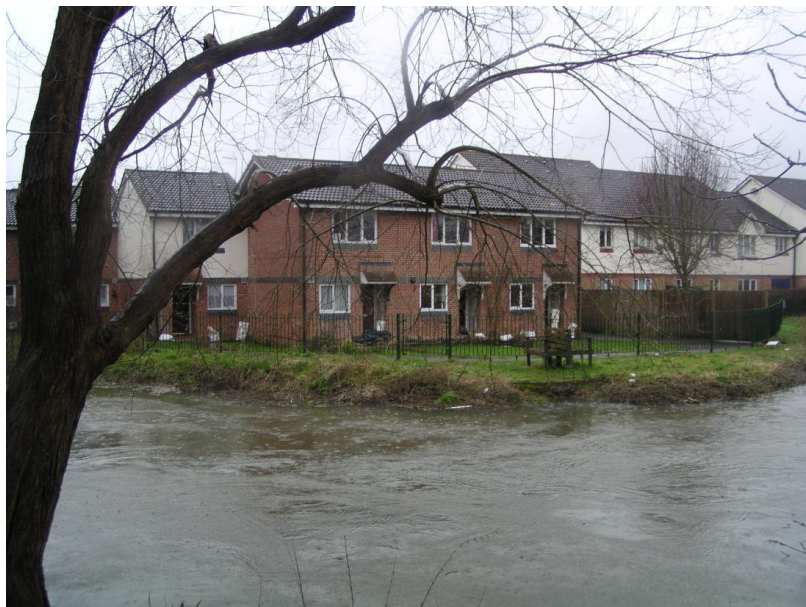
P1010108 TQ0500185118 Looking W to Oakeside  
Evidence of sandbagging in Oakeside properties, number 42-44, from Willowbank Island.

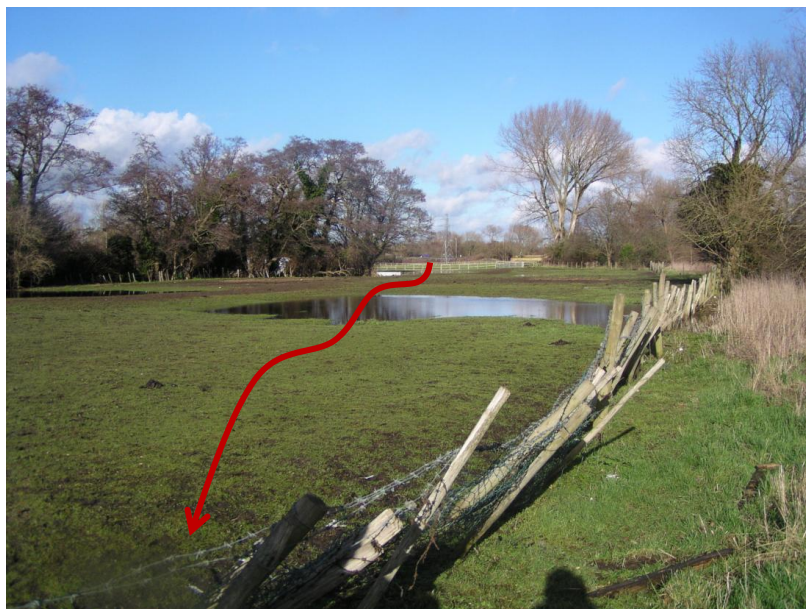
P1010127 TQ0488185165 Looking NNE ponding-flow route  
Reported overland flow route from River Colne near gauging station at the north of Willowbank Island (ID 2880).

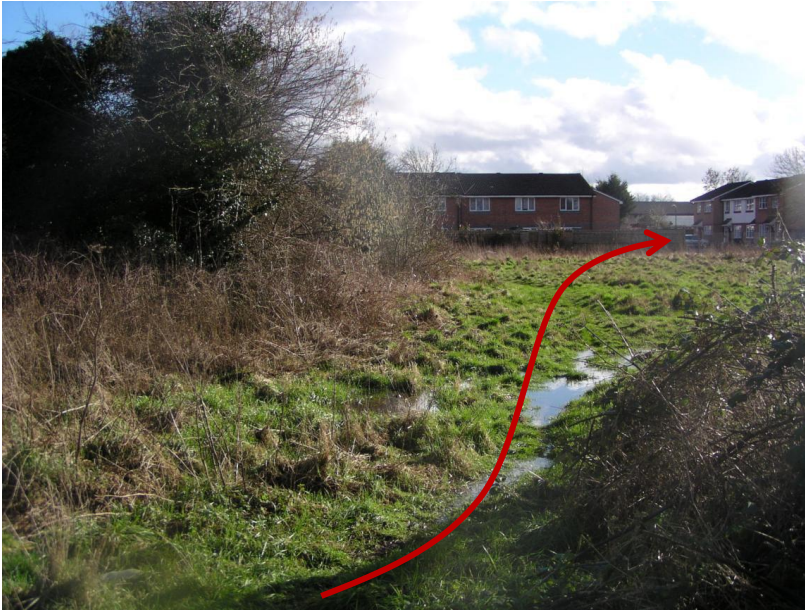
P1010128 TQ0488185165 looking SE ponding-flow route  
Reported flow route towards Oakside

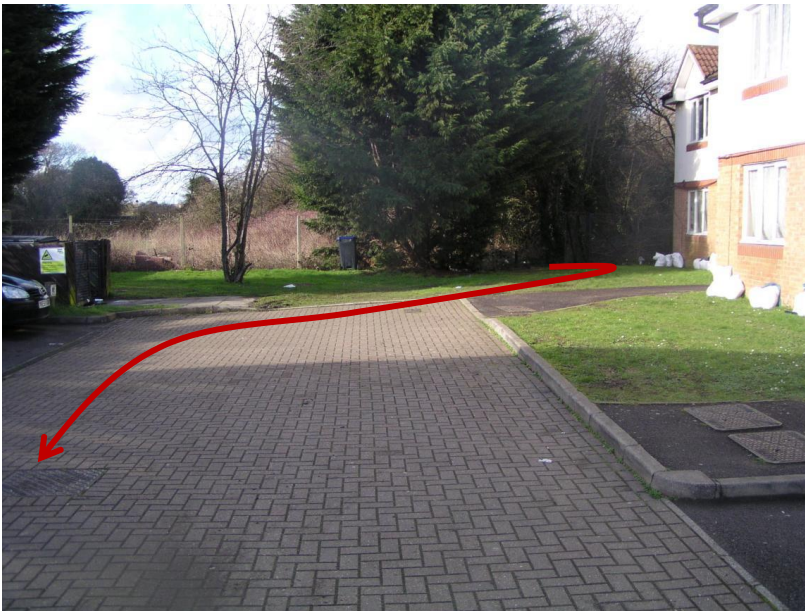
P1010130 TQ0493885111 looking NW flow route  
Reported flow route into Oakside

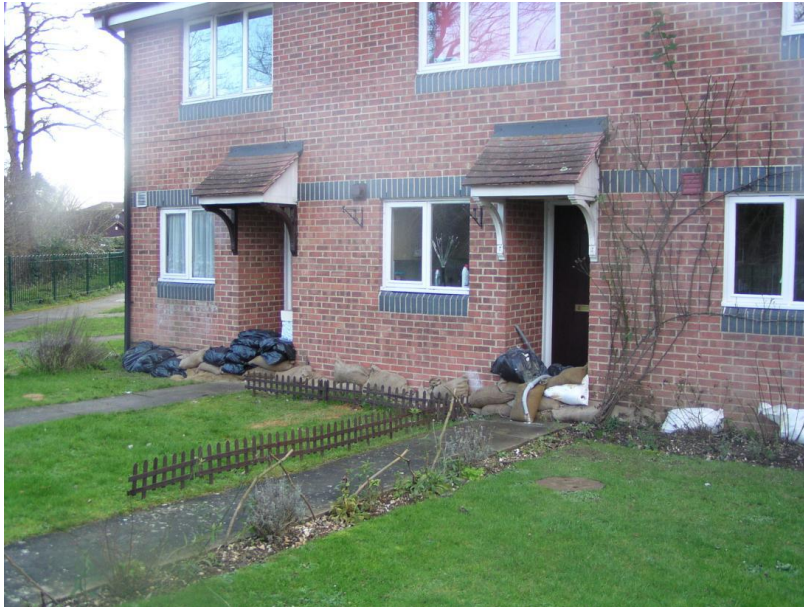
P1010131 TQ0497585128 looking SW 43-42 Oakside  
Significant sandbagging, though no riverside flooding reported.

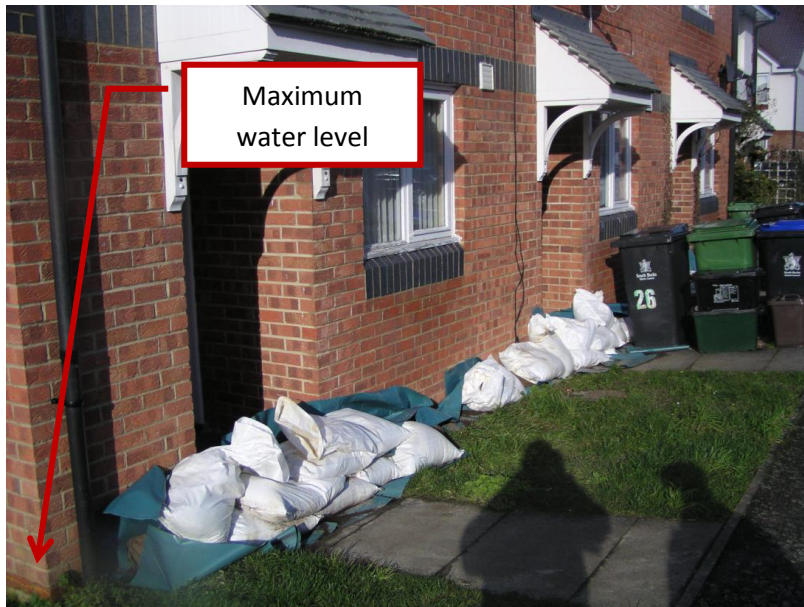
P1010133 TQ0491785087 Looking NE 25-27 Oakside  
Sandbagging to properties that came closest to flooding internally. Water level marked with yellow crayon in bottom left corner.

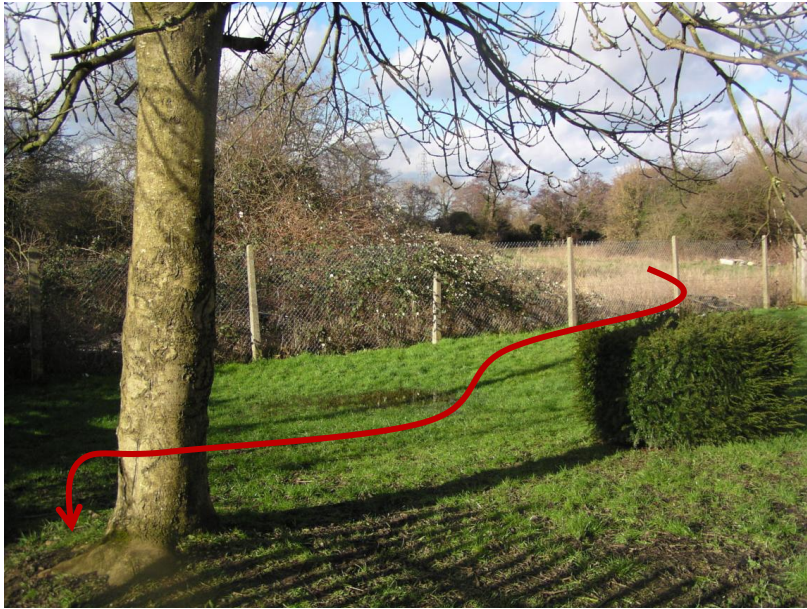
P1010136 TQ0489385097 Looking N overland flow route  
Reported flow route from P1010128 (above).

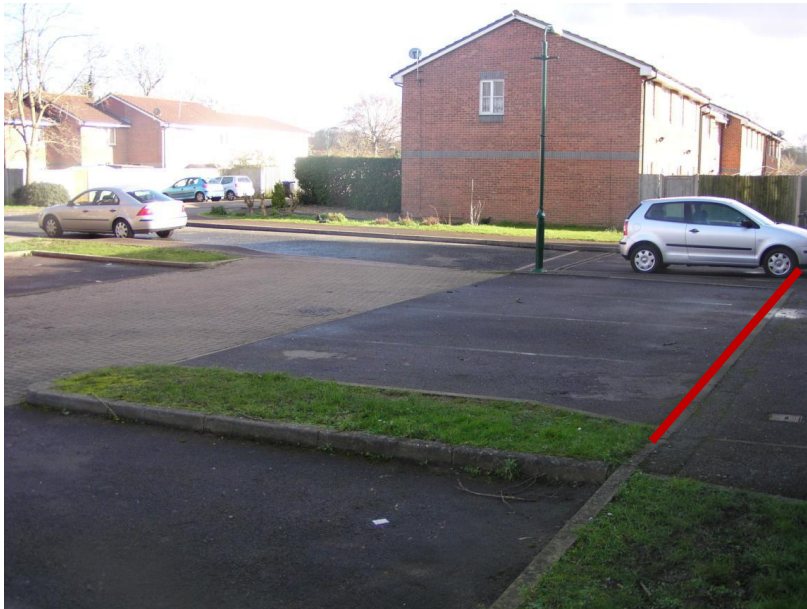
P1010137 TQ0489385097 Looking SSE car park  
Reported maximum flood extent at edge of westerly car park.

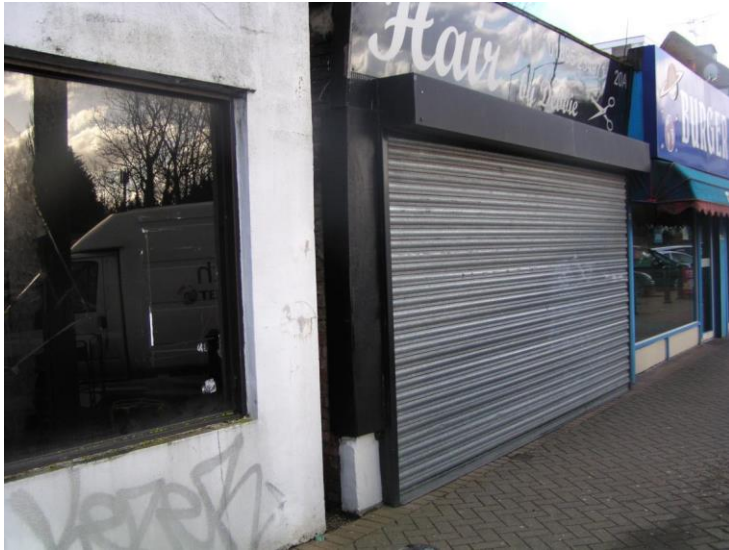
P1010140 TQ0503584750 Looking E 20a Oxford Rd  
The gap beside the hair salon through which flood water flowed.

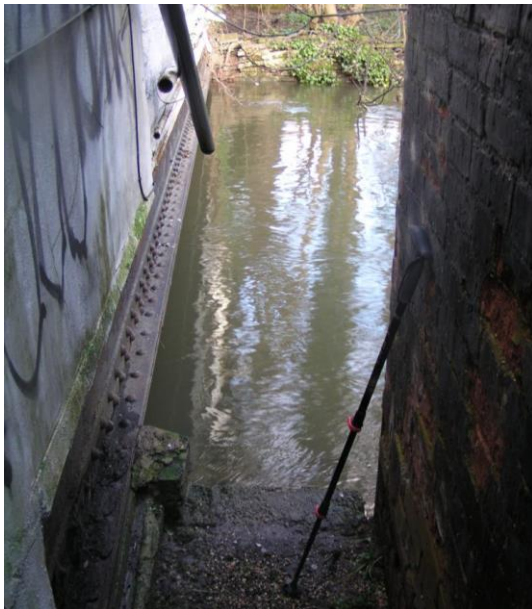
P1010143 TQ0504084755 Looking NE low bank level  
Showing the low bank compared the opposite bank and bridge soffit.

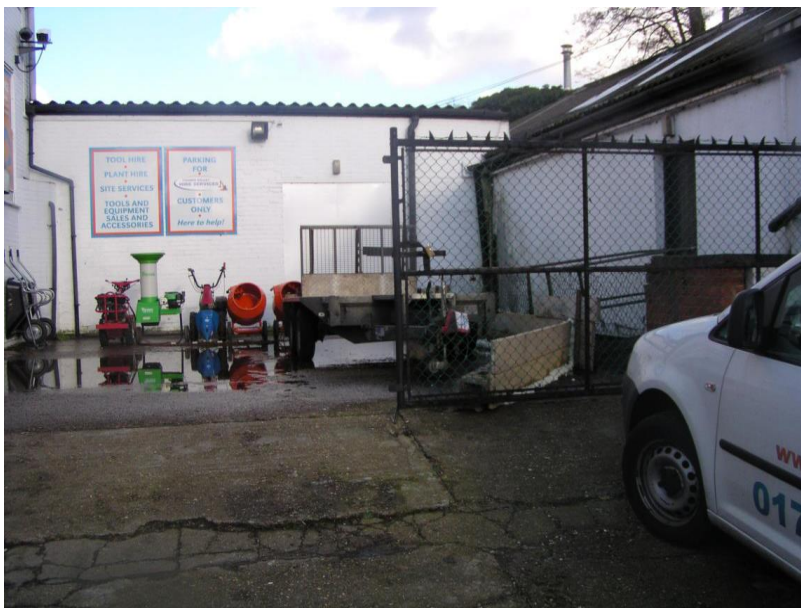
P1010149 TQ0502684761 Looking NE TV Hire Temp defence Thames Valley Hire Services entrance and temporary defence (scaffold boards and foam sealant to the right).

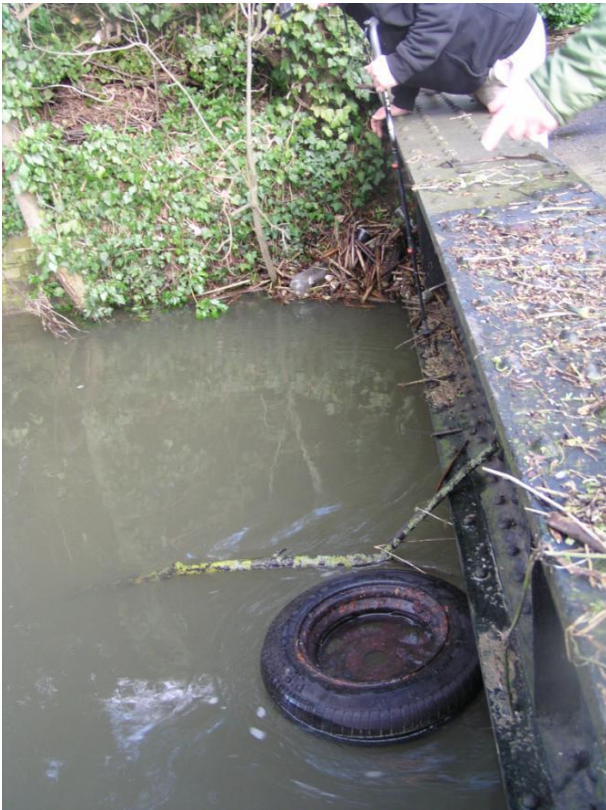
P1010145 TQ0500984800 Bridge max w-l u-s

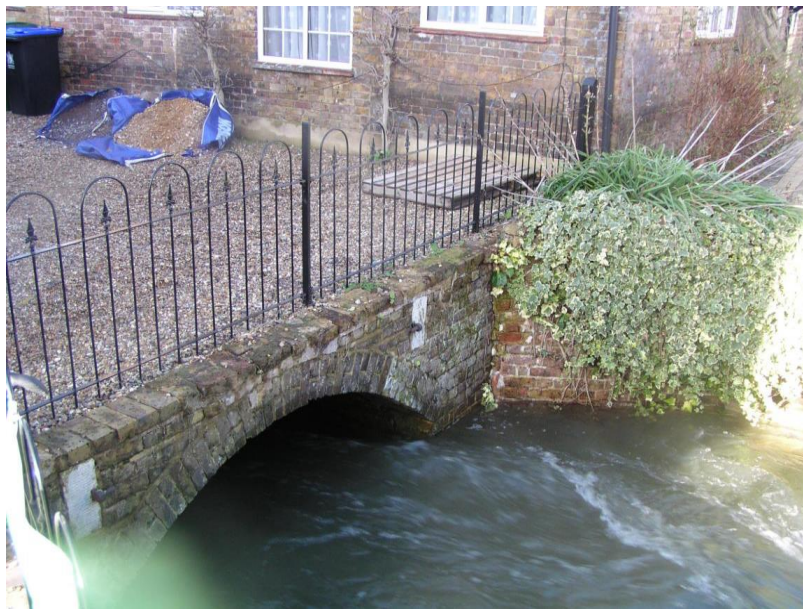
P1010154 TQ0510884741 Looking N culvert exit w-l  
Water level in the channel by Mill Stream Cottage.
