# Buckinghamshire County Council

## Flood Investigation Report

Old Amersham, Amersham

January – February 2014

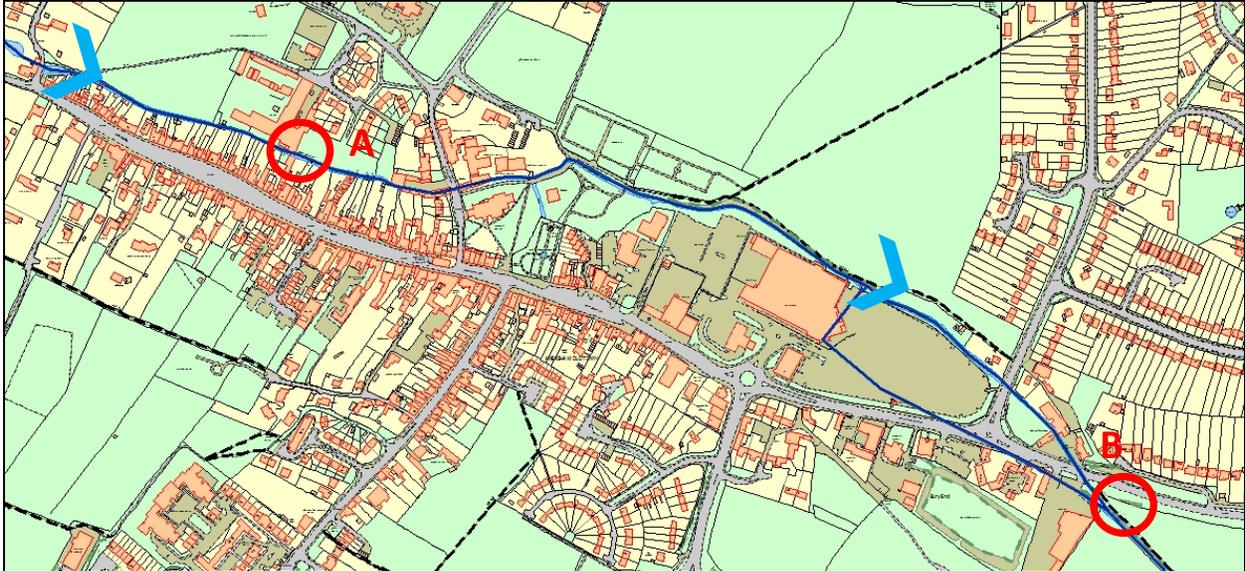
**Figure 3:** Culvert flow restriction (A) and bank collapse (B) locations in Old Amersham.

The flow in the culvert located under The Maltings (see A, figure 3) was partly restricted.

The section of watercourse downstream of The Maltings' culvert (see A, figure 3) contains several weirs, which impede the flow of water and cause a build-up of sediment by preventing the flushing of sediments by the flow of the river itself. Although this sedimentation did not cause the flooding as it was downstream of the flow restriction, it would have contributed to the problem by preventing the fast flow of water out of the culvert and causing a backing up of the water, and is worth noting for future flood risk management.

It is not known whether the section of riverbank which collapsed on 07 February 2014 downstream of the Jaguar garage was at risk of failure prior to the flooding or whether the exceptional rainfall on 06 February 2014 caused the collapse.

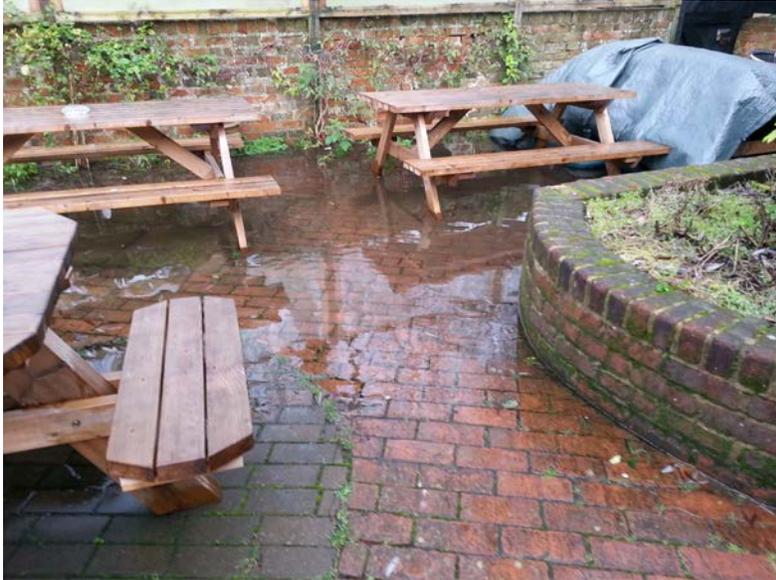
High Street Public House garden flooding. Photo courtesy of Glynis Chanell, 30/01/14

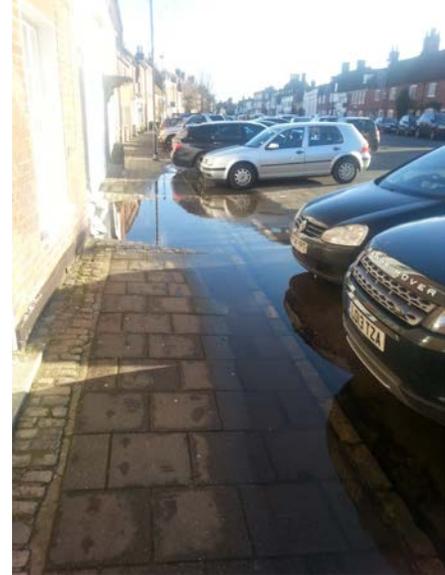
High Street flooding. Photo courtesy of Sam Richards, 09/01/14

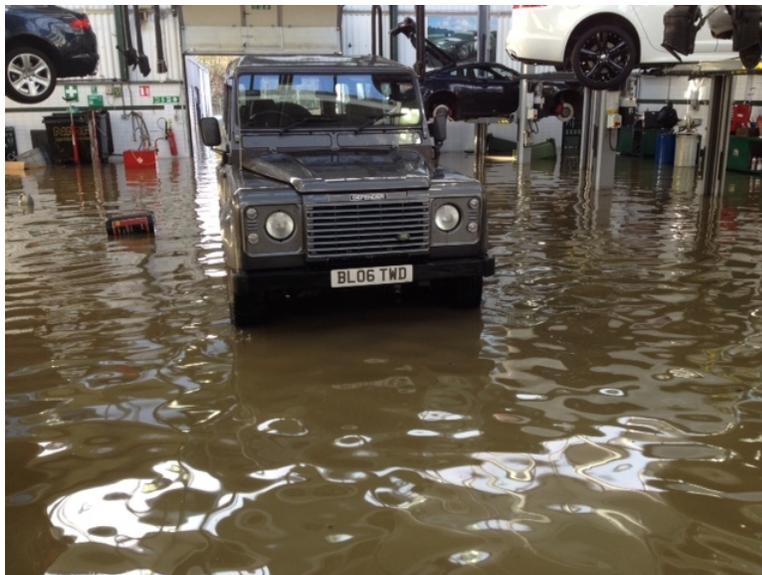
Jaguar garage repair shop. Photo courtesy of Glynis Chanell, 30/01/14

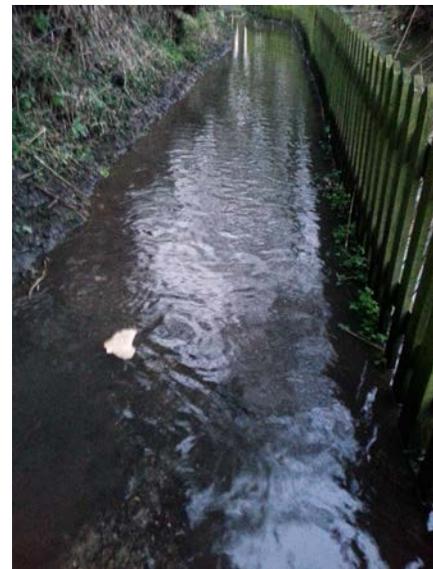
Path into Barn Meadow. Photo courtesy of Glynis Chanell, 07/02/14

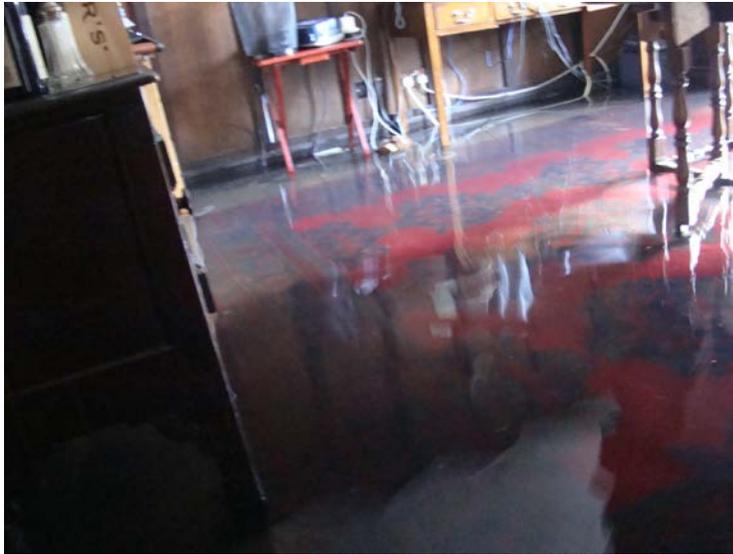
High Street – internal property flooding. Photo courtesy of Stephanie & Martin Brooks, 08/02/14

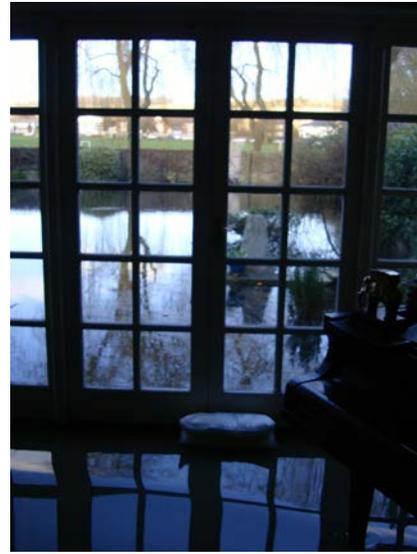
High Street – internal property flooding. Photo courtesy of Stephanie & Martin Brooks, 07/02/14

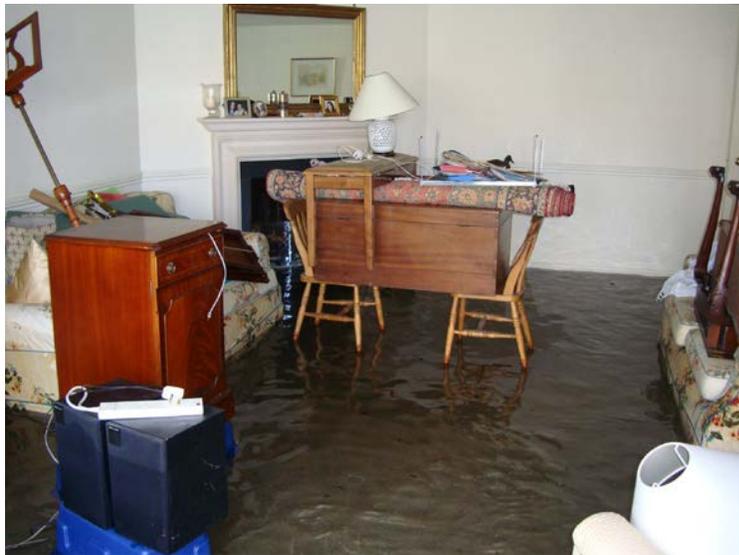
High Street – internal property flooding. Photo courtesy of Stephanie & Martin Brooks, 08/02/14

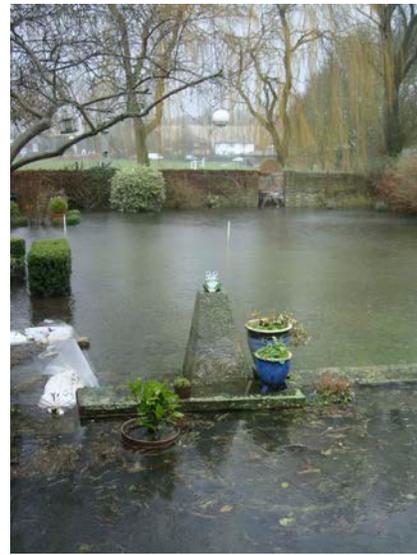
High Street – garden flooding. Photo courtesy of Stephanie & Martin Brooks, 08/02/14

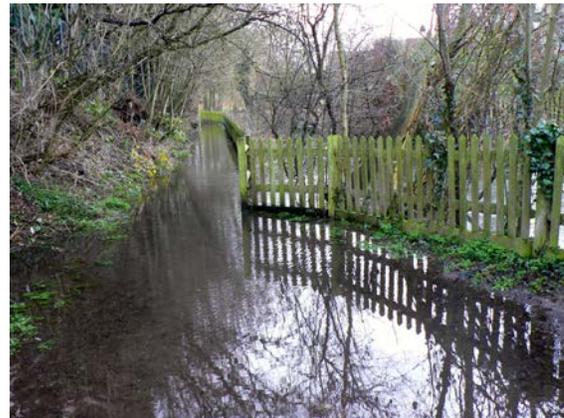
Flooded footpath to Barn Meadow from Mill Lane. Photo courtesy of Peter Borrows, 10/02/14.

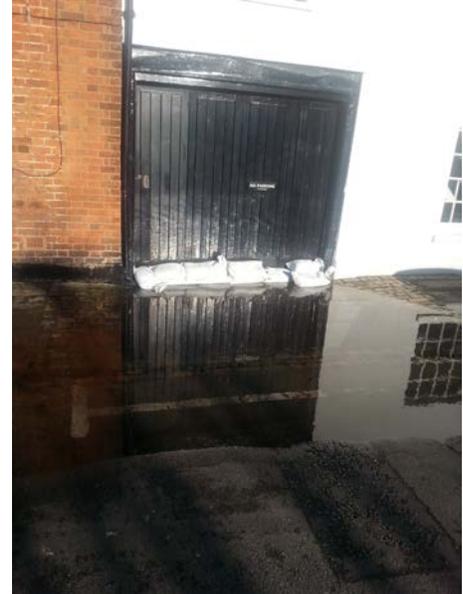
High Street flooding. Photo courtesy of Sam Richards, 09/01/14

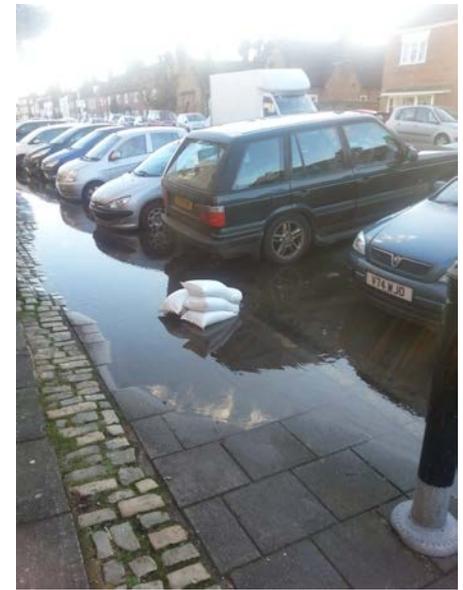
High Street flooding. Photo courtesy of Sam Richards, 09/01/14

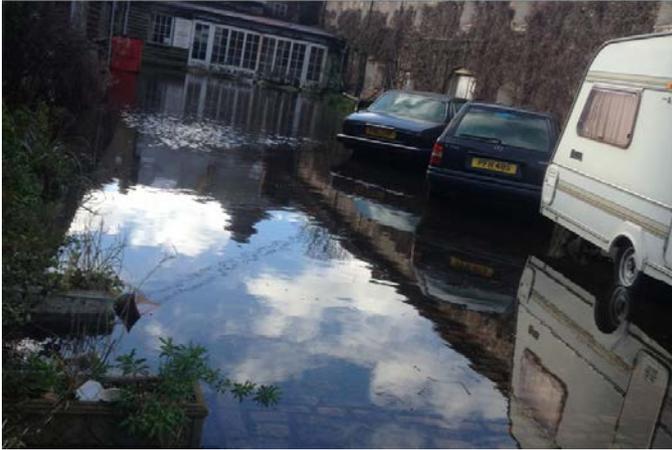
Flooding at The Maltings. Photo courtesy of Laura Mowat.

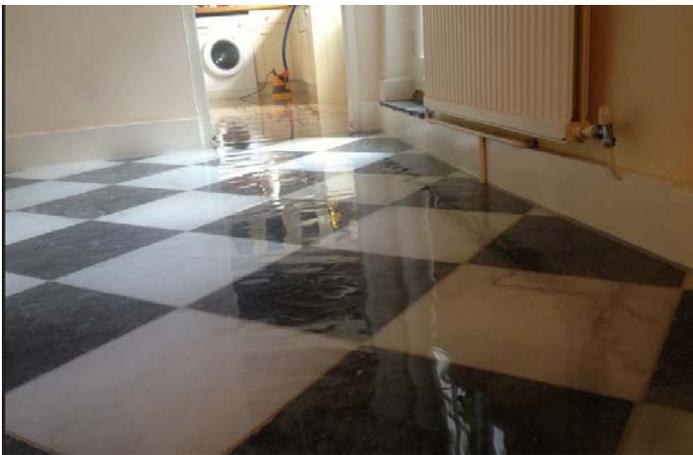
Internal property flooding on the High Street. Photo courtesy of Laura Mowat.
