Flood investigation report

High Street, Chalfont St Peter 2019

High Street, Chalfont St Peter

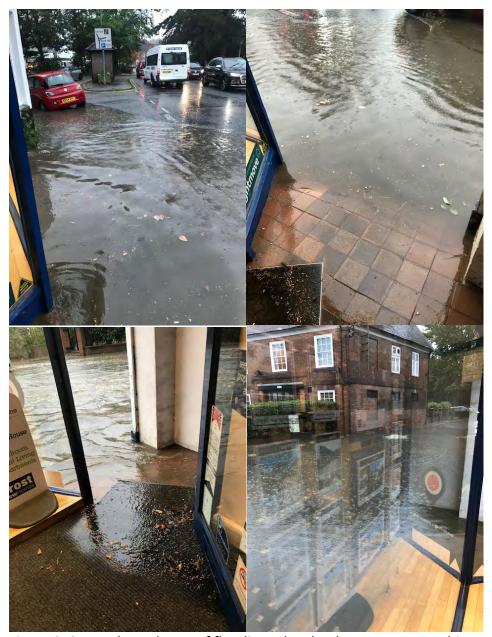
The flooding event led to the internal flooding of 5 business properties at approximately 09:00 on the morning of the 24th of September 2019 in the location of High Street, Chalfont St Peter, figure 1. The flooding started at approximately 06:00 and started to recede early in the afternoon at approximately 14:00, the maximum depth was approximately 18 inches deep.

Figure 2, 3, 4 and 5 – Photos of flooding taken by the Frost Partnership on 24/09/2019

The sewer system was the main cause of the flooding event on the 24th of September 2019. Due to the heavy rainfall the previous evening water had entered the sewer system which overwhelmed the system and caused a surcharge of water from a foul manhole cover in the middle of the carriageway. This caused a large amount of water to discharge very quickly onto the highway, filling the highway drainage system which wasin turnoverwhelmed and the water was not able to discharge and started to flood properties.

Summary - Heavy rainfall and surface water runoff from the road and hard surfaces entering the highway drainage system and foul sewer system caused the foul sewer to become overwhelmed and reach maximum capacity, this caused sewage to flow out of a manhole located in the middle of the carriageway and as such flowed into the highway drainage system causing this to become backed up resulting in ponding in the road and rising water levels which then encroached into the shops along the High Street, Chalfont St Peter.

All drainage assets should be cleaned and maintained by the responsible parties (outlined above).

Thames Water did look into the possibility of a Flooding Local Improvement Project but unfortunately this failed the initial engineering assessment. Thames Water will continue to monitor and undertake routine maintenance to the system and respond if severe weather conditions cause further flooding.

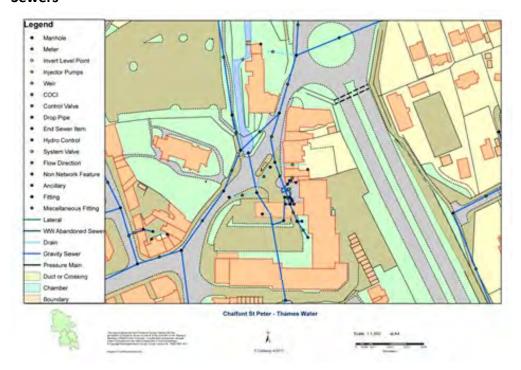
Figure 6 – Plan showing foul sewer network

A foul sewer main runs along High Street, Chalfont St Peter in the middle of the carriageway as shown in figure 6. Following the heavy rain the main sewer surcharged and sewage discharged from a foul sewer manhole covers on High Street which resulted in the flooding in the businesses.

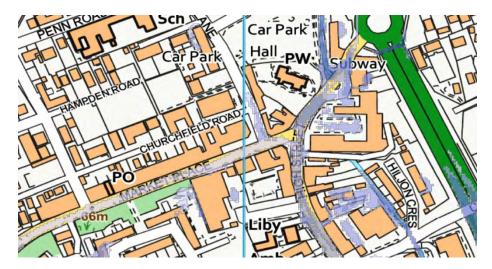
Figure 11 – Surface water map

Surface water – As water was unable to drain away from areas of hard standing due to existing standing water and maximum capacity being reached of the highway drainage system, caused by the rainfall from the previous evening and early hours of the morning, these factors could have been a contributing factor.

Please see below the surface water mapping, this shows that the area is prone to surface water flooding. The flooding located in the area shown on figure 11 was consistent with what happened on the day of the event but was enhanced by the sewer issue.
