Buckinghamshire County Council

Flood Investigation Report

The Willows, Aylesbury, 7th February 2014

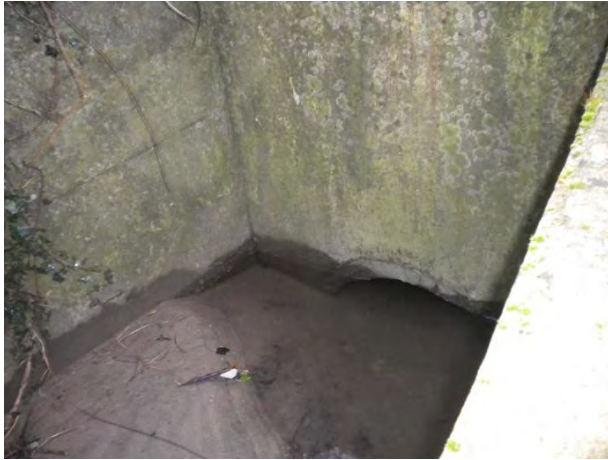
Figure 9 Silted up gully at Stratford Drive (Chris Spreadborough, Resident)

The gully outfalls from the surface water drains on the Willows housing estate were silted up as they entered the Stoke Brook. Figure 9 shows one of the outfalls before de-silting and figure 10 shows one after de-silting.

There was some siltation of the outfalls into Stoke Brook from the road drainage pipes. This siltation would have caused some backing up at lower flow levels but as the water levels in Stoke Brook would have been high these would have been the primary reason for backing up of water into the drainage pipes and gullies.

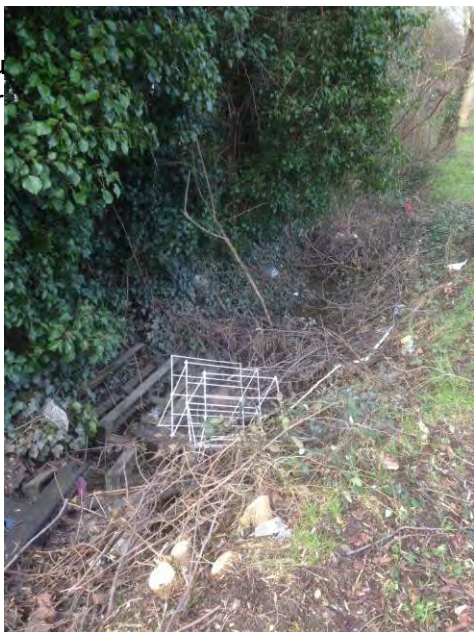
The Stoke Brook was fairly over grown in places and had suffered from fly tipping. Figures 11, 12 and 13 below show some of the debris taken out of the brook after the flood event.

Figure 11 Debris taken out of Stoke Brook prior to flood event

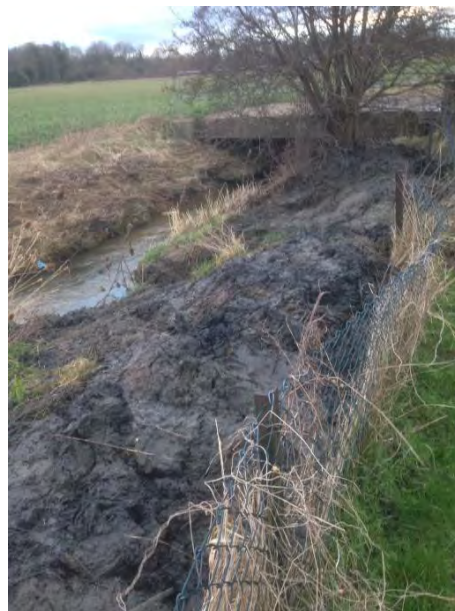
Figure 12 10/02/2014 16:52 Silt removed from Stoke Brook and gully outfall at end of Fox Glove - Councillor Steven Lambert

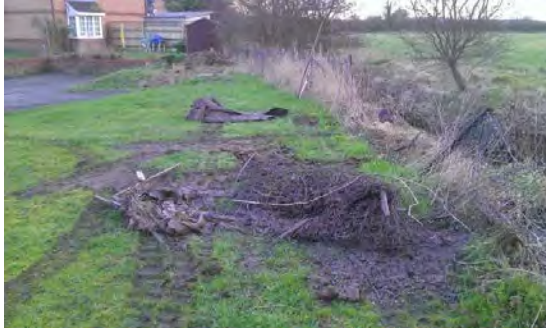
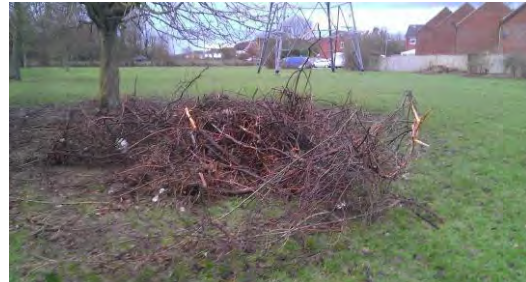
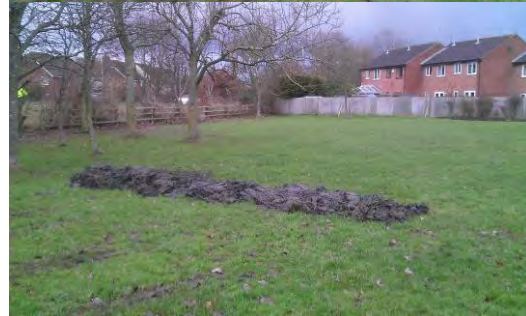
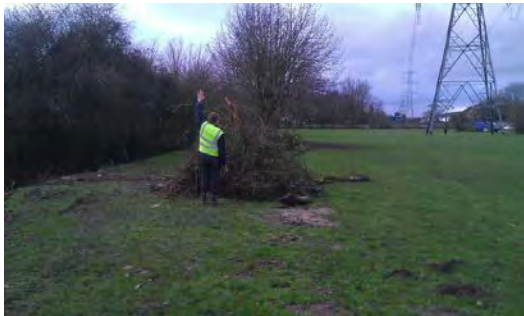
Figure 13 10/02/2014 Rubbish removed from Stoke Brook – Councillor Steven Lambert

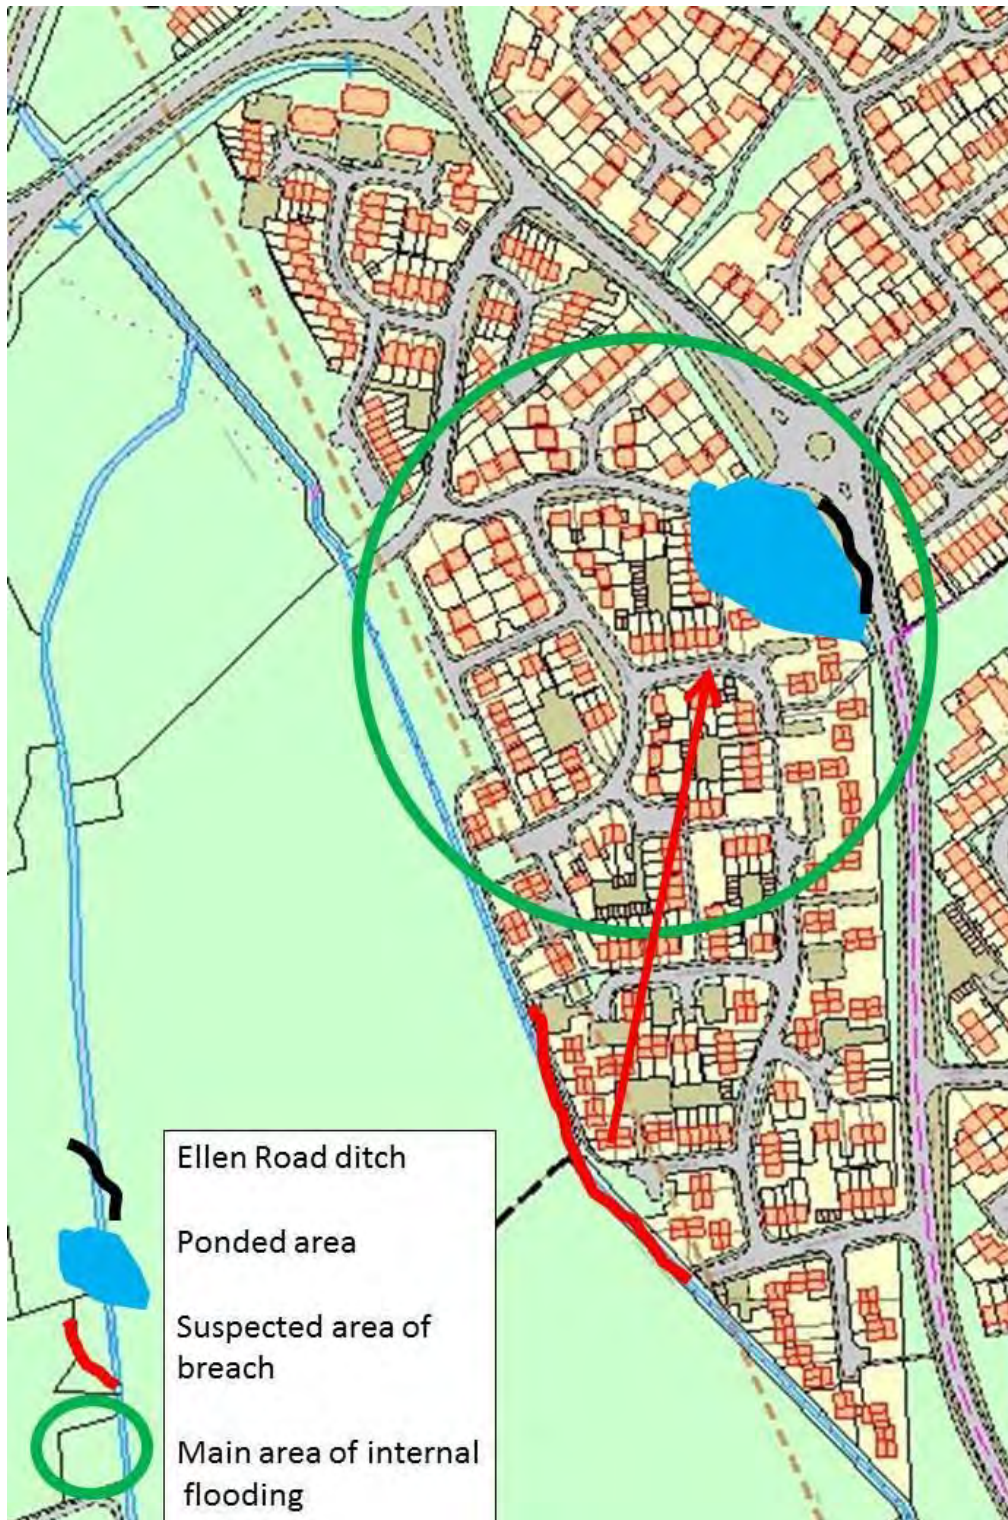
Having investigated the exact flow paths that the flood water took with all the stakeholders involved; AVDC, BFRS, EA, Bucks Resilience, TfB, residents and the County Councillor there are some differences in opinion as to what happened and why. The timeline of events and actions taken by the stakeholders is summarised in table 1 below. The main likely flow paths are shown in figure 14 but it is also known that the Stoke Brook flooded over the green area adjacent to Dormer Close and Parrot Close into the roads and subsequently into some properties. There were also several reports from stakeholders that water was bubbling out of the gullies which is likely to be a result of the surface water drainage system being overwhelmed by the high rainfall and not being able to flow away due to the water courses being at capacity.

Figure 14 Possible flow paths for flood event on 7th February 2014

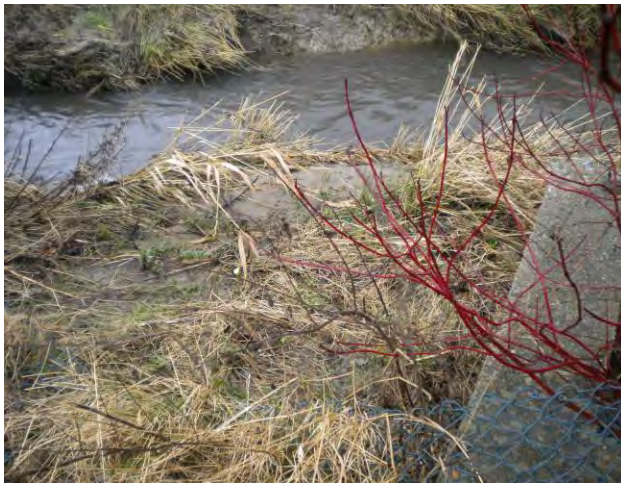
Overgrown banks with huge amounts of silt & vegetation.

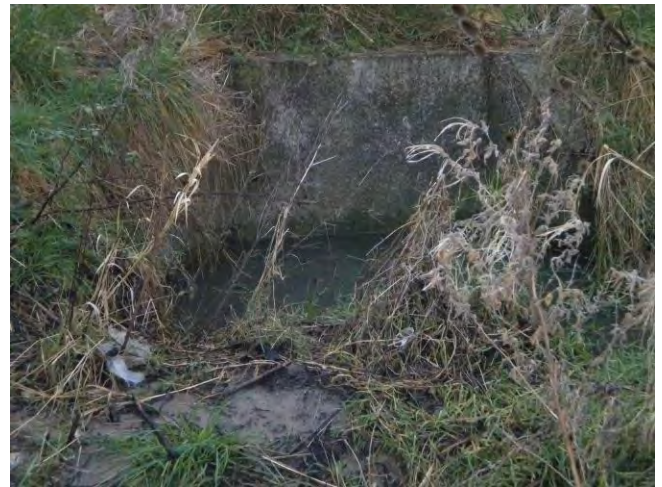
Choked up brook at foxglove.

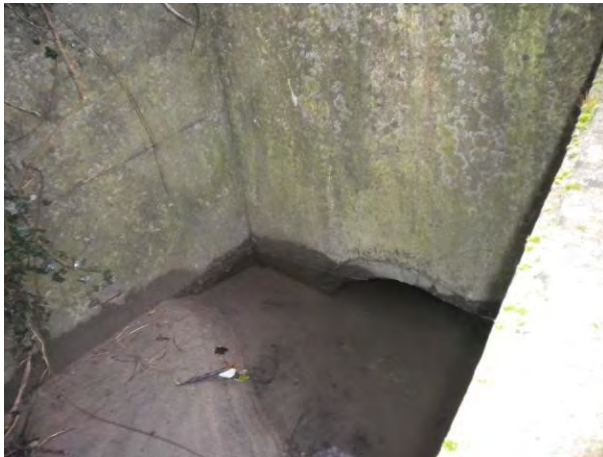
Silted up gully at Stratford Drive

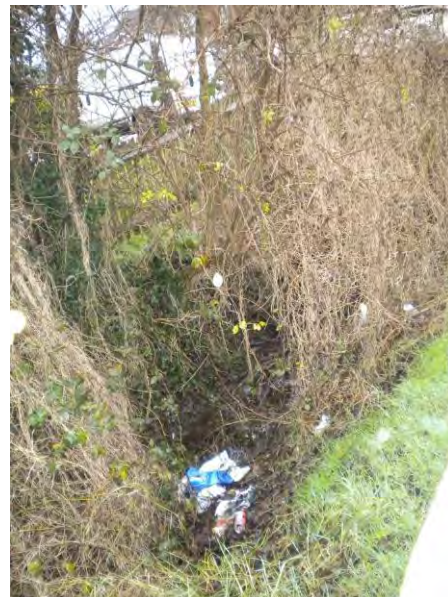
Overgrown ditch in Ellen Road.

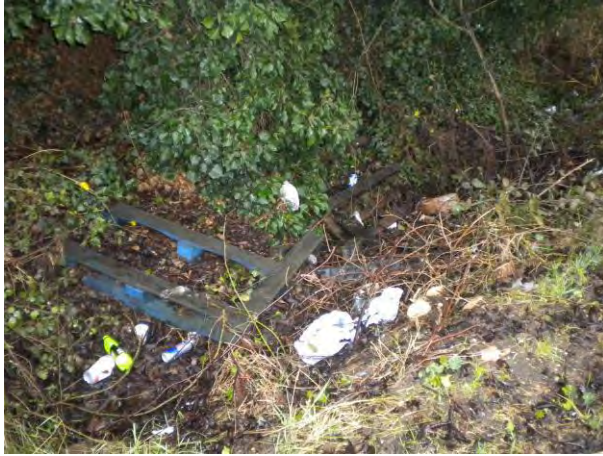
Pallets and rubbish in Ellen Road Brook Chris Spreadborough

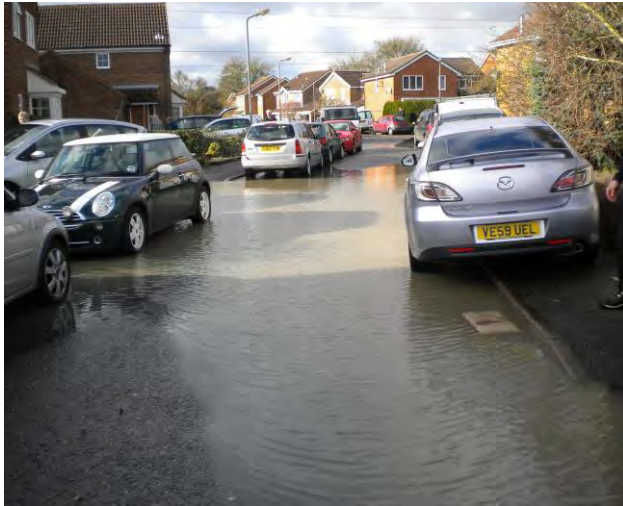
07/02/2014 11:30 Water had been coming up out of the drains and the road was flooding, this is about 200m from the brook Chris Spreadborough

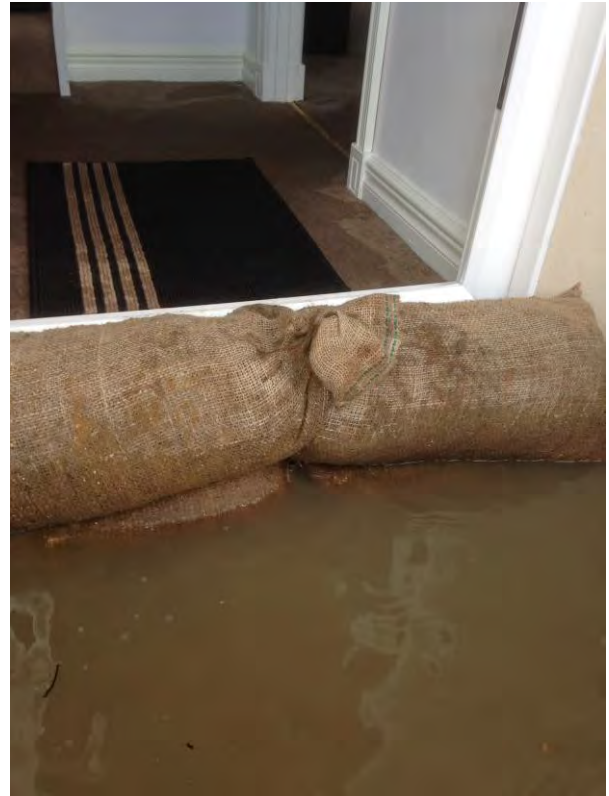
07/02/2014 12:24 Internally flooded property - Councillor Steven Lambert

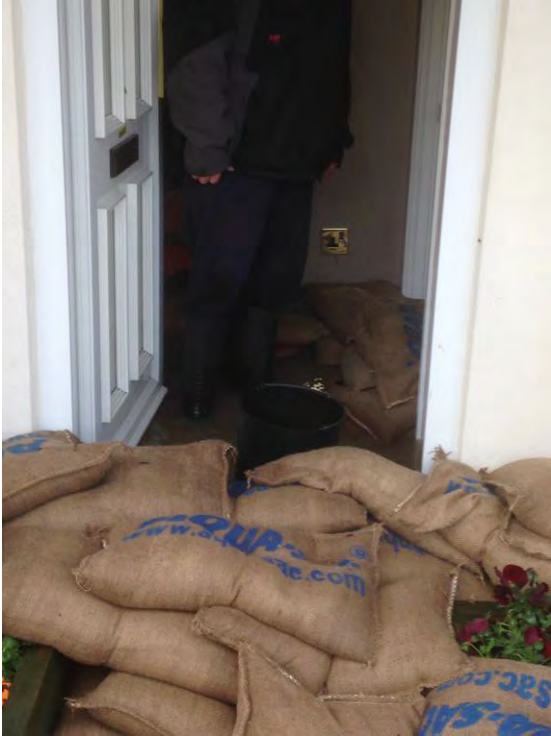
07/02/2014 12:27 Internally flooded property -
Councillor Steven Lambert

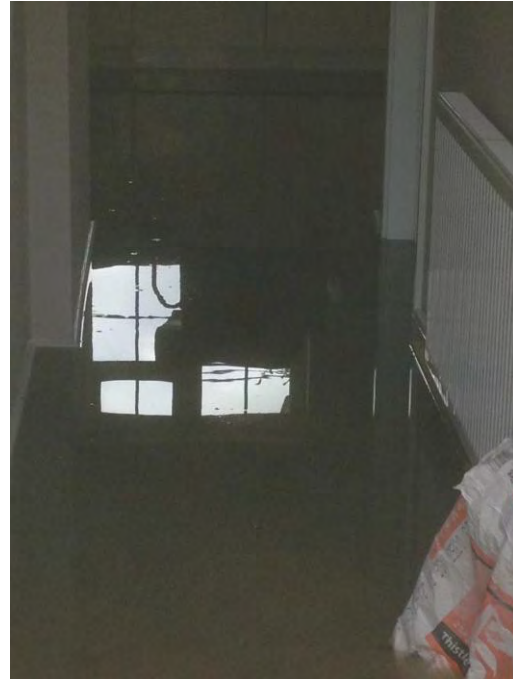
07/02/2014 12:27 Internally flooded property -
Councillor Steven Lambert

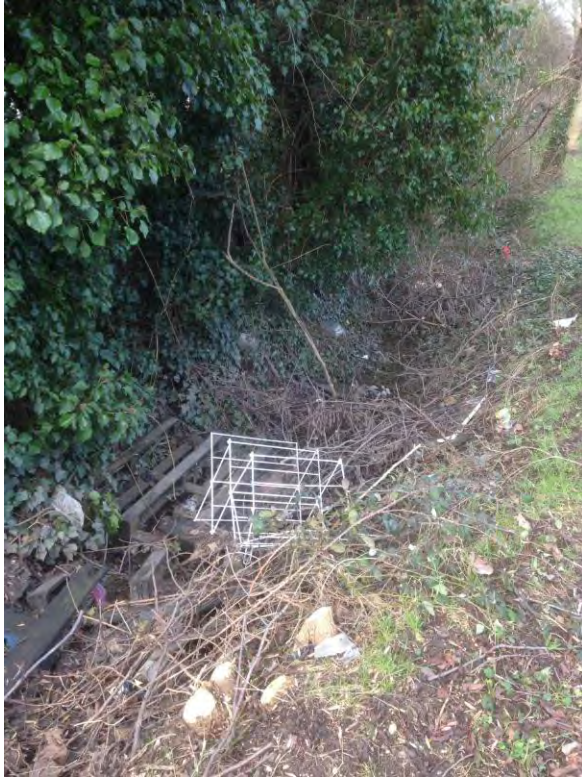
09/02/2014 11:24 Ellen Road ditch prior to clearance - Councillor Steven Lambert

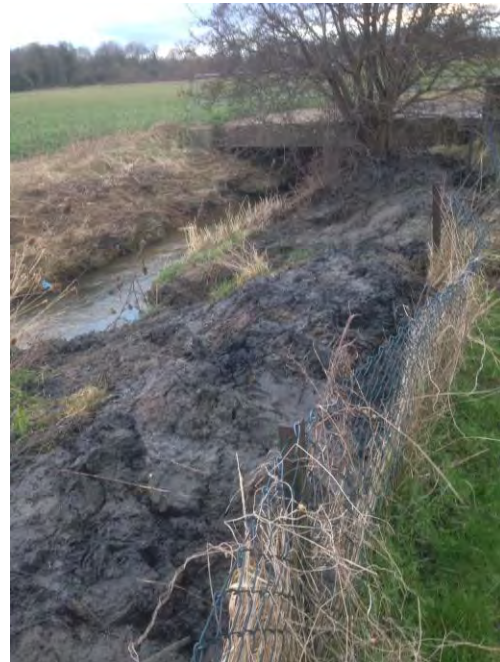
10/02/2014 16:52 Silt removed from Stoke Brook and gully outfall at end of Fox Glove - Councillor Steven Lambert

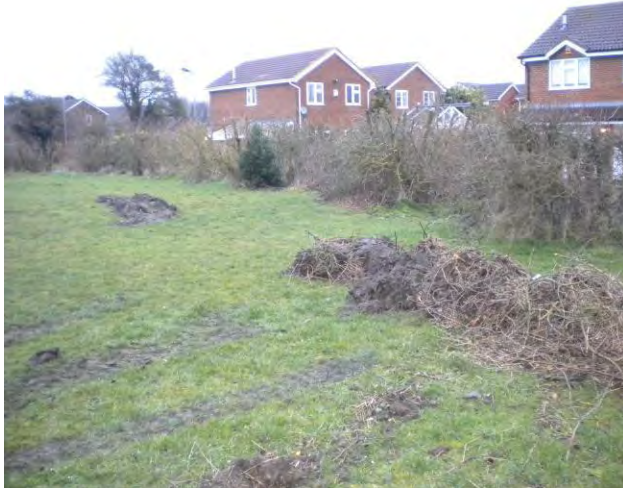
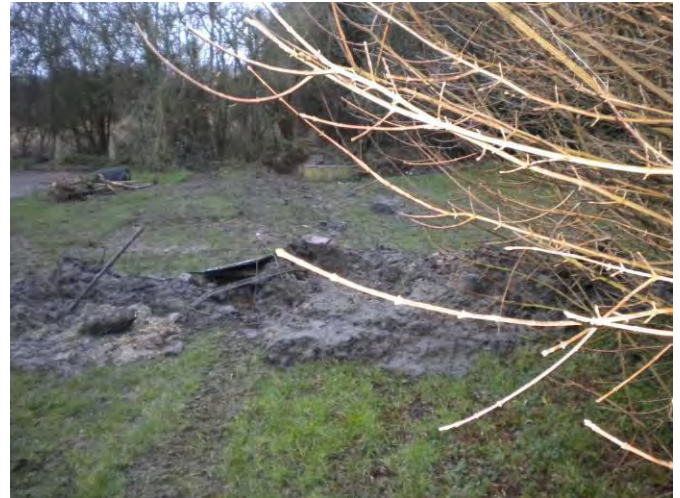
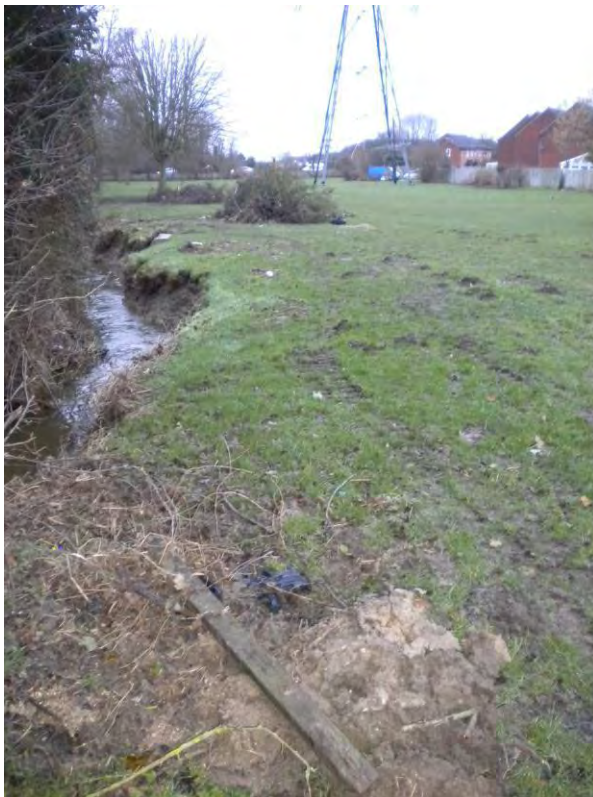
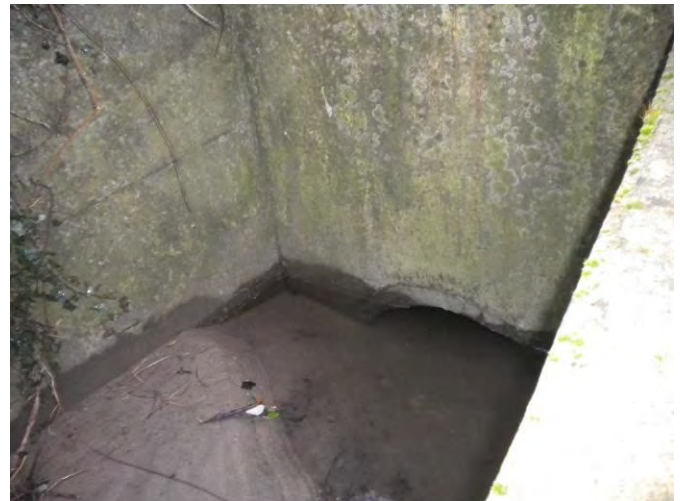
Photos of rubbish removed from Stoke Brook after the flood on 07/02/2014 Chris Spreadborough

Gully outlet at the end of Stratford Drive. This was before the silt was removed, if viewed today the bottom can be seen which shows it would have been about 60cm deep to the bed of the brook.
