Thornborough Section 19 Flood Investigation

Final Technical Report

July 2022

Buckinghamshire
Council

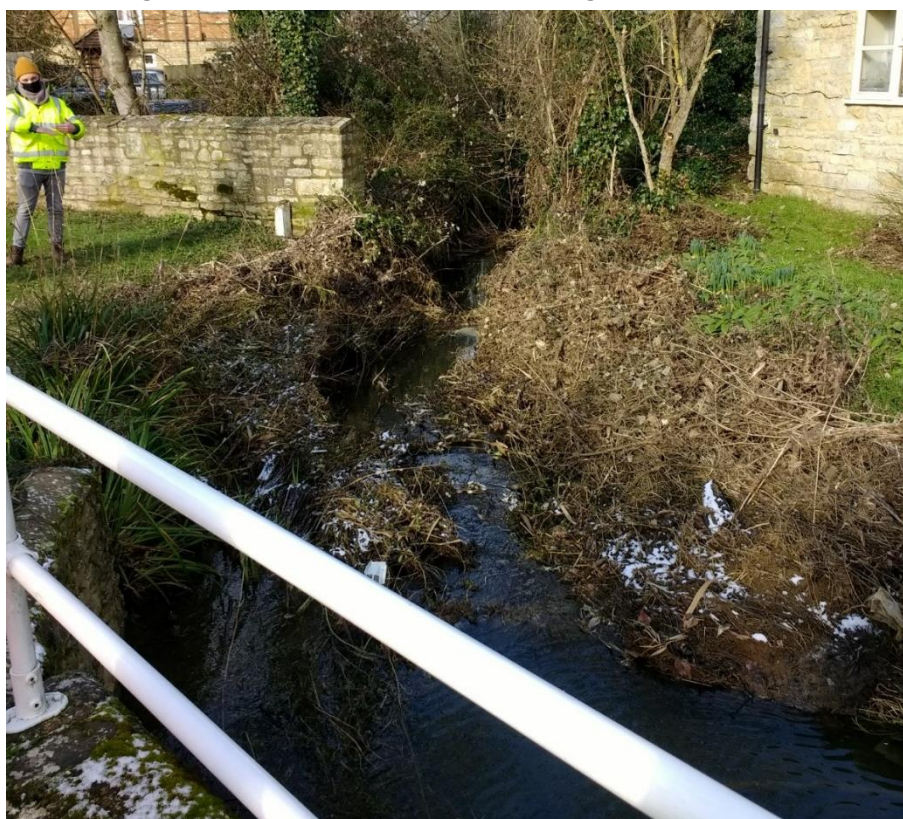
Figure 5-4: The watercourse at the 'second' bridge in the village on the High Street, which is maintained by riparian owners, February 2021. Credit: Buckinghamshire Council

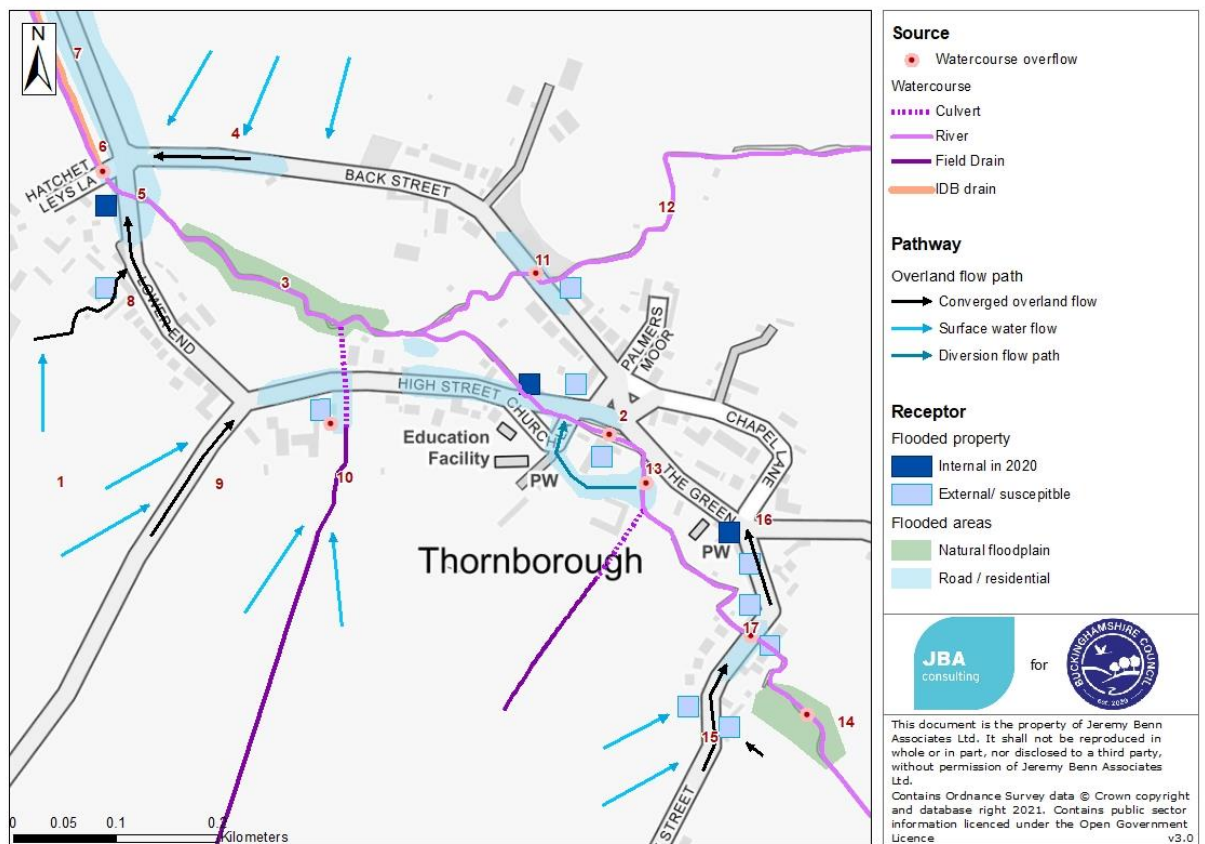
Figure 8-1: Map of sources, pathways and receptors in Thornborough village

The ordinary watercourses were overtopped in at least seven locations in the village during the event, as shown in Figure 8-1. Overtopping occurred on the unnamed watercourse at the Old Manor (10), Cowerde Brook at Hatchet Leys Lane bridge (5, 6), Thorn Brook at Back Street Ford (11), Tonne Brook at the pond next to the Village Hall (2, 13), Bridge Street (15) and the footbridge upstream of the Maltings (14).

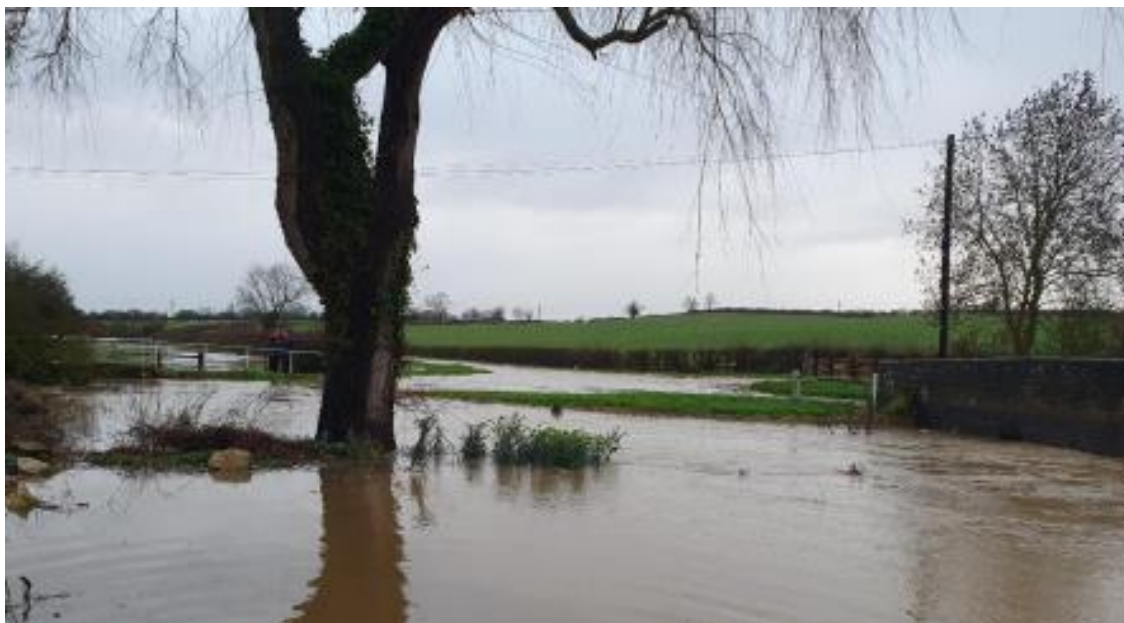
At Hatchet Leys Lane (6) Cowerde Brook overtopped the bridge and spilled into the road, submerging areas of Back Street and Lower End. This flooding began at around 16:00 and is shown in the photo in Figure 8-2.

Figure 8-2: Photo of flooding at Lower End Bridge and Hatchet Leys Bridge (Locations 6 and 7), taken at approximately 16:00 on 23 December 2020 from the left bank of the watercourse. Credit: Thornborough residents

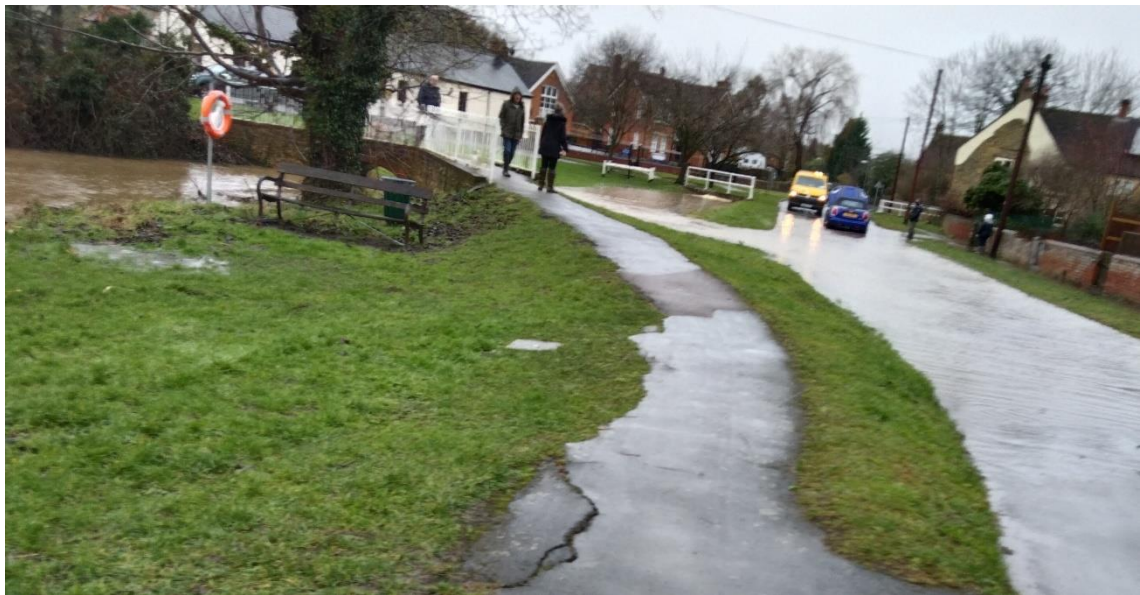
Near the Old Manor (10) the culvert that runs under High Street surcharged due to the volume of water passing through. Water backed up and flowed out on to High Street, where it combined with surface water exacerbated by blocked drains.

Figure 8-3: Tonne Brook beginning to overtop at High Street, taken from Location 2 and looking downstream. Credit: Thornborough residents.

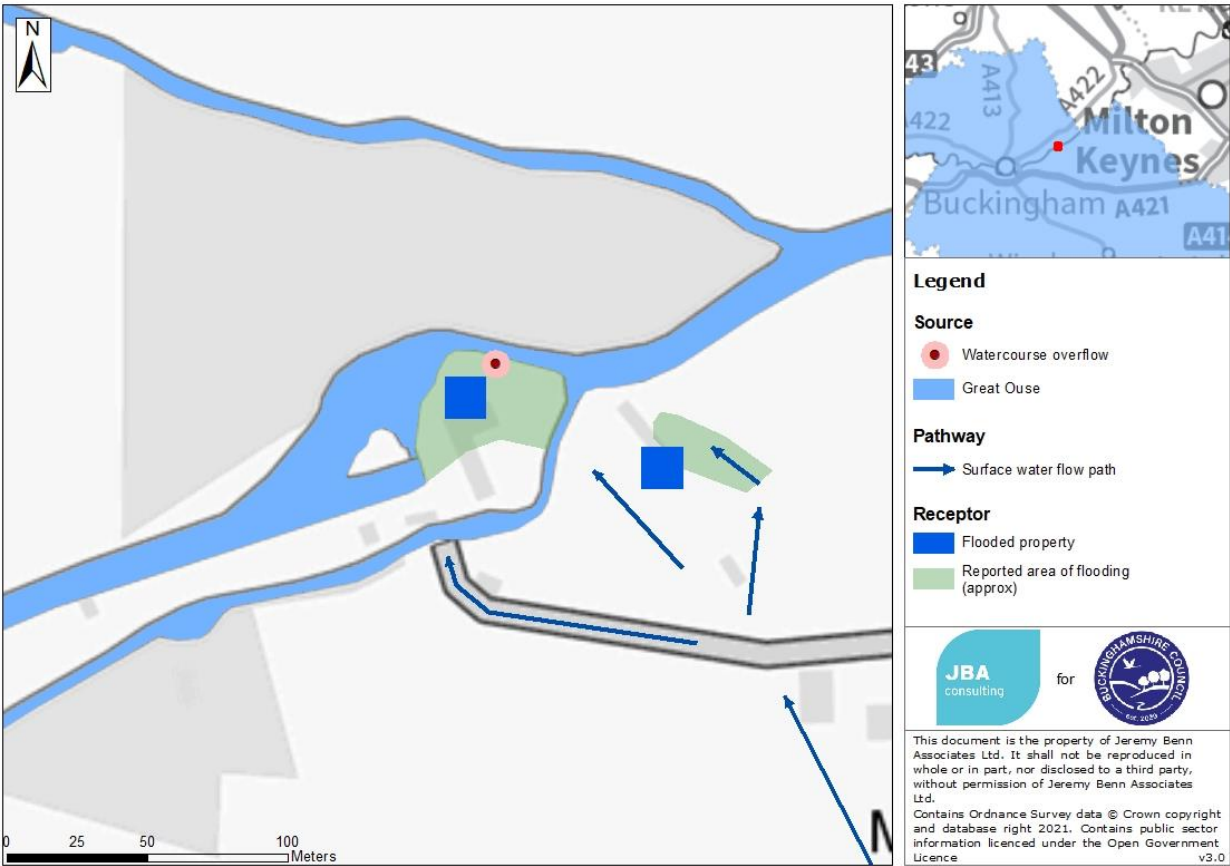
Figure 8-4: Map of sources, pathways and receptors in the Thornborough Mill area

There were high river levels on the River Great Ouse during the event, including at Thornborough Mill (Figure 8-4), where the south bank was overtopped.

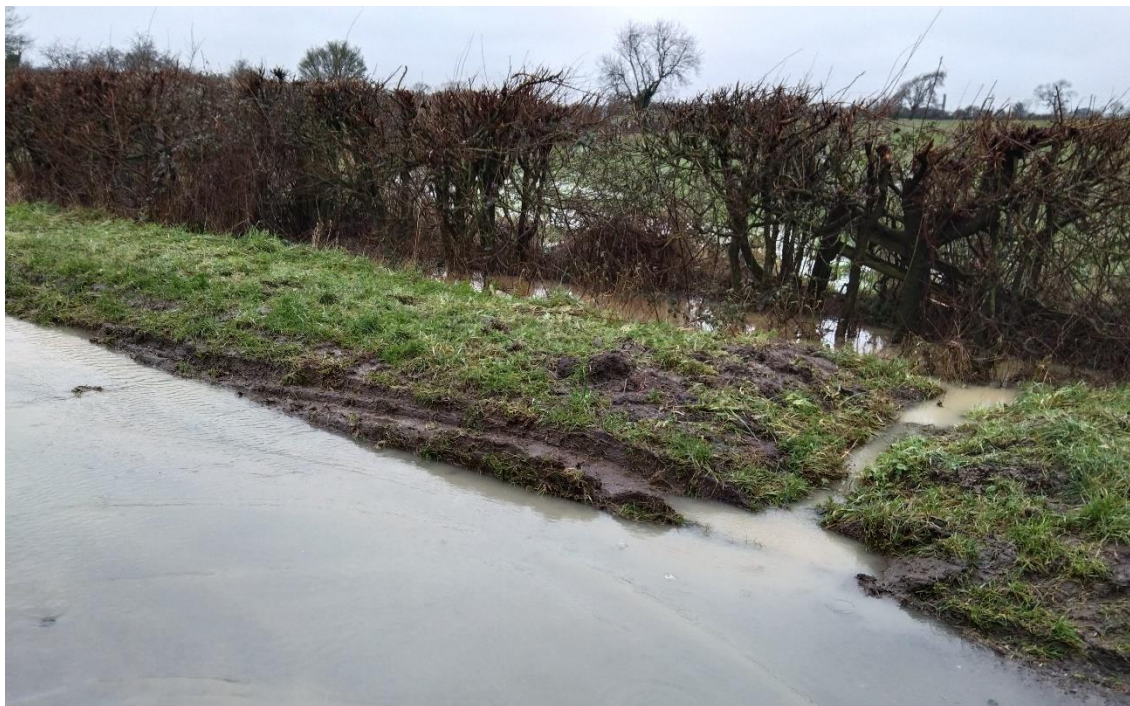
Extreme rainfall on already saturated fields led to overland surface water flows developing on the fields surrounding the village at Locations 1, 4, 10 and 15 (see Figure 8-1). In particular, flows from the area surrounding Stonelands Farm was noted for contributing significant amounts of water towards the rear of properties on Lower End and High Street (1). Along Back Street (4) water was also observed flowing off the fields and on to the road, exacerbated by an overflowing drainage ditch along a hedge line on the highway verge. Water was also observed 'pouring' off fields and flowing on to the road at Bridge Street (15). At Thornborough Mill, surface water was also observed flowing off the fields to the south, as indicated in Figure 8-4.

Figure 8-5: Overland flow from fields accumulating on Back Street. Credit: Thornborough residents.

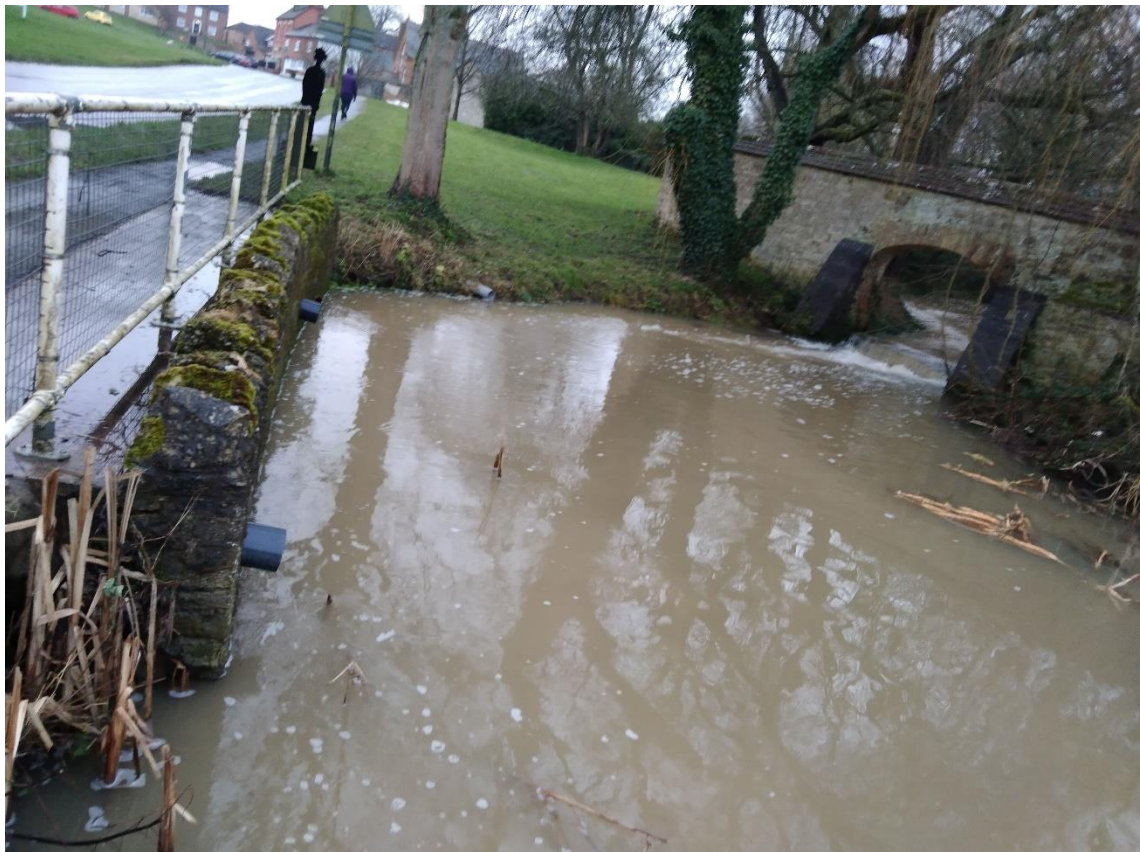
In the centre of the village on the High Street (Location 2), two other properties flooded externally, in addition to the internal flooding experienced by another nearby property (noted above). At one property the flood water reached the sill of front door, and at the other, floodwaters from Tonne Brook (13) flowed through the rear garden (denoted by the 'diversion flow path' in Figure 8-1). Residents noted that flooding in this garden is a regular occurrence, and there is a sluice fitted at the bottom of the gate to allow floodwater to pass downstream.

Figure 8-6: The inlet to Thornborough Pond at time of high flow. Credit: Thornborough residents

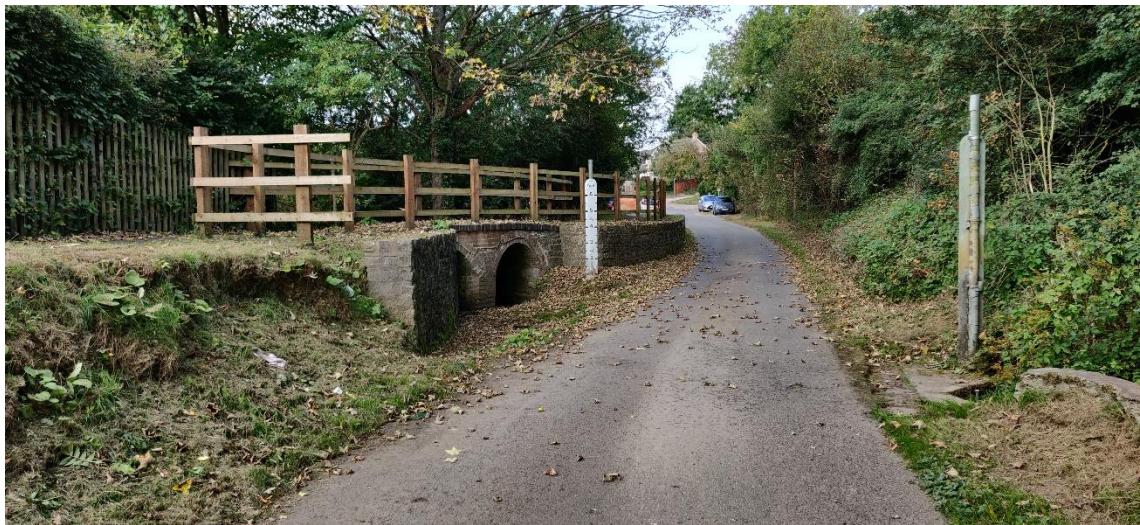
Figure 9-5: Back Street Ford, September 2021

Although the Thorn Brook channel is constrained in a culvert and engineered channel with heavily vegetated banks at Back Street, there is a notable relief flow route in the form of the Ford. However, upstream of Back Street, the fields at the right bank of the watercourse are reported to have been raised in recent years, which encourages flow to leave the left bank of the watercourse, and flow towards properties on Back Street.

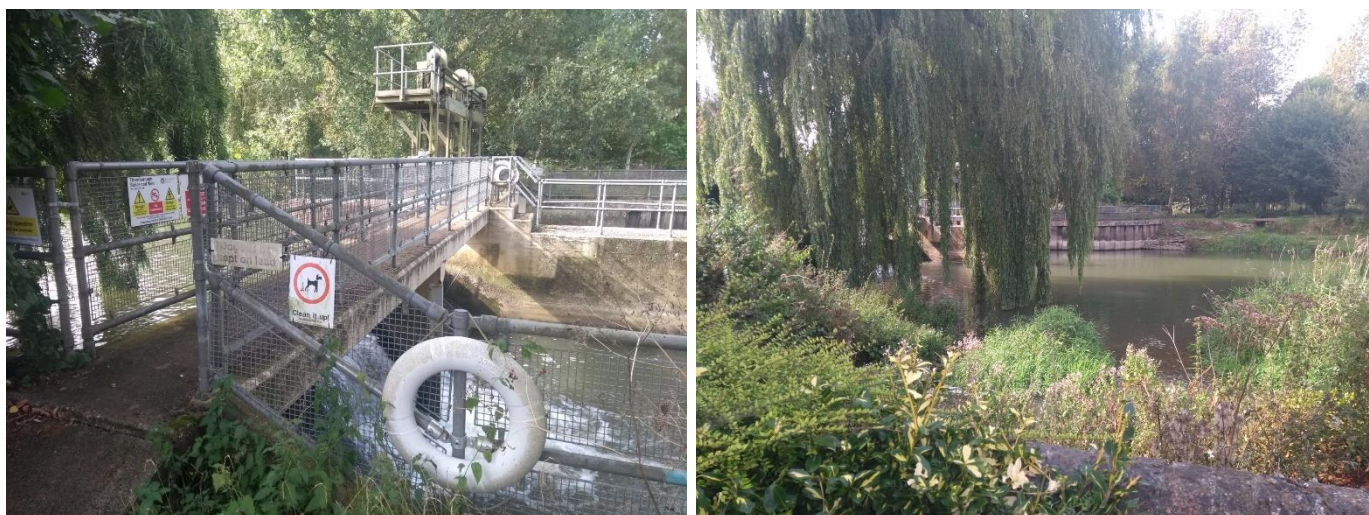
Figure 9-7: Weir on the Great Ouse at Thornborough Mill, September 2021

At the time of the site visit in September 2021, the watercourse and weir were clear of visible vegetation and sediment. However, there is concern among residents that the weir is contributing towards increased siltation of the channel. Assessment of the impact of the weir on sedimentation of the Great Ouse is beyond the scope of this Section 19 investigation, although it is understood that the Environment Agency is carrying out an appraisal to inform future management of the Great Ouse weir at Thornborough Mill.
