# Thornton Section 19 Flood Investigation

## Final Technical Report

14 July 2022

Buckinghamshire  
Council

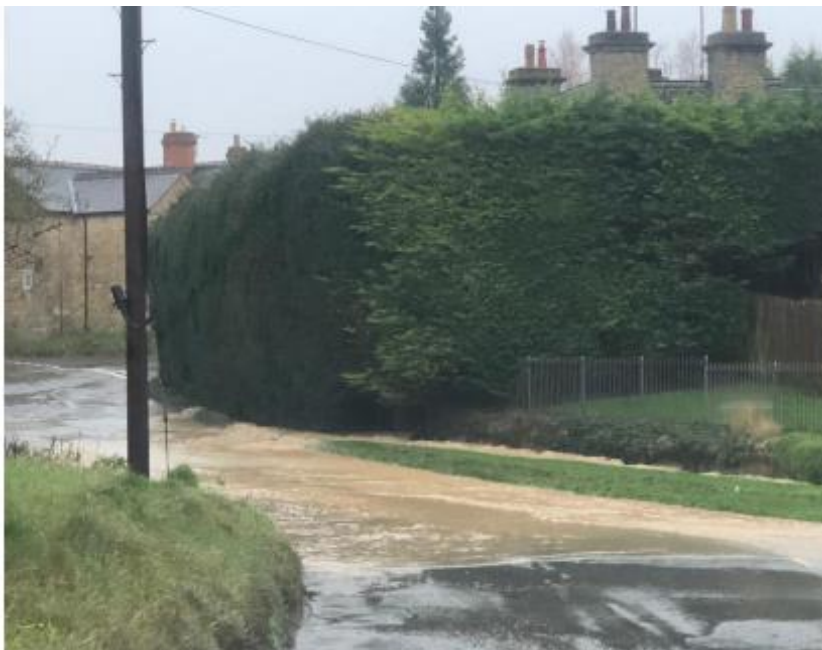
adjacent to Crossbridge Barn before returning to its original course towards the Great Ouse. There was one reported overtopping of the watercourse, shown in Figure 8-1b at location 8, where the watercourse spilled out across the road rather than following the diversion channel.

**Figure 8-2: Overtopping of the watercourse in Thornton Village (location 2). Credit: Thornton residents**

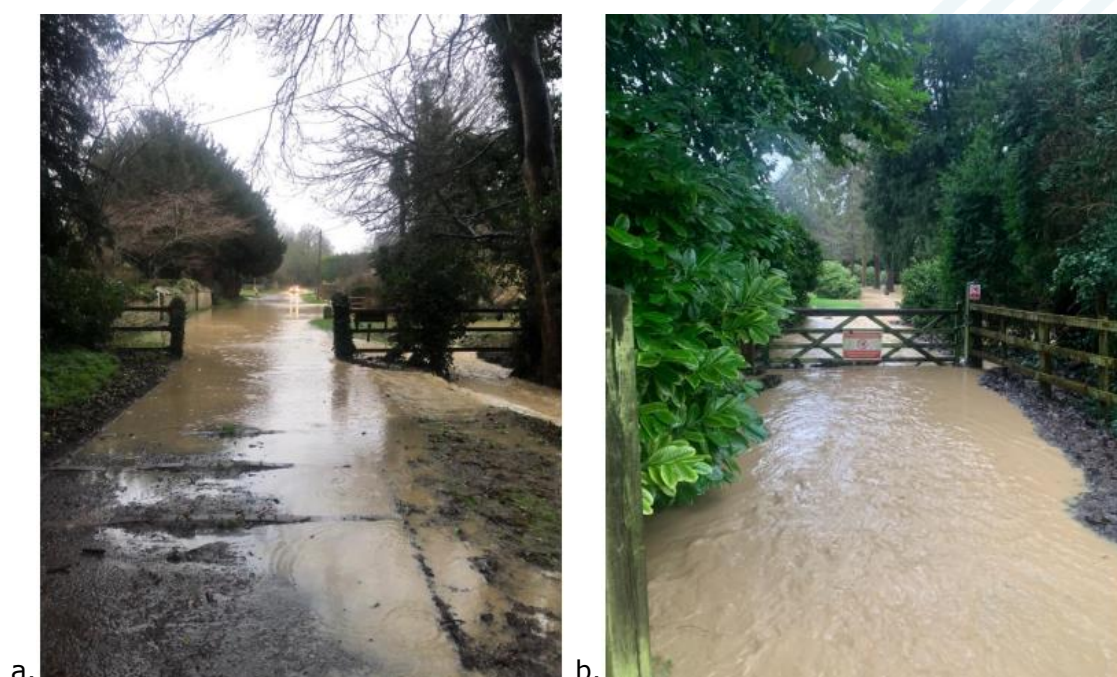
A culvert upstream of the village at Beachampton T-junction was believed to have been blocked at the time of the flooding on 23 December and caused water to overtop and flow across the road. This caused marginal highway flooding and access issues, although it is not believed to have caused flooding to properties or worsened the impacts downstream. The culvert was cleared by Transport for Buckinghamshire in February 2021.

**Figure 8-3: Location 2 on College Lane near the village (note water has come down from the village) (a); and Location 1: Lane outside the entrance to the Coach Houses (b). Credit: Thornton residents.**

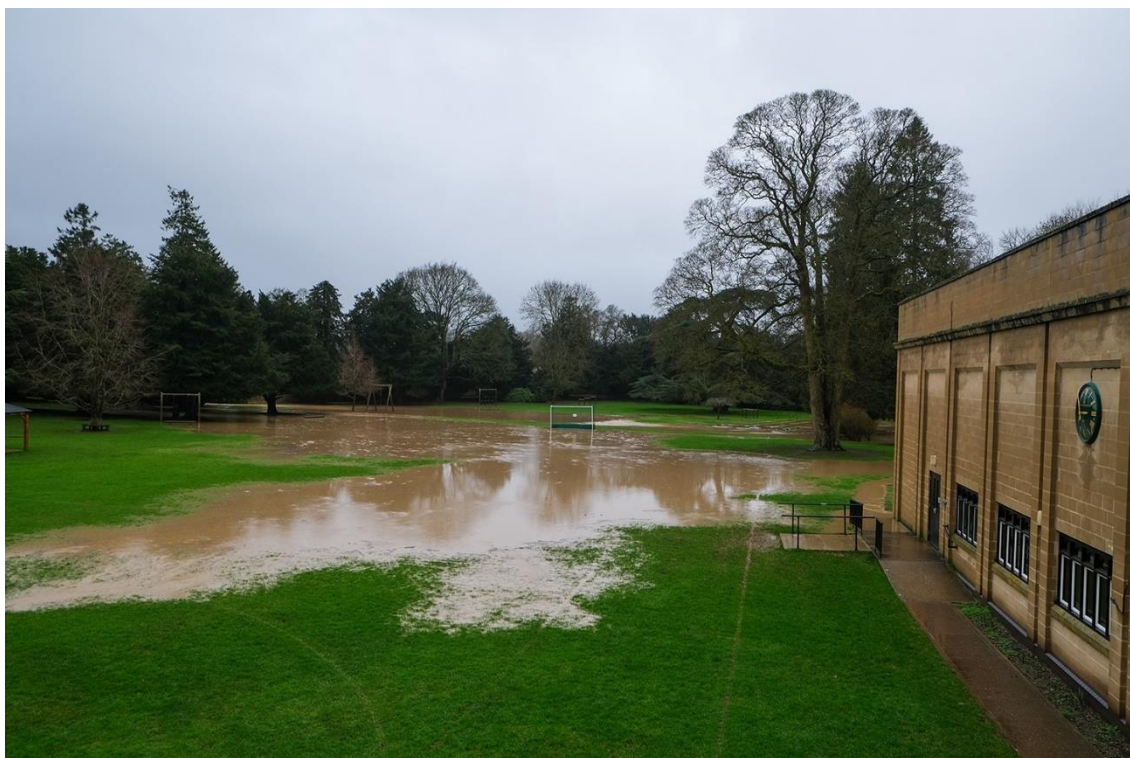
**Figure 8-4: Flooding at the school fields. Credit: Unknown.**

The calculated culvert capacities are shown in Table 9-1. The theoretical capacity of the School Fields culvert is similar to the estimated peak event flow. Exceedance of this culvert was a contributing factor to the flooding observed around the school fields.

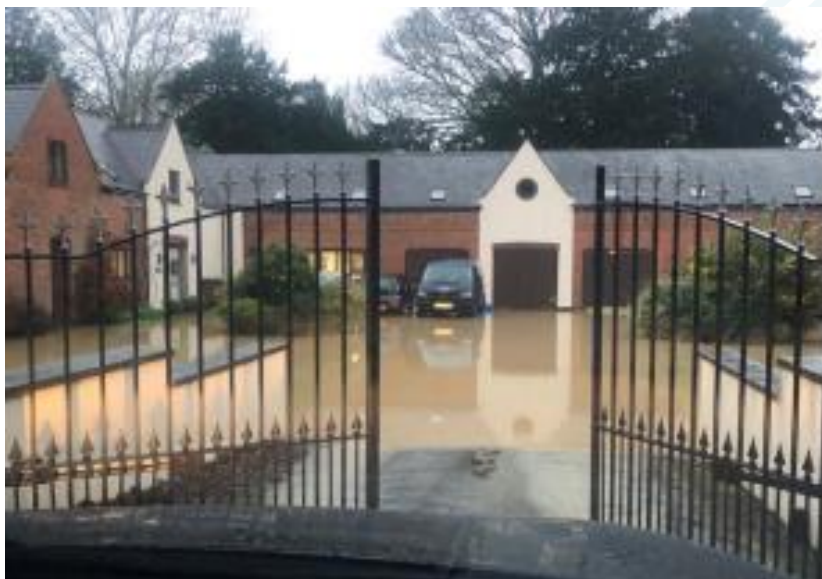
At least seven properties are known to have flooded internally during the event in Thornton village. Internal water depths at the Coach Houses (location 4) reportedly reached 75mm to the ground floor and garages, and externally a maximum water depth of 500mm was reported in the courtyard (Figure 8-5). Properties along the main road in Thornton were also flooded internally due to overland flow from the rear fields at location 2. This includes a report of internal flooding of 20mm. Thornton College also flooded internally, no recorded depths have been provided but carpets and tiles on the floor were damaged.

**Figure 8-5: The Coach Houses courtyard. Credit: Thornton residents.**

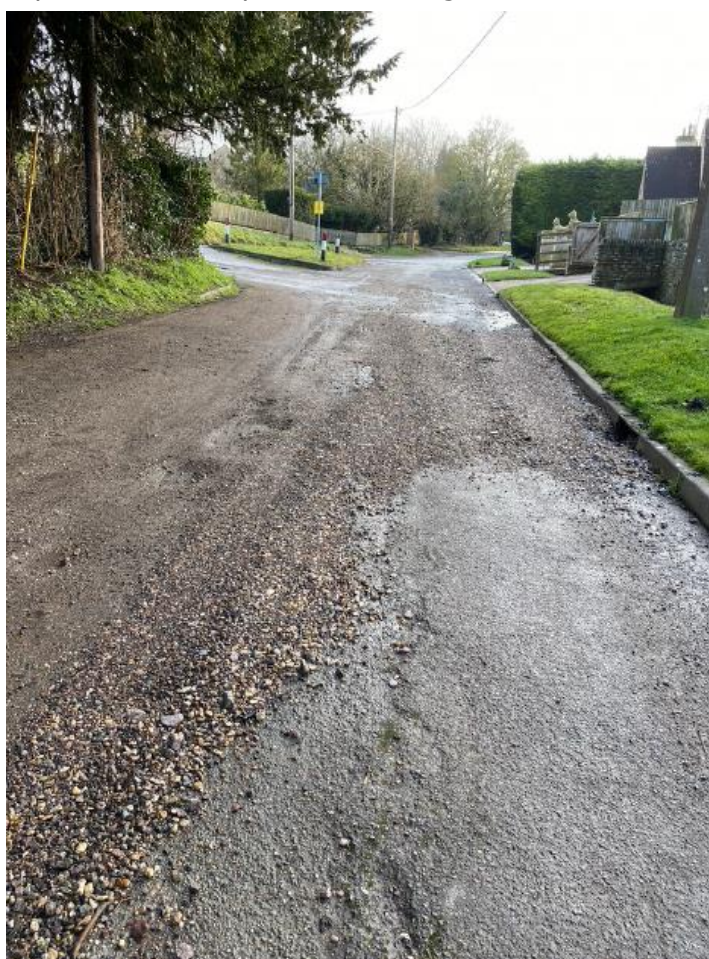
Flooding caused damage to roads and caused a large pothole to develop on the main road through the village. At the time of the flood, many of the roads around the village were temporarily unpassable. Sediment deposits from the floodwater accumulated on some roads in the village, causing a hazard to traffic in several locations including Beachampton Road junction opposite Village Farm Barn and College Lane and near Bridge Cottages. They were reported to Transport for Buckinghamshire and subsequently cleared in February 2021.

**Figure 8-6 Sediment deposited on road near Bridge Cottages**

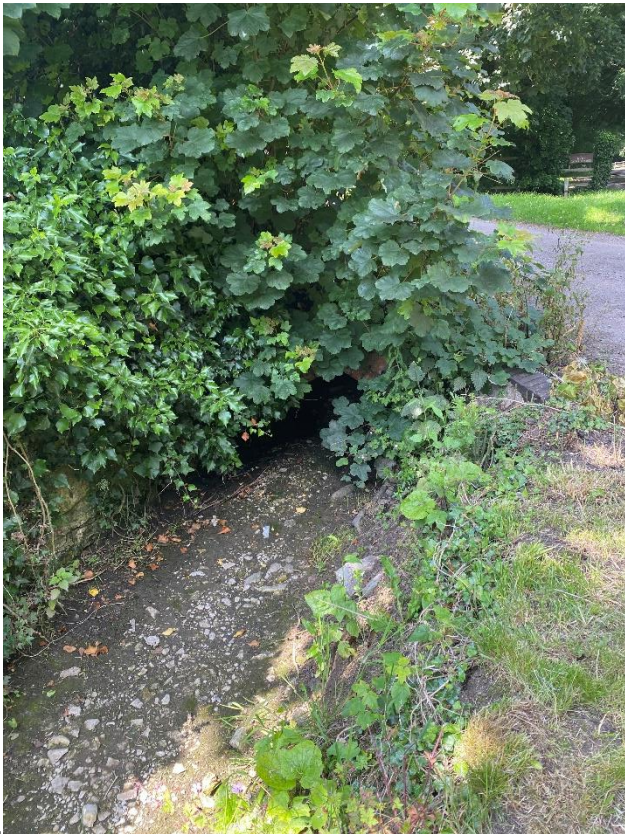
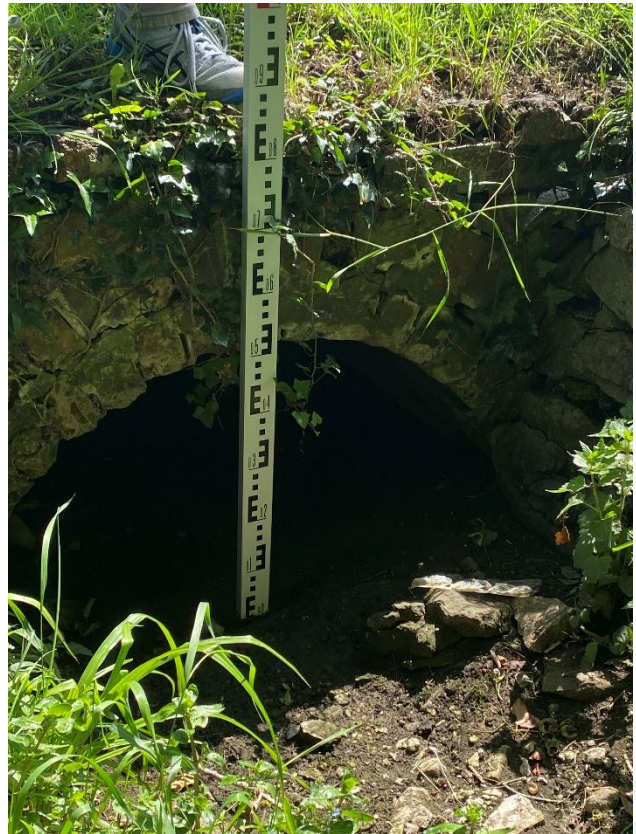
a. **Figure 10-1: Channel condition around the Bridge Cottages culvert inlet (a); and Bridge Cottages culvert outlet (b).**

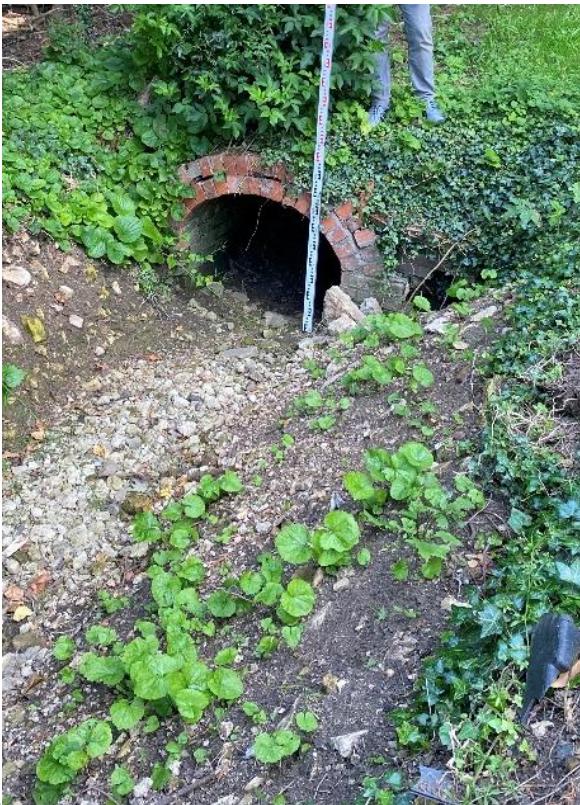
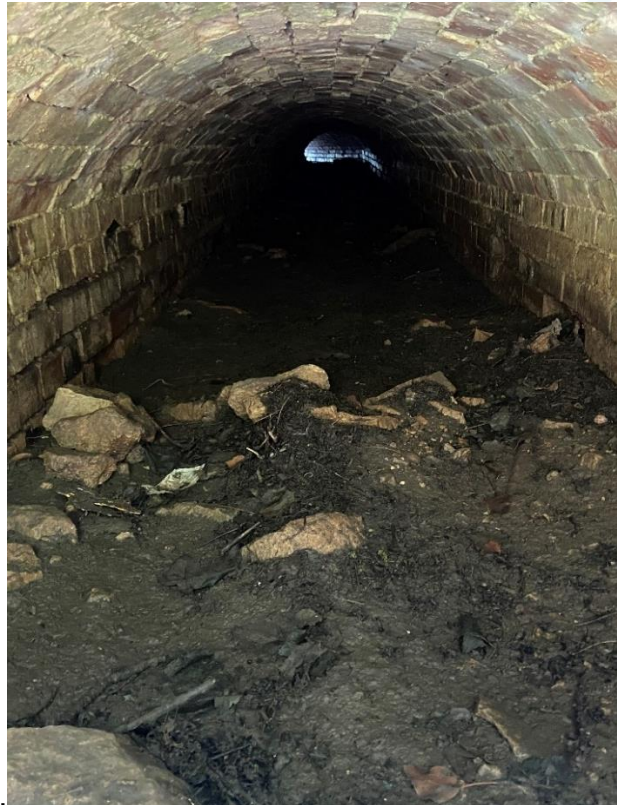
The observed levels of silt and gravel deposits in the Thornton village watercourse appear low; however, assessment of the culvert dimensions shows that the bed level is raised in places causing the flow to become squeezed, for example at the downstream end of the Bridge Cottages culvert, where the vertical size of the outlet opening is 100mm smaller than the size of the inlet opening, so the area of the culvert is less (Figure 10-1). There are also signs of rocky or rubble deposits within the culverts (Figure 10-2b).

a. **Figure 10-2: Coach Houses inlet (a) and Coach Houses outlet looking upstream (b)**

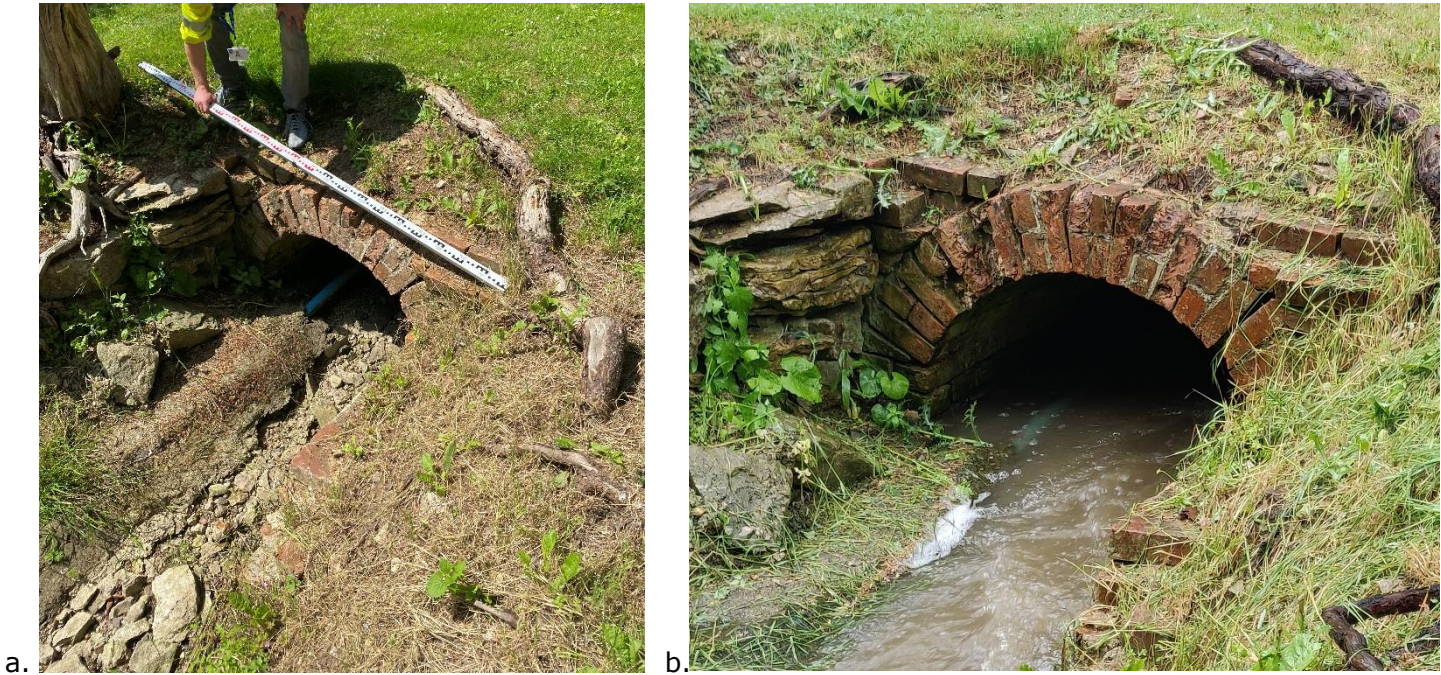
The banks are quite steep in places but show no signs of significant undermining or scour, although there is some slumping and widening in places. In places the headwalls of the culverts present an obstruction compared to the channel banks. There are signs of uneven wear and scouring around the culverts, for example to the right of Coach Houses culvert (Figure 10-2a). There are also signs of modifications made to the channel immediately upstream of the School fields inlet that have the potential to cause obstruction. This is shown in Figure 10-3 where a blue pipe can be seen held in place by concrete.

**Figure 10-3: Channel condition at the School Fields culvert inlet, showing channel modifications, with no flow on 02 July (a); and with flow on 18 June (b).**
