# Ley Hill Section 19 Flood Investigation

## Final Technical Report

September 2023

Buckinghamshire  
Council

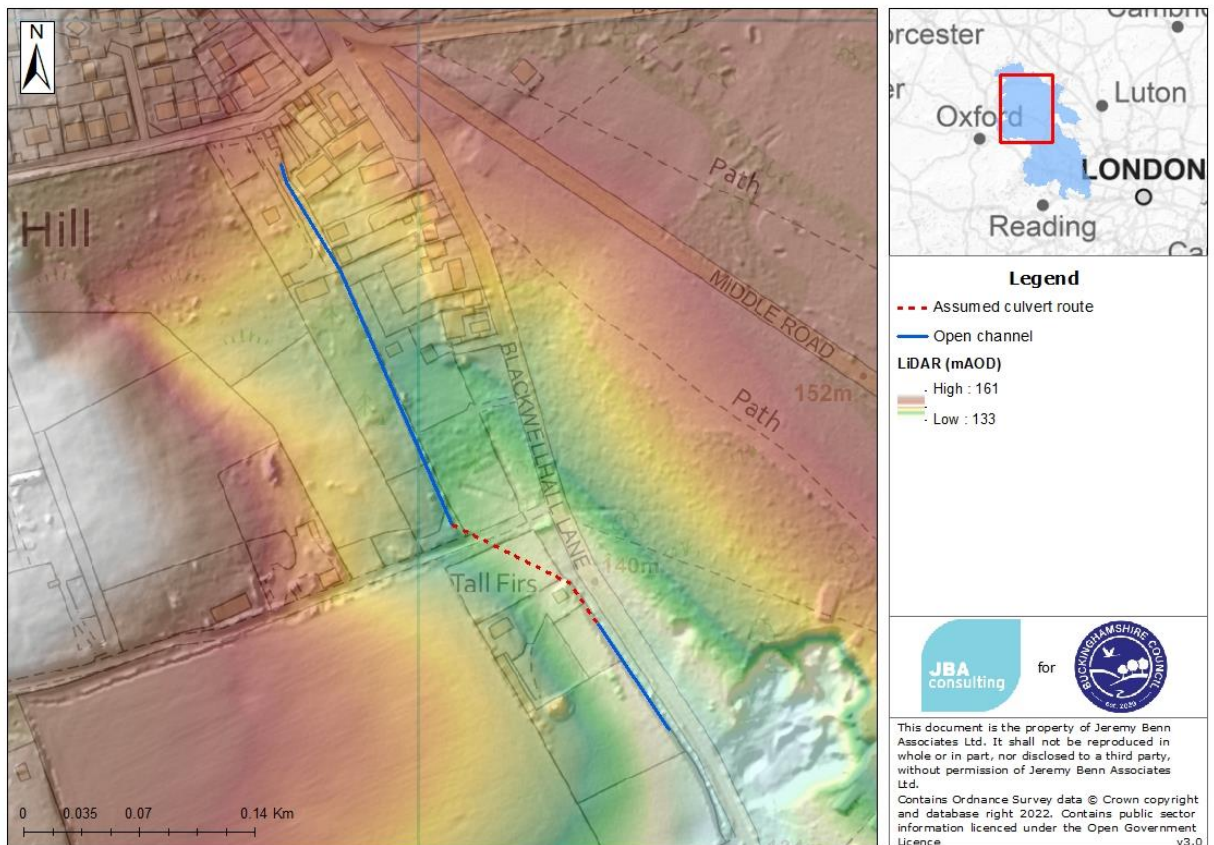
There are no mapped watercourses within the vicinity of Ley Hill. There is a drainage ditch (shown in Figure 3-1) into which there are two known outfalls from the highway drainage. The ditch flows through Horticon Nurseries before it is culverted below the unnamed road off Blackwell Hall Lane.

It is assumed that the culvert outfall is located along Blackwell Hall Lane, downstream of an access road to a property. This is yet to be confirmed through CCTV/dye tracing. Street View imagery from 2010 shows that there was an additional section of open channel upstream of the access road. However, when a site visit was completed, this is no longer open channel. It is not understood if the section was culverted or simply infilled. Further discussion in Section 10.2.1.3.

**Figure 3-1: Approximate route of ditch and assumed culvert route**

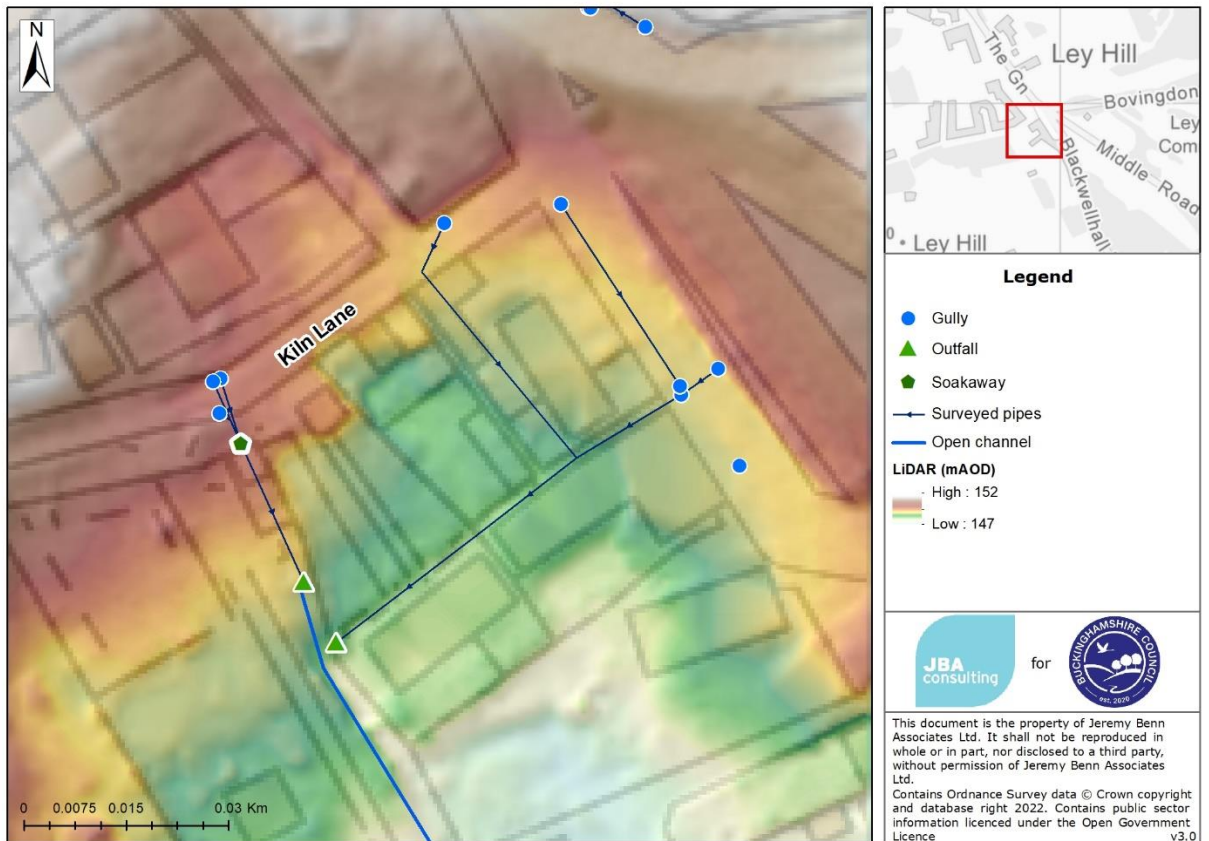
Highway drainage data was provided by Buckinghamshire Highways. In addition, survey of the network was collected in July 2022 to fully understand the drainage in the village, and connections to the ditch. Figure 3-2 shows the location of highways drainage assets around Crown Cottages. There are several gullies along Blackwell Hall Lane which connect into a highway drainage piped system, which flows in a south-westerly direction below the footpath outside Crown Cottages. This system discharges into the drainage ditch to the south-west.

There is also a gully and piped network on Kiln Lane which connects into this piped section of the highways drainage network outside of the Crown Cottages. Along Kiln Lane, there are further gullies which also discharge into the ditch from the north, these however do not form part of the public highway drainage network.

**Figure 3-2: Surveyed highway drainage near Crown Cottages**

It is noted that the number of gullies along Kiln Lane is limited, compared to the catchment they are serving. There are four gullies at the low point of Kiln Lane (shown in Figure 3-2) which discharge to the ditch. Three of these gullies connect into a 225mm pipe. There are

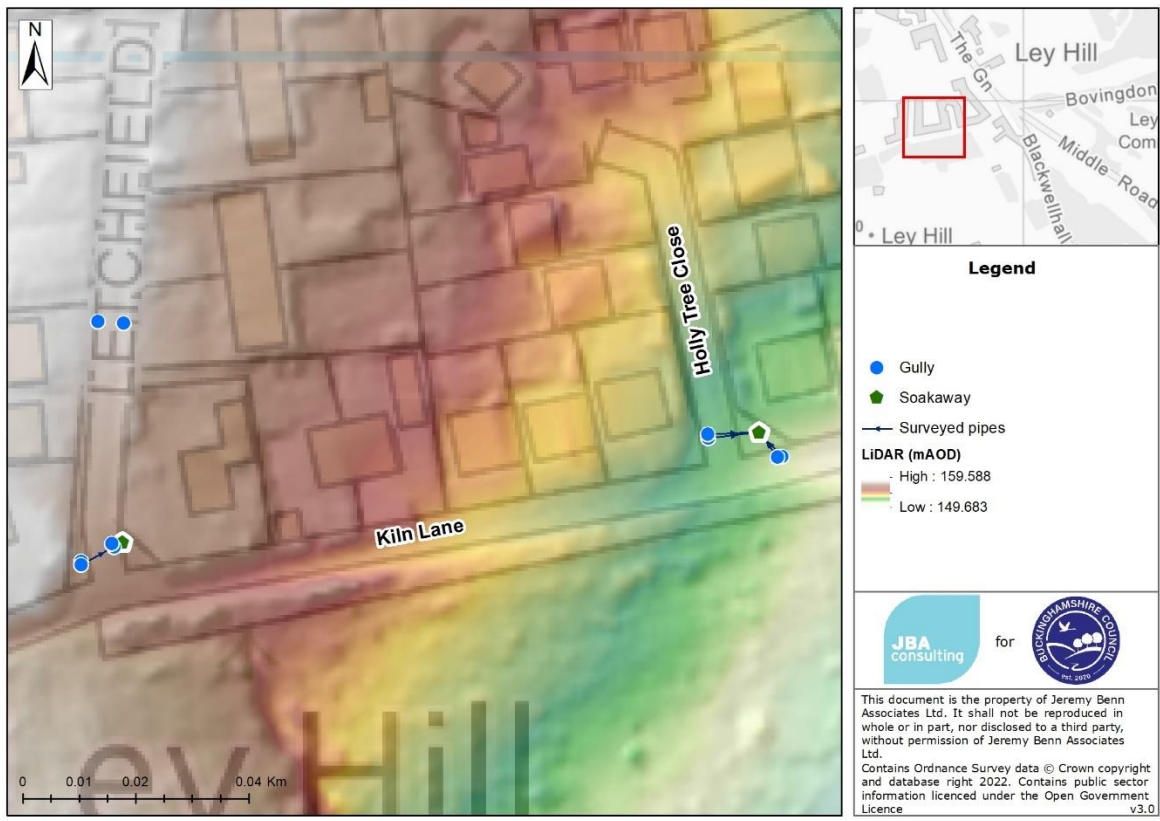
Further west along Kiln Lane, there are two soakaways, into which the gullies from Letchfield and Holly Tree Close discharge, as shown in Figure 3-3.

**Figure 3-3: Surveyed highway drainage along Letchfield and Holly Tree Close**

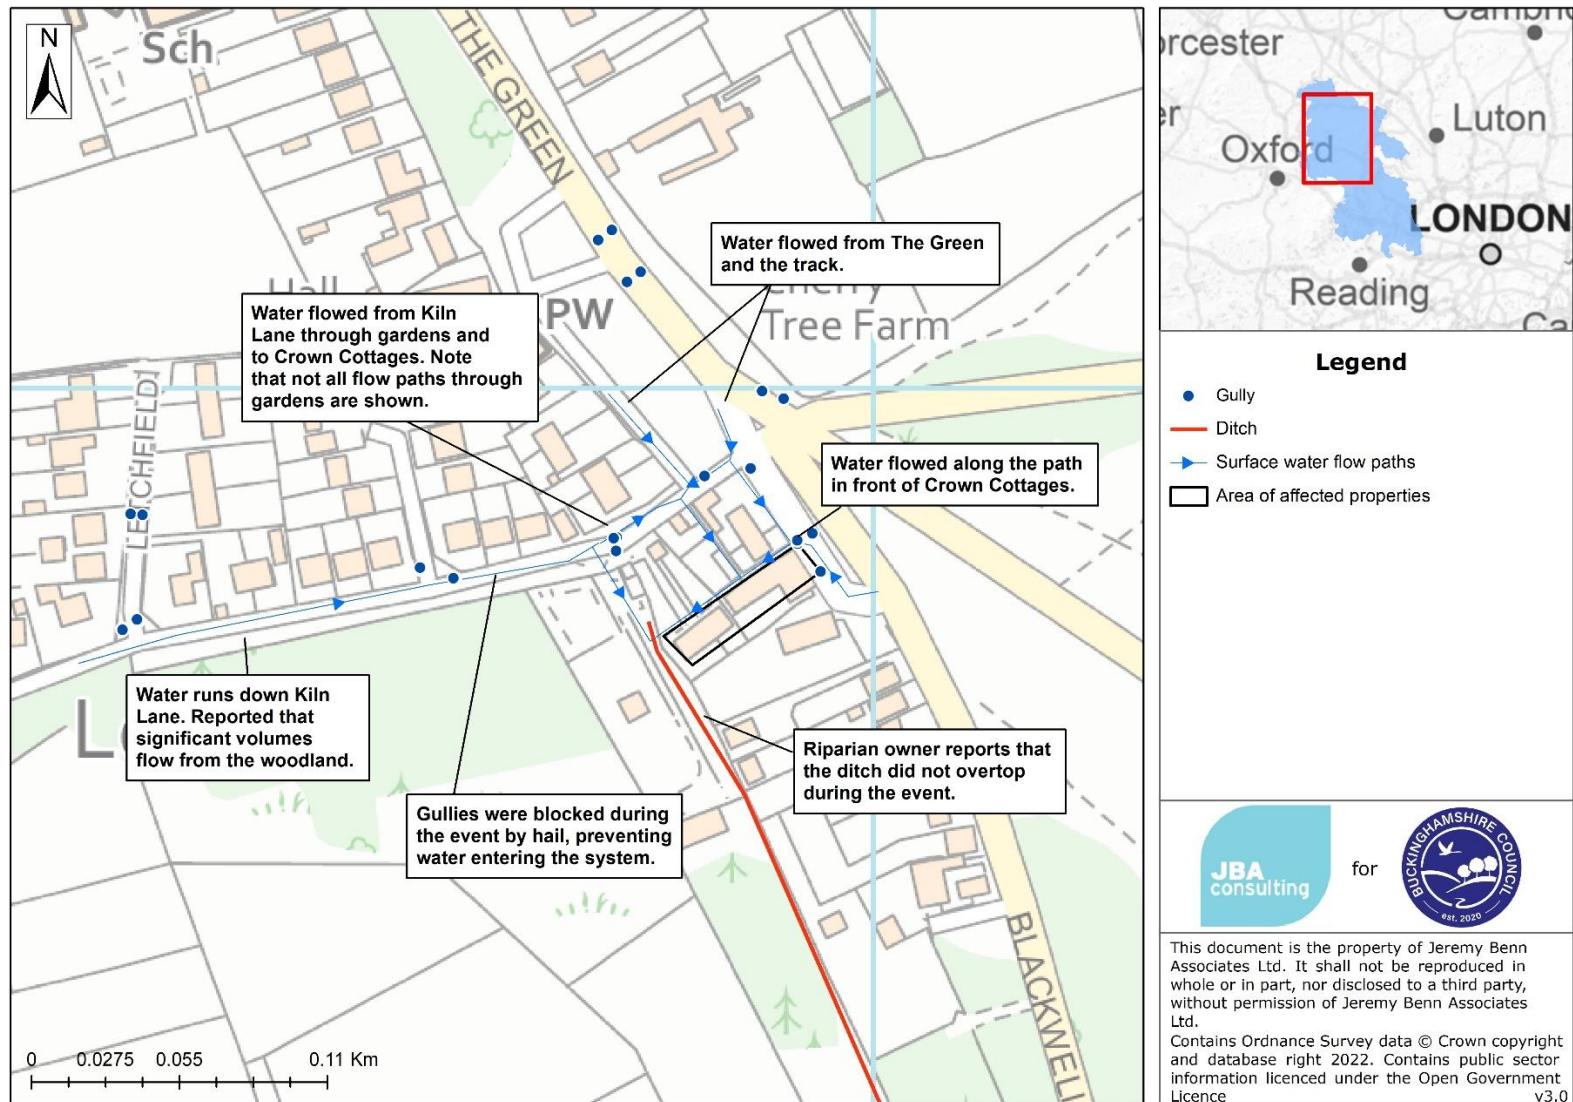
We analysed all the information available to determine the main sources of the flood water, the pathways it took and the main receptors. These are summarised in Figure 8-1.

**Figure 8-1: Map showing the sources, pathways and receptors during the flood event**

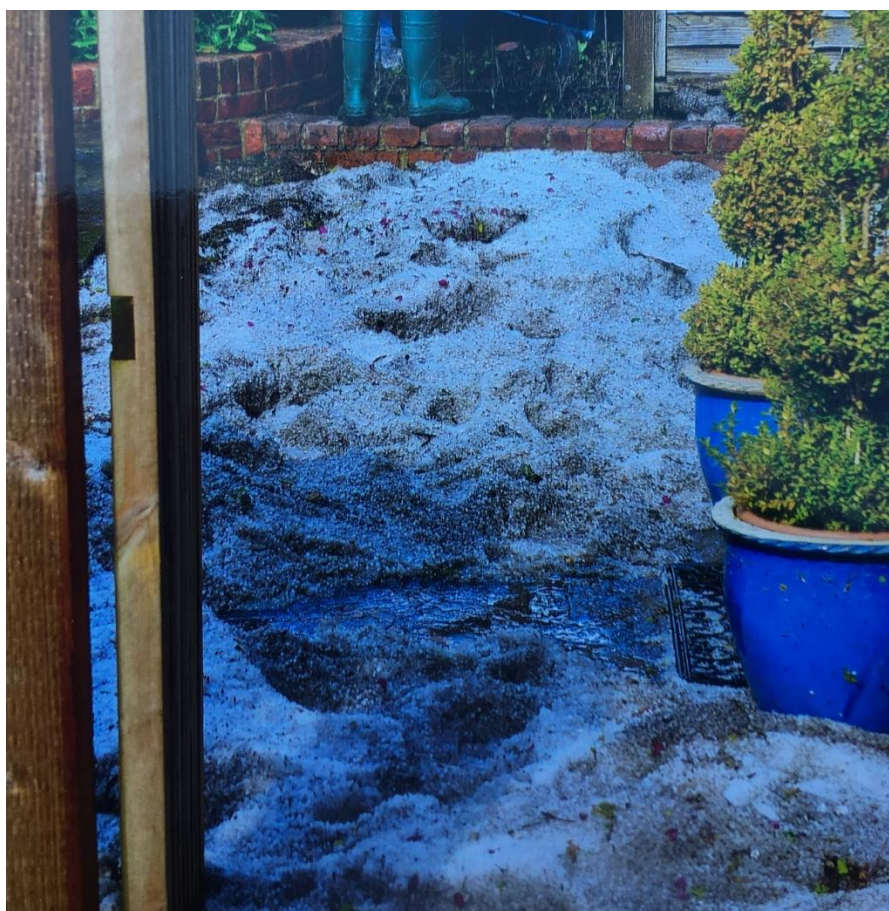
The storm also resulted in a significant amount of hail, which cannot be measured in the same way (see Section 6). Some of the hail was washed along with surface water flows, and some was left behind to melt slowly in situ. Figure 8-2 shows the depths of the hail against a low brick wall previously constructed to divert flows of water away from properties during heavy rainfall.

**Figure 8-2: Photograph showing hail outside Crown Cottages during the event**

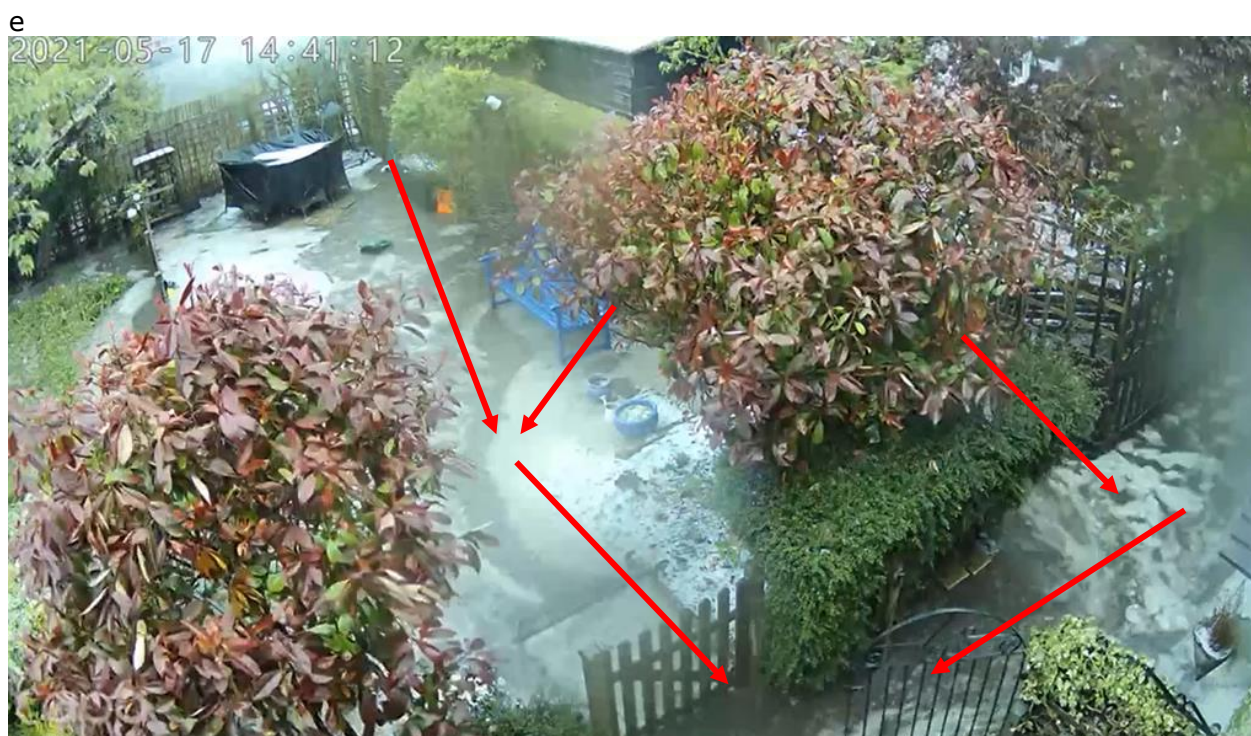
There were several surface water flow routes (shown in Figure 8-3). Notably, along Kiln Lane, the gullies are typically in a poor condition as a result of excess surface material from the degrading road. It is reported that the debris from the road often blocks the gullies which would inhibit the capacity of the drainage system and increase overland flow volumes.

The drainage system was further restricted during the event by the hail, which is reported to have sealed the gullies, preventing the drainage of surface water. The hail was also washed along with the surface water runoff, which may have increased the volume of the flow. Surface water from Kiln Lane affected properties by flowing through the front gardens, shown in Figure 8-3.

**Figure 8-3: Screenshot taken from video during the event, from Crown Cottages in the direction of Kiln Lane. Video shows hail floating on top of surface water.**
