Buckinghamshire County Council

Flood Investigation Report

Wooburn Green

February 2014

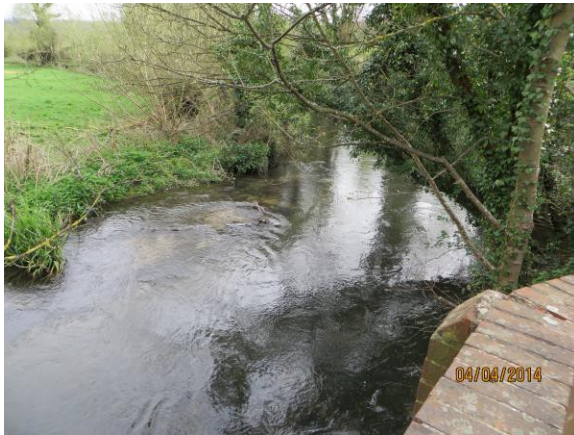
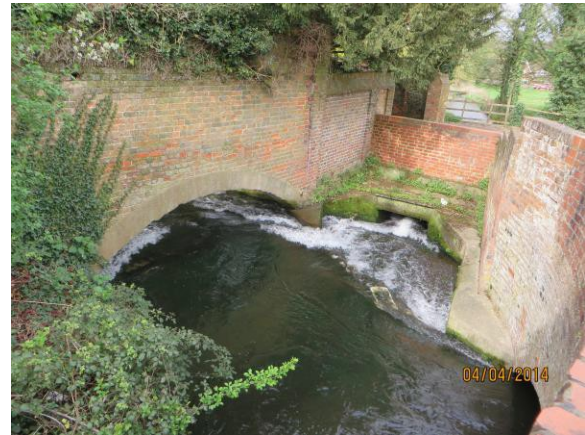
The River Wye is the main river through Wooburn Green. The river comes from High Wycombe upstream and flows into the River Thames downstream at Bourne End. The river is perched above the floodplain between the B4440 and Windsor Hill and does not flow along the base of the valley. Once the river flows under the road at Windsor Hill the channel splits and part of it flows west towards the main road A4094 and then follows the main road. The other channel flows SW around the east boundary and then turns through a right angle and follows the southern boundary of Wooburn Manor Park residential area. The two channels come together again at the SW corner of Wooburn Manor Park before following a route SW along the A4094 through Wooburn. The river channels around this area are all main river and fall under the responsibility of the Environment Agency.

Photos below show the upstream and downstream views of the channel from the road.

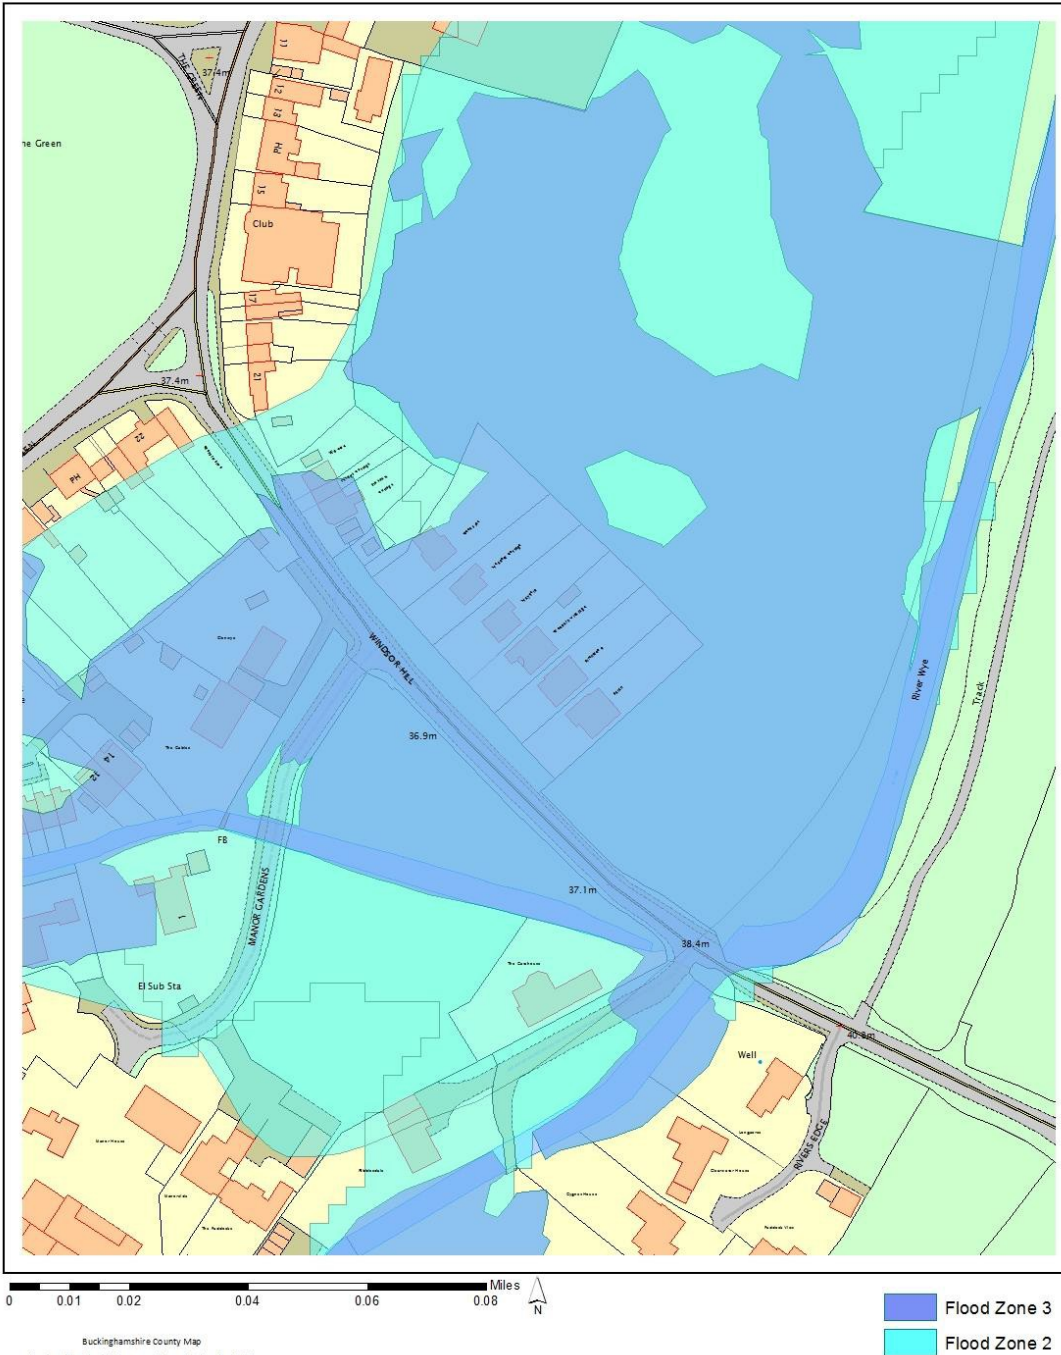
Figure 3 Areas at risk from river flooding, EA 2014

Figure 3 shows the fluvial flood zone. This shows that there are 9 properties on the north side of Windsor Hill which are at risk from a 1 in 100 year flood (Zone 3) and more at risk from a 1 in 1000 year flood (Zone 2). On the south side of Windsor Hill there are further properties at risk from fluvial flooding from the River Wye along Manor Gardens.

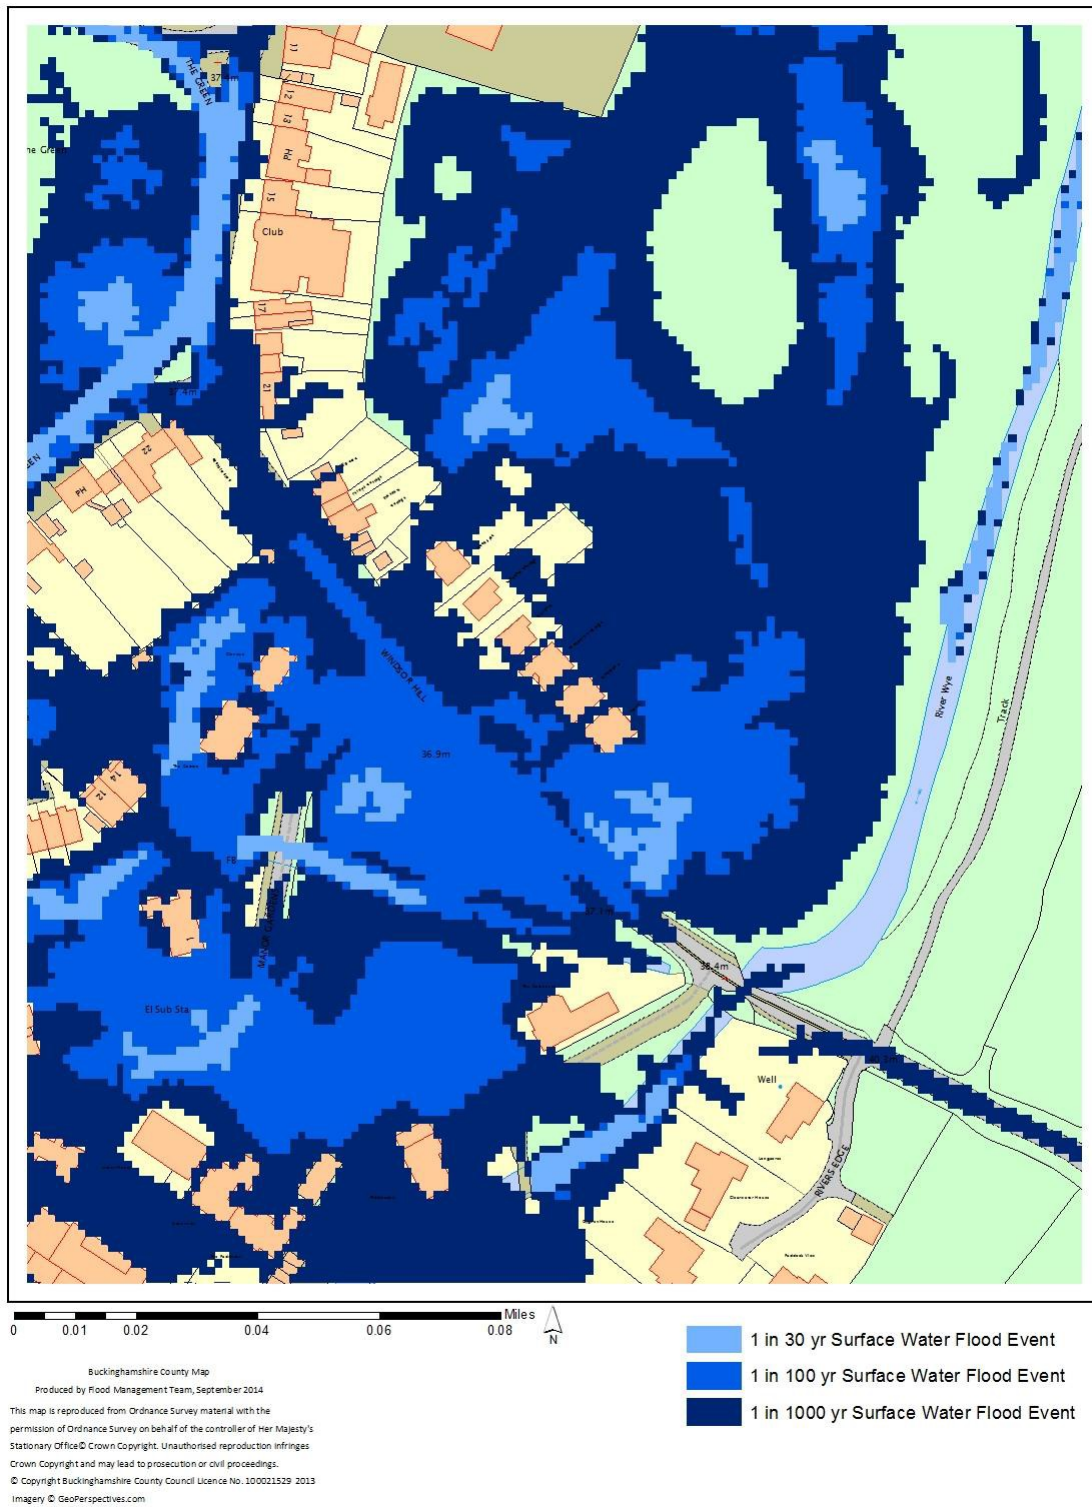
The predicted surface water flooding for a 1 in 100 year event is shown in Figure 4. This shows that although the road is at risk the water would only reach the properties along Windsor Hill in a very extreme 1 in 100 year flood although water would pond around the houses in less extreme events of 1 in 30 year and 1 in 100 year surface water events.

Figure 4 Areas at risk from Surface water flooding, EA, 2014

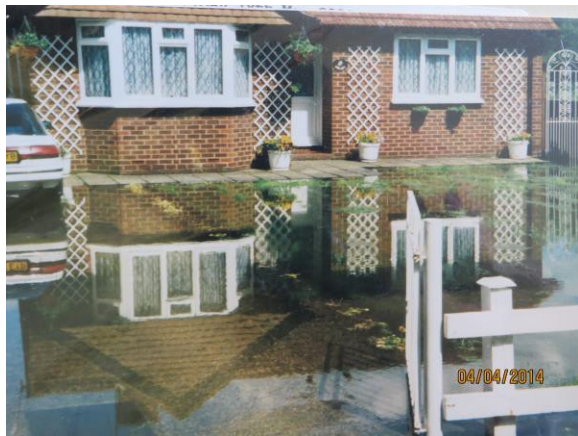
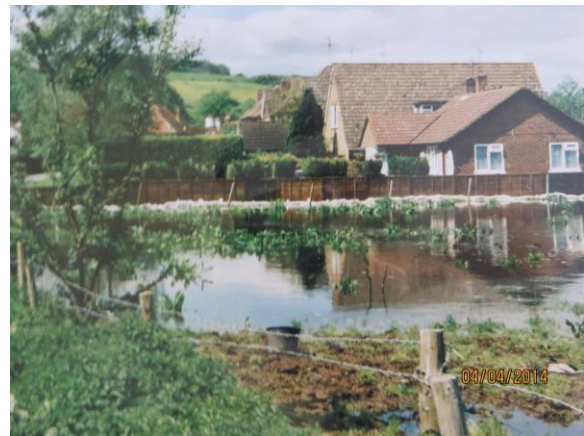
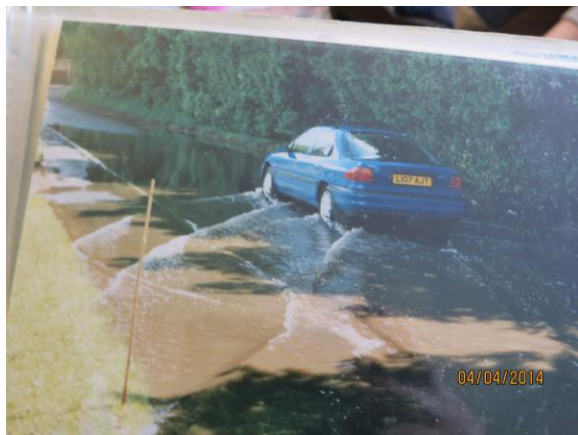
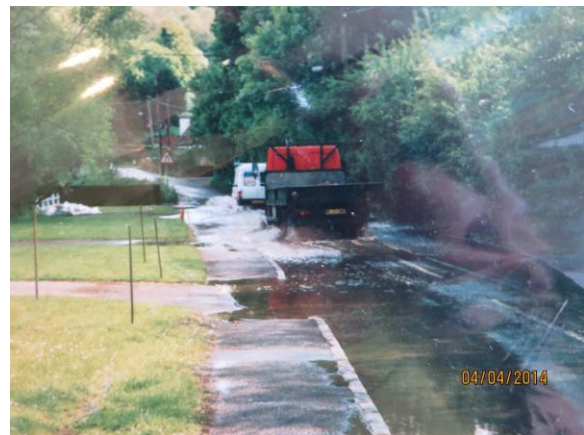
From records from residents there has been flooding on previous occasions from 2001 and 2003. Photos below show that the nature of the flooding is consistent with the maps in Figures 3 and 4 with flooding on the Windsor Hill road and then in the fields between the river and the property Salan. These fields are lower than the river and therefore it is the route of flooding when the river bursts its banks. Photos below show this historic flooding.

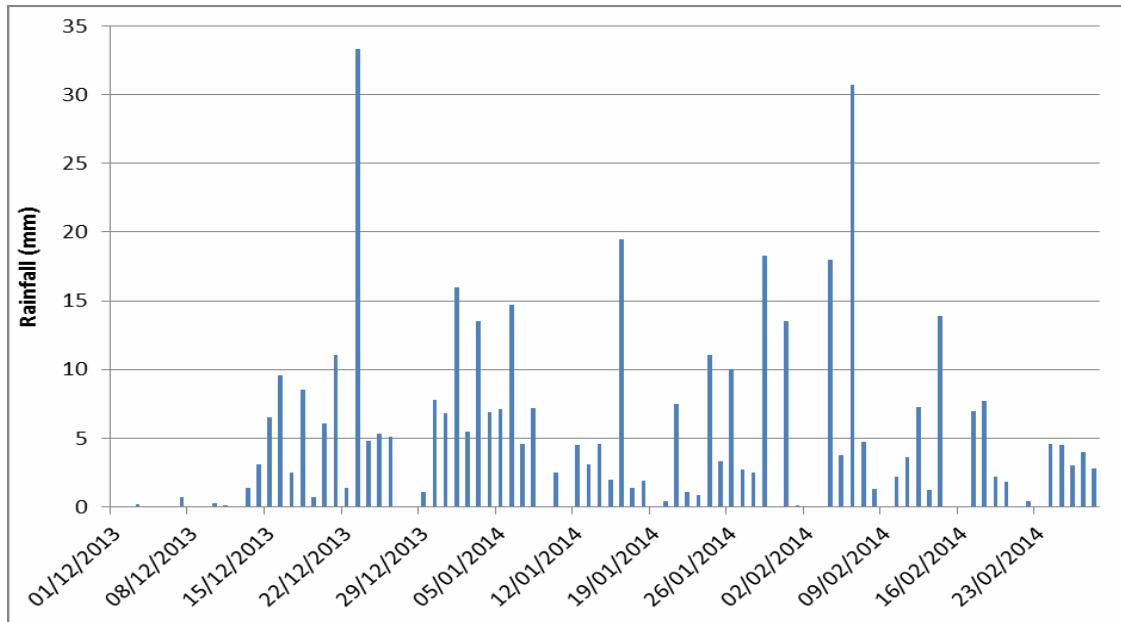
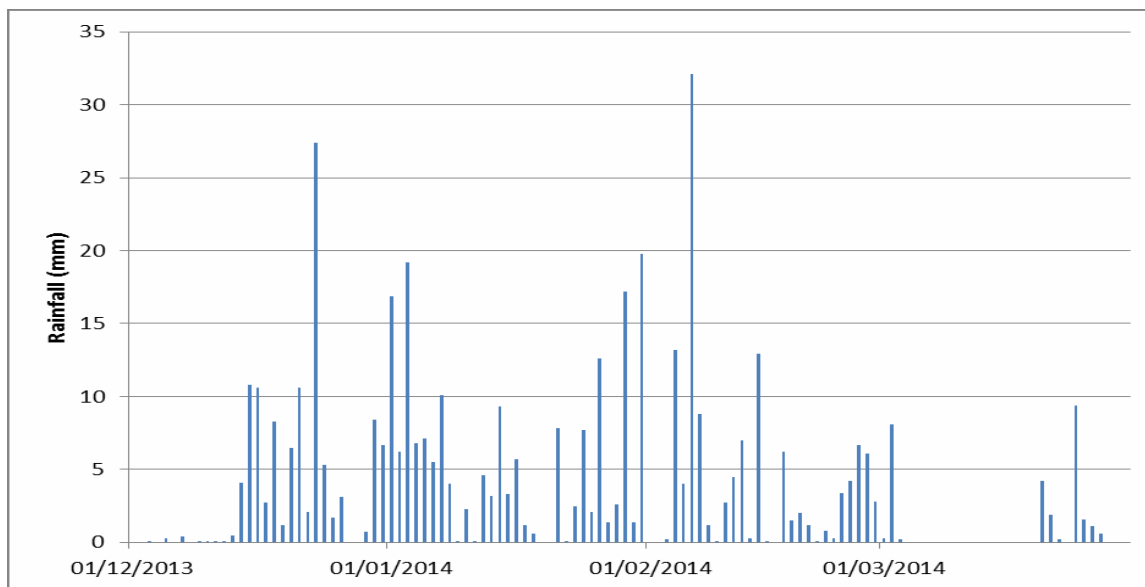
Figure 5 Rainfall data from Hambleton and Little Chalfont

Figure 5 shows the rainfall data from the Hambleton and Little Chalfont rain gauges which are the closest gauges to Wooburn Green. These records show rainfall nearby for the three month period December 2013, January and February 2014. This figure shows the consistently high rainfall over this period with rain on the majority of days and 6 days when the rainfall totals were over 15mm. The winter rainfall recorded in Buckinghamshire in December 2013, January and February 2014 was 420mm in comparison to 185mm average winter rainfall.

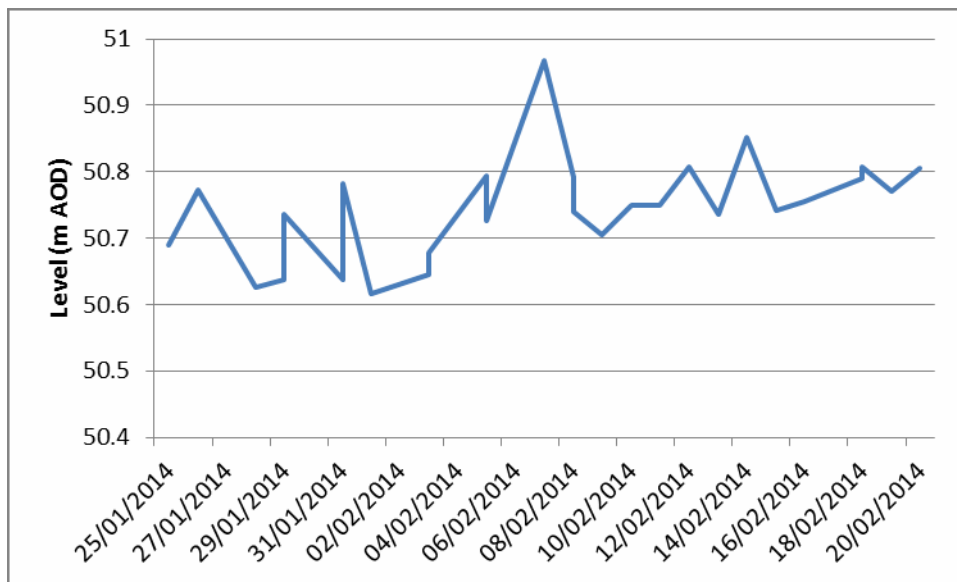
During the period of Winter 2013/14 the very high levels of rainfall had caused the levels in the River Wye to be high. Figure 7 below shows the river gauge levels from the gauge upstream at Loudwater for the early February 2014 period. This shows that the levels were at a peak on 7th February 2014.

Figure 7 Levels at the Loudwater gauge January and February 2014
