# Buckingham Section 19 Flood Investigation

## Final Technical Report

February 2022

Buckinghamshire  
Council

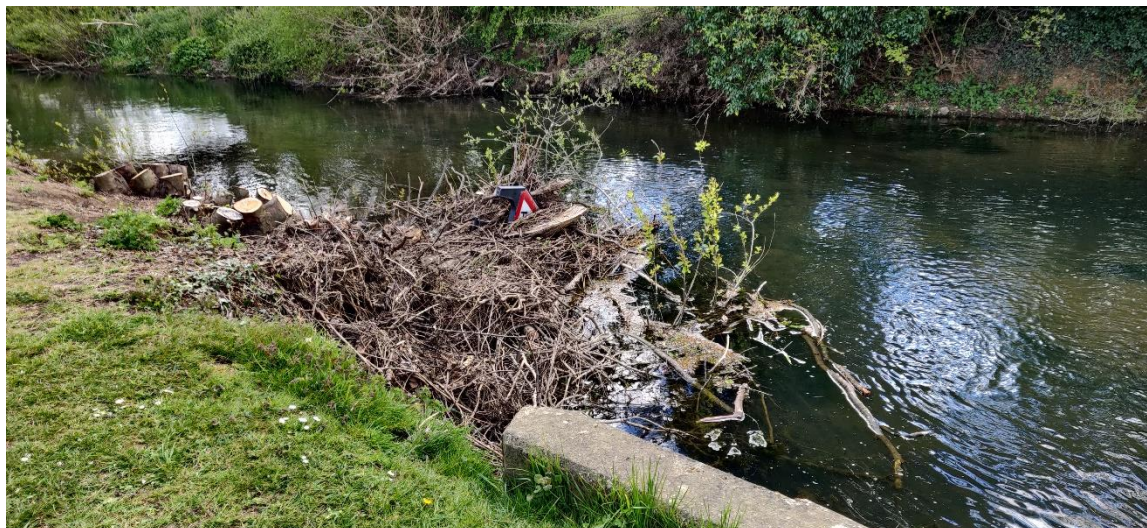
**Figure 5-2: Debris in the channel in Buckingham**

Aside from a number of weirs and old mill races through the centre of Buckingham, the river has a relatively natural channel and tree-lined banks, considering it is in an urban area. The weirs serve no operational or flood risk management purpose. During a site visit in May 2021, there were a number of locations where natural debris (tree branches etc) and man-made debris (e.g. road signs) was observed in the channel (Figure 5-2). There were a number of locations where localised siltation and re-vegetation had occurred. There were also a number of obstructions in the floodplain such as fences observed, which are

likely to be unconsented by the Environment Agency. However there were no major blockages to flow and it is not thought that these would have had a significant impact on water levels in the extreme flows experienced in December 2020.

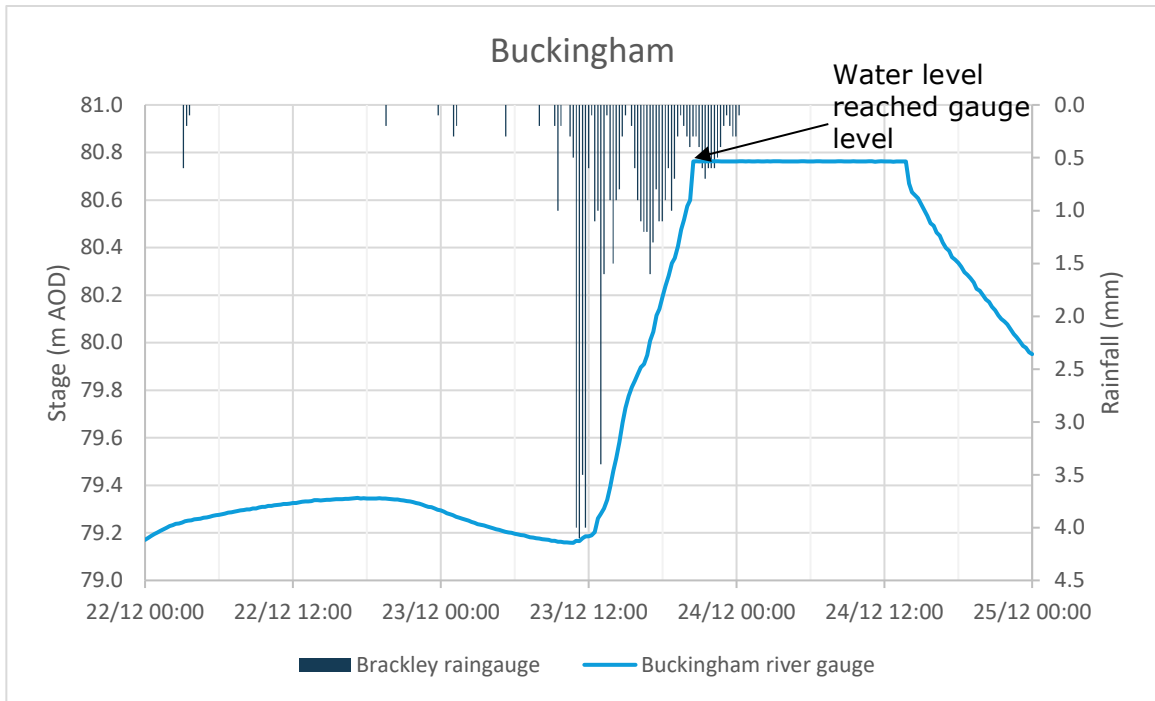
**Figure 6-1: Rainfall and river level data**

River levels started to rise almost immediately from about 11:00 on 23 December and continued to do so until 20:30. At this time, the water level reached and overwhelmed the gauge and it was unable to record any further rise in water level (shown as a flat line in Figure 6-1). Peak recorded water level was 80.8mAOD (higher than the peak recorded in 2007). The river level gauge shows that at about 13:45 on the 24 December river levels had fallen enough for the gauge to record water level correctly.

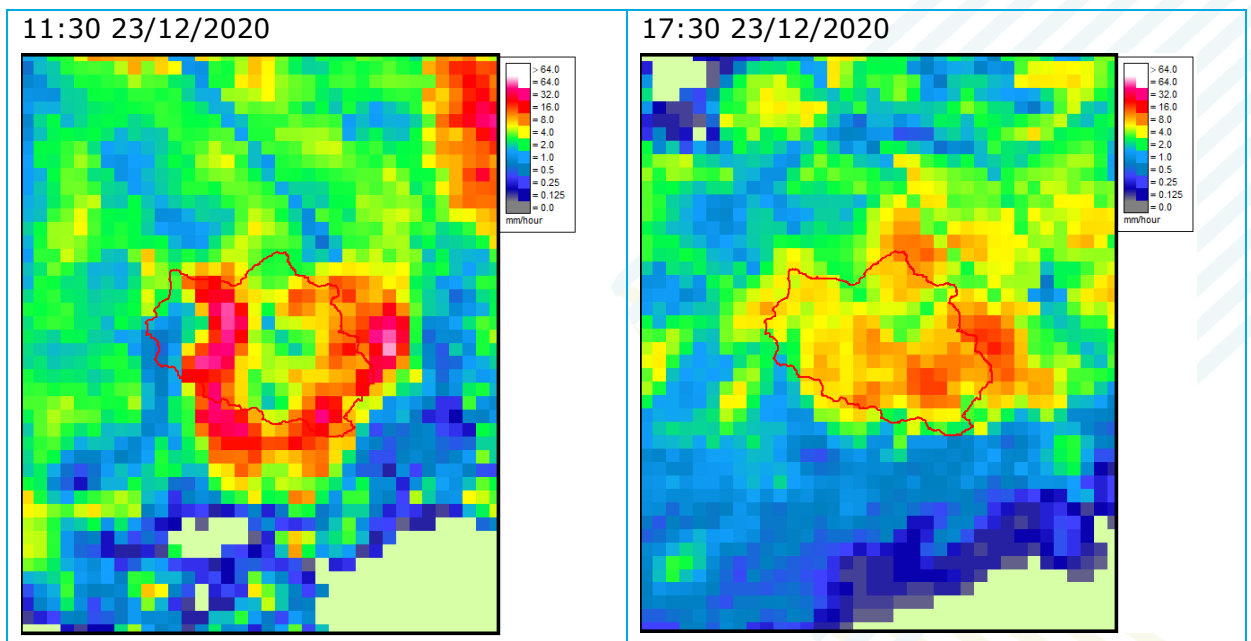
**Figure 6-2: Hyrad (radar) rainfall for the Buckingham area**

HYRAD observed radar rainfall data from the Met Office shows that for the majority of the event the storm passed from south to north across the catchment. After about 17:00, as the weather system turned, the storm passed in a southerly direction.

The images below show the HYRAD observed radar rainfall for the Buckingham catchment (red boundary line in the centre of the image). Colours show rainfall rate at the time shown. Total HYRAD radar rainfall for the storm event, averaged across the catchment, was 39mm.

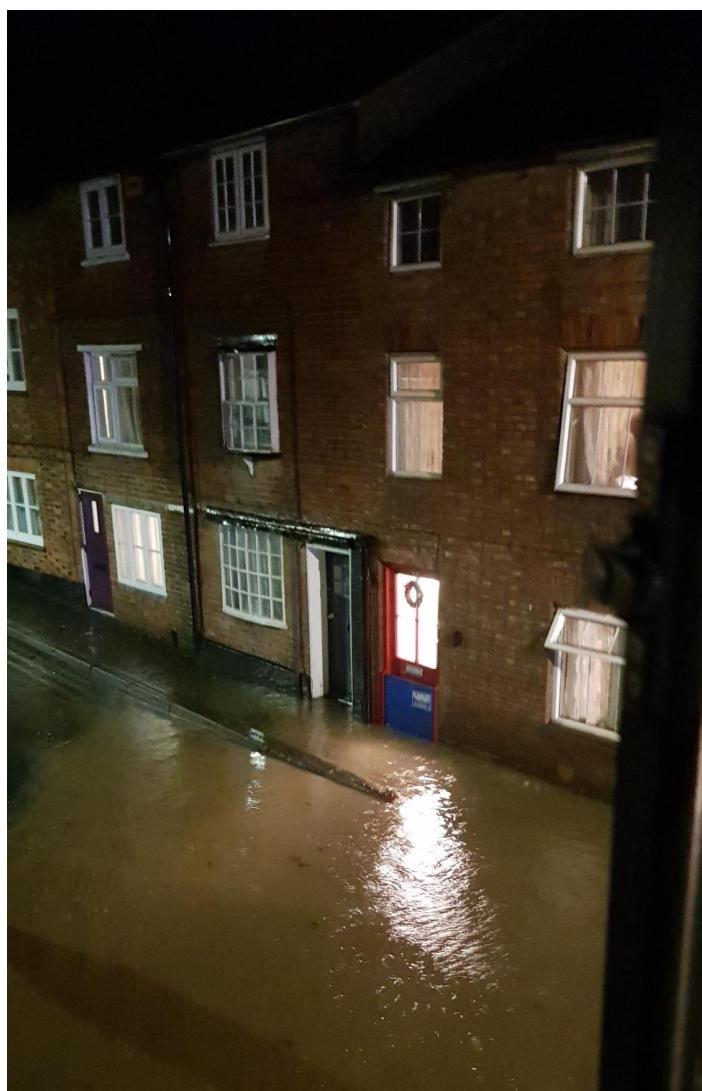
**Figure 7-1: PFR deployed at Nelson Street, 23 December 2020 (photo credit: Sharon Oaks)**

PFR effectiveness may be affected by the age of the products, the knowledge of the residents (particularly in rented properties or where properties have changed owners), or by alterations to the property introducing new ingress routes. For example, it is known that many of the houses on Nelson Street and Hunter Street are rented accommodation. The timeliness of a flood warning will also impact how quickly PFR can be deployed.

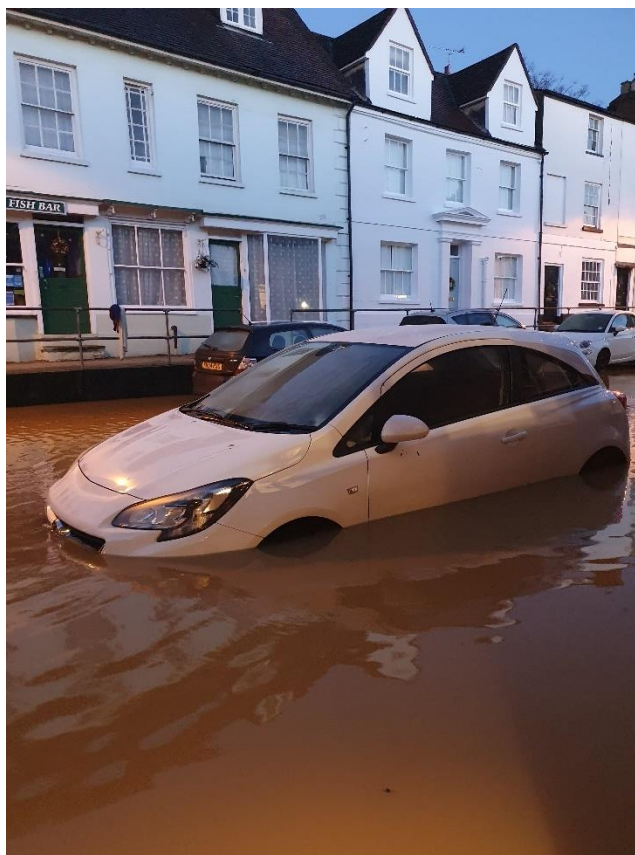
Several vehicles were written off by floodwaters, many of these at Candleford Court, where the undercroft car park flooded. This car park is open to the sides and is designed to accommodate flooding as it is located within the flood plain. However, a flood plan should be in place for Candleford Court to notify residents to move their cars ahead of flooding. No such flood plan was in place at the time of the flooding. Mechanical and electrical systems within the building, such as the lifts, were damaged by the flooding. Significant costs were incurred for subsequent repair work, with some repairs still ongoing at Candleford Court as of December 2021.

**Figure 8-1: Well Street, 24 December 2020 (photo credit: anonymous )**

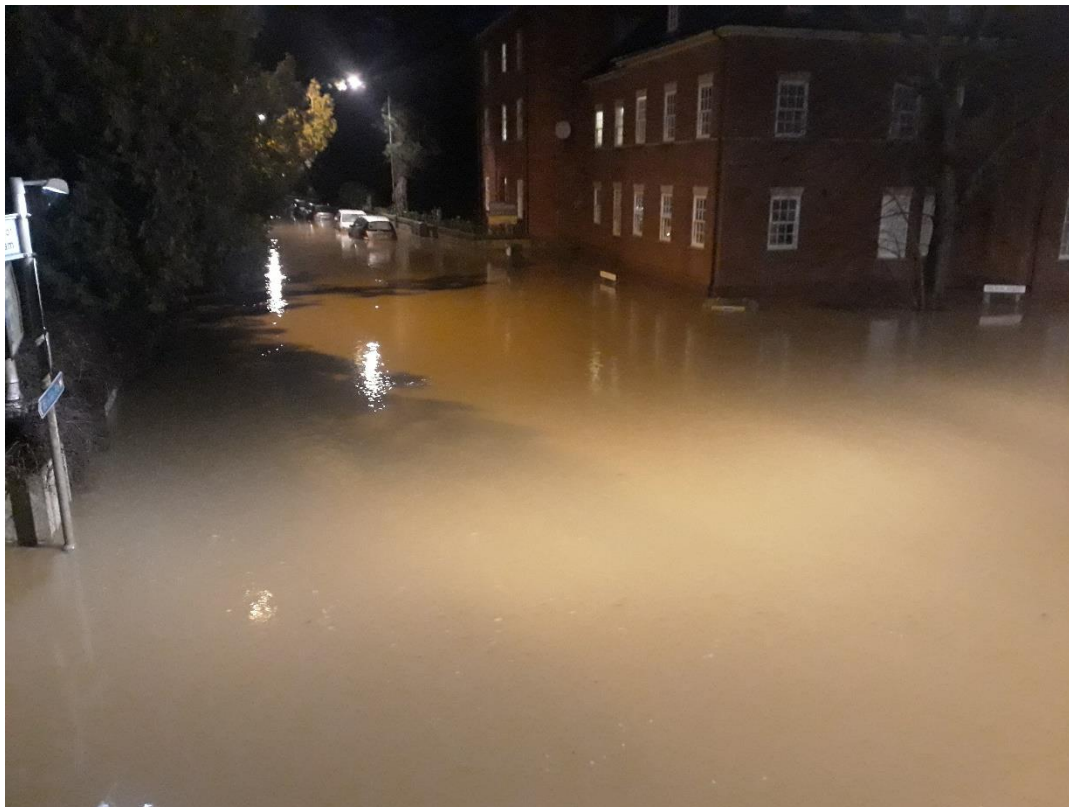
Many roads within Buckingham were impacted by surface water and the River Great Ouse throughout the 23 and 24 December. Road closures were issued at Well Street, Ford Street, Nelson Street, Stratford Road, and Tingewick Road.

**Figure 8-2: Tingewick Road, 23 December 2020 (photo credit: Tyne Marshall)**
