Buckinghamshire County Council

Flood Investigation Report

The Orchards Residential Park, Wexham

December 2013 – February 2014

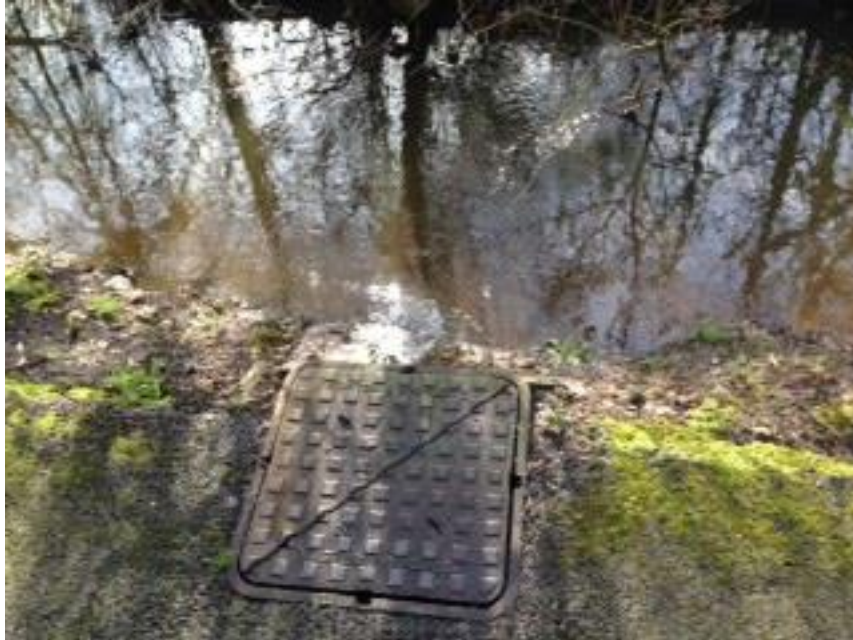
- Combined system full to capacity due to groundwater infiltration and excess runoff.

Surcharging combined sewer (Tingdene Park Homes, 10th February 2014)

Authority/Stakeholder	Recommended Action
Tingdene Park Homes	<ul style="list-style-type: none"> • Conduct a full investigation in to the combined drainage system, recording location of pipes, gullies and manholes. • Conduct a survey of combined drainage system to establish the condition of the assets. • Carry-out any repairs or improvements recommended or identified by the drainage survey.
Thames Water	<ul style="list-style-type: none"> • Ensure that this location is highlighted as a high risk area and that extra mitigation may be required at Middle Green pumping station in similar future events.
BCC	<ul style="list-style-type: none"> • To ensure the riparian owners of the watercourses in the area are aware of their responsibilities. • To facilitate sharing of information between RMAs and the community. • If required to use enforcement action under Section 25 of the Land Drainage Act where land owners have failed to maintain/remove obstructions from ordinary

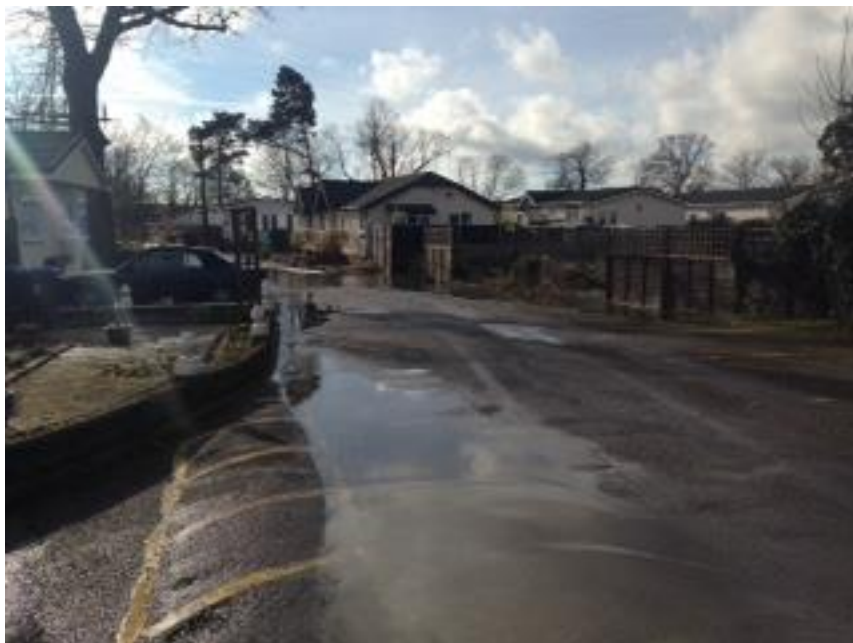
It was noted by everyone on site that there was a sudden receding of flood water towards the end of the flood event, whereby water which had been standing and accumulated for some time disappeared quickly. This was thought to have been down to the pumping station fault being corrected, however based on Thames Water's report it is now thought that this must have been due to the extra pumping they carried out at the pumping station to relieve the system.

Flood water after it had receded (Tingdene Park Homes, 10th February 2014)
