Buckinghamshire County Council

Flood Investigation Report

Chalfont St Peter

January – March 2014

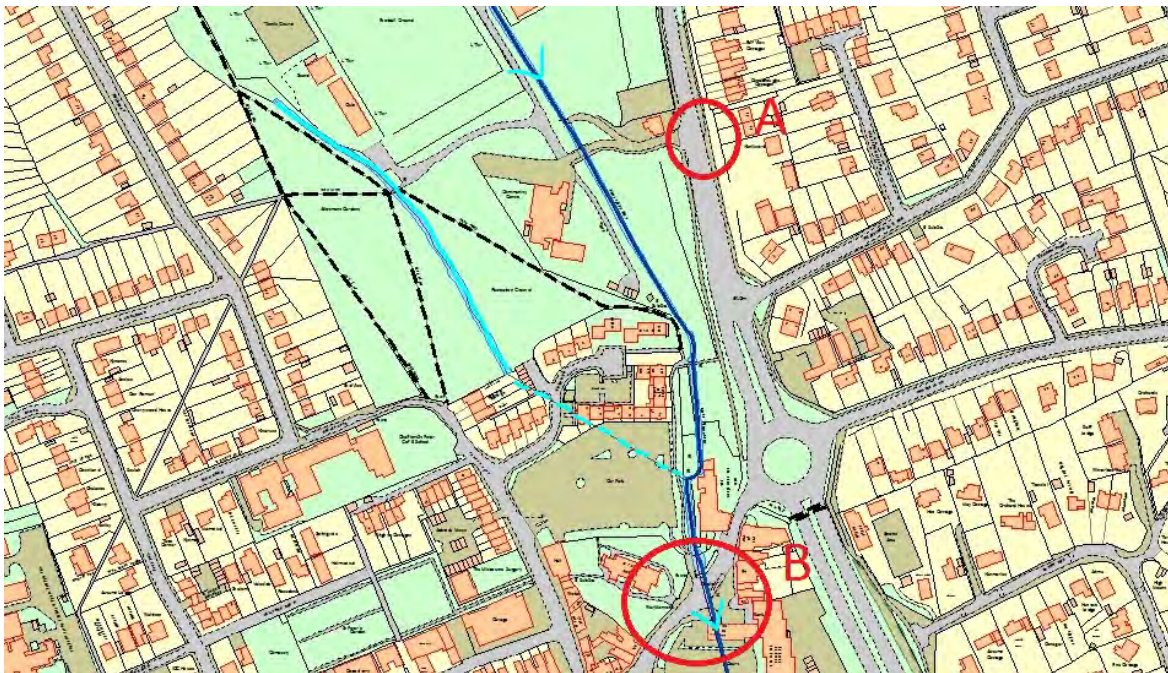
The two main areas of concern are shown in Figure 3 below: A is the location of the sewer overflow onto Gravel Hill (TQ 00088 91109), while B shows the location of the road and property flooding (around TQ 00102 90885). The explanation of these areas of concern is given below in Section 3.4.

Figure 3: Sewer overflow (A) and main road and property flooding (B) locations in Chalfont St Peter (Ordnance Survey License 100021529 2014)

The flow in the culvert located under St Peter’s Court (see B, figure 3) was partly restricted, as evidenced by the CCTV survey attempt of 2010 (see Section 2.2). The

Groundwater had infiltrated into the sewer network, not because of any cracks or collapses, but rather because the sewer network is not sealed to prevent ingress of water. In addition, it was reported to BCC that Thames Water found a blockage within the sewer network next to the A413 (see A, figure 3).

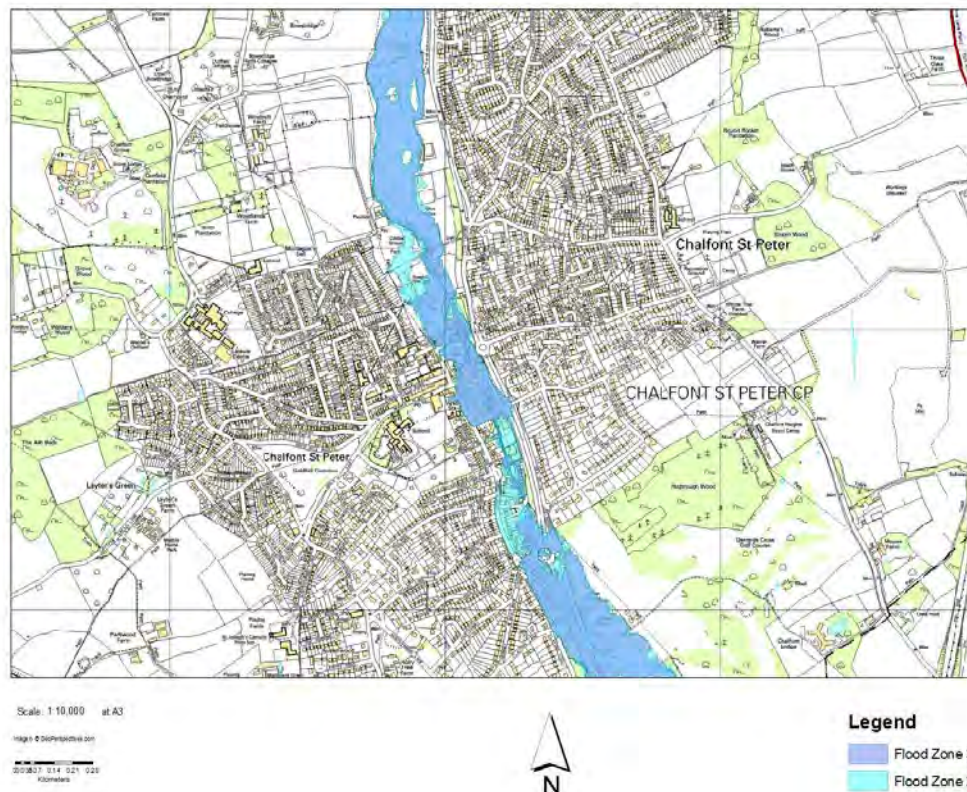
The fluvial flood map (figure 9) shows the flooding which would occur from the main river in a 1 in 100 year and 1 in 1000 year event. The flood water in these situations would come from the river and flow out onto the impacted areas shown on the map.

Figure 9: EA flood map showing the River Misbourne 1:100 year event (flood zone 3) in dark blue and 1:1000 year (flood zone 2) in light blue (EA, 2014) (Ordnance Survey License 100021529 2014)

Figures 9 and 10 show that although there is a band of fluvial flood risk running along the valley bottom parallel to the A413, a more extensive area within the village is at risk of flooding from surface water.

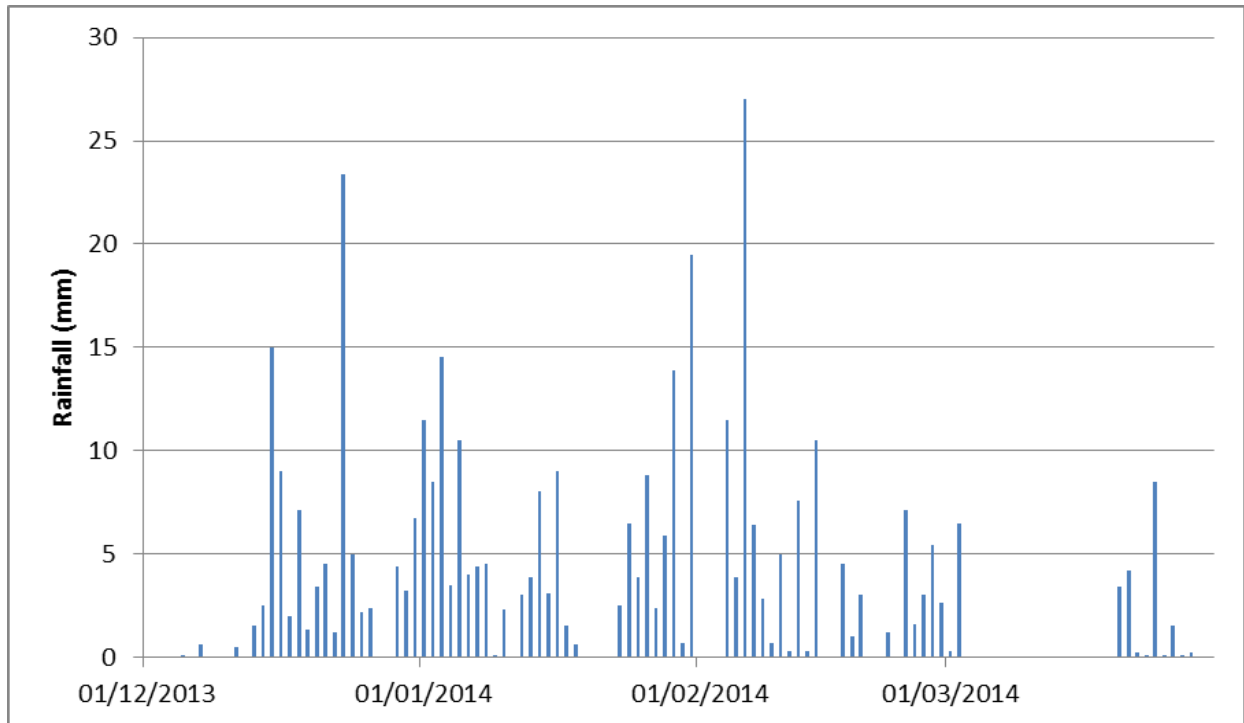
The EA provided rainfall data for the period of 01 December 2013 to 30 March 2014. The nearest EA rain gauge is at Maple Lodge Sewage Treatment Works. Figure 12 gives the daily rainfall totals from the Maple Lodge gauge for the period from December 2013 to March 2014. From this data it can be seen that there were constant high levels of rainfall from mid-December 2013 to early March 2014, with peaks on 23 December 2013, 31 January and 06 February 2014. There was almost daily rainfall from mid-December 2013 until early March 2014, and the gauge registered a maximum (for the period) of 27 mm of rainfall on 06 February 2014.

Figure 12: Daily total rainfall for rain gauge at Maple Lodge from 01 December 2013 to 30 March 2014 (EA, 2014)

- Continued high levels of rainfall throughout December 2013, January and February 2014 (see figure 12).
- Saturated soils due to exceptionally high groundwater levels.

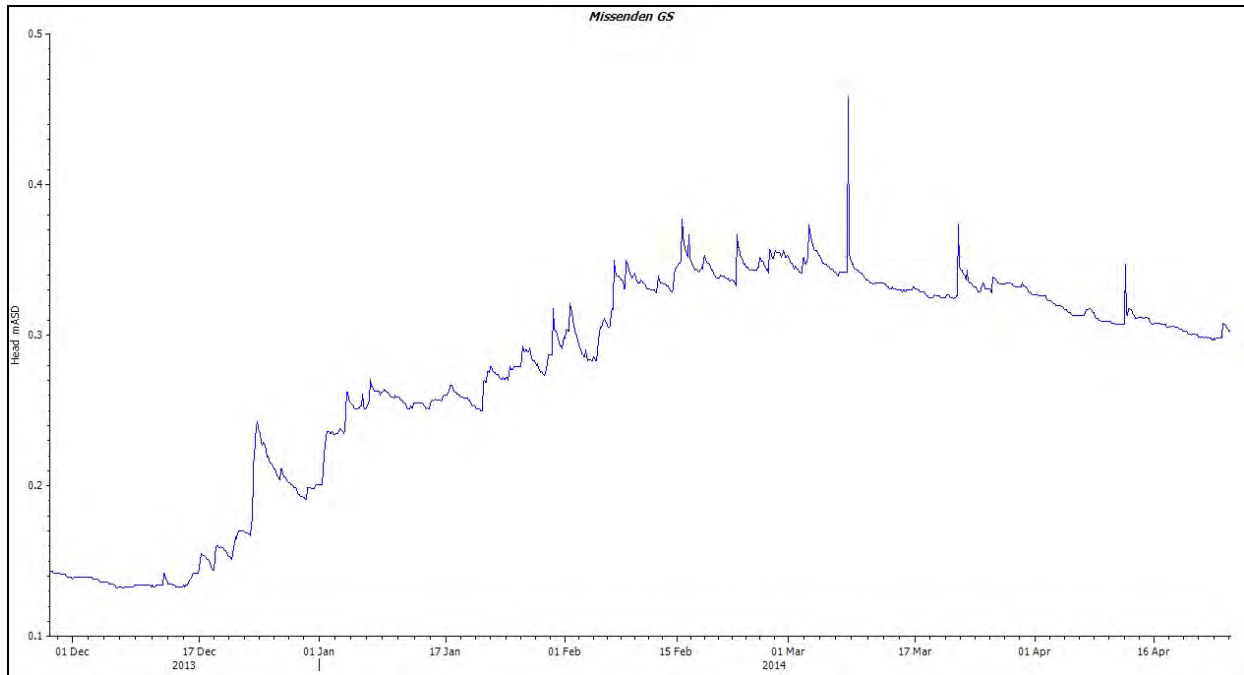
The EA's nearest telemetered river level gauge is at Little Missenden (SU 9342198458, approximately 11 km upstream of the centre of Chalfont St Peter). Figure 13 shows the river levels for December 2013 to April 2014.

Figure 13: River Misbourne hydrograph, as per Little Missenden gauge measurements, December 2013 to April 2014 (EA, 2014)

The Little Missenden gauge has been in operation since October 1993. The EA's records for the gauge show that the entire event (the three months leading up to March 2014) is listed as number 1 of the top 10 levels ever recorded at this site. The peak level of the event was on 08 March 2014, at 459mm, although there were other peaks in river levels during the event in question, for example on 07 and 08 February 2014.

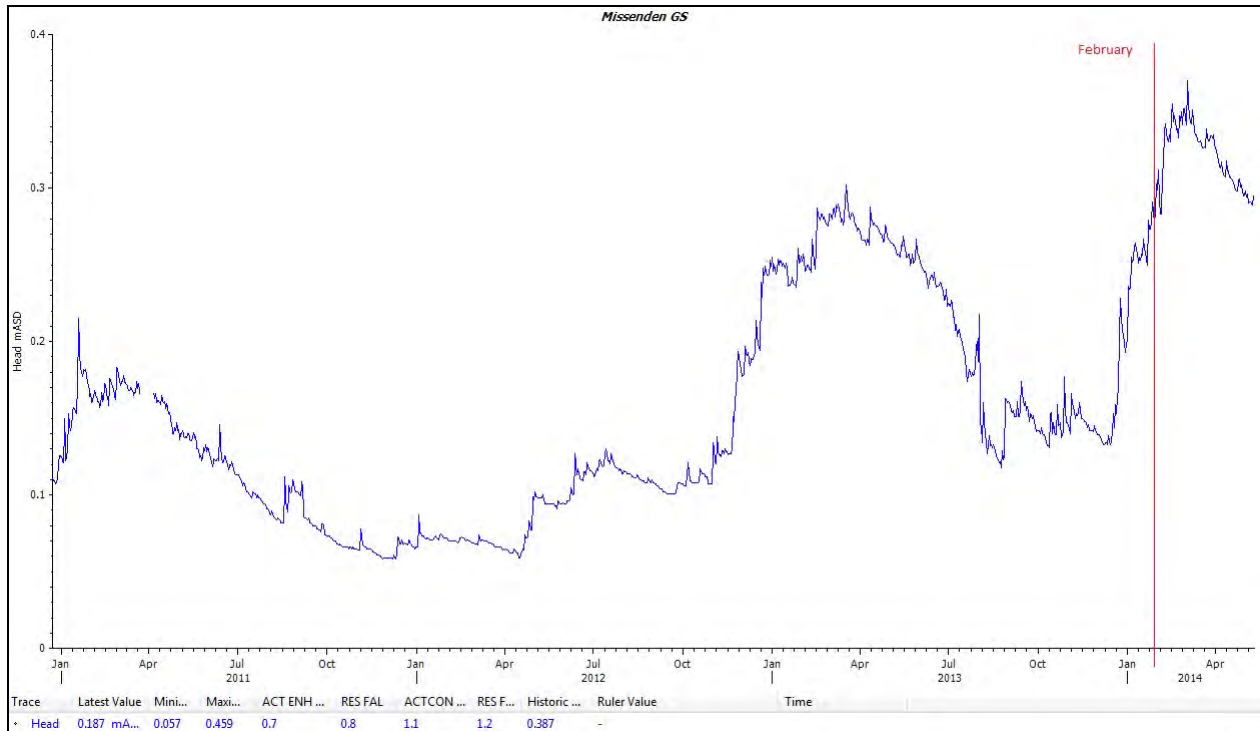
The measurements from the Little Missenden gauge can only give an indication of levels in Chalfont St Peter. Indeed, it is too far upstream from the village to accurately reflect the local river levels in Chalfont St Peter, which are primarily affected by the presence of culverts, natural restrictions to flow, blockages and other things. However, Figure 14 – the hydrograph for the past three years – can give an indication of levels in the area. It shows the high levels of February/March 2014, with similar levels recorded in March/April 2013. As a note, river levels in the area vary in the period analysed by 443mm (the difference between the lowest and the highest recorded levels).

Figure 14: River Misbourne hydrograph, as per Little Missenden gauge measurements, January 2011 to April 2014 (EA, 2014)

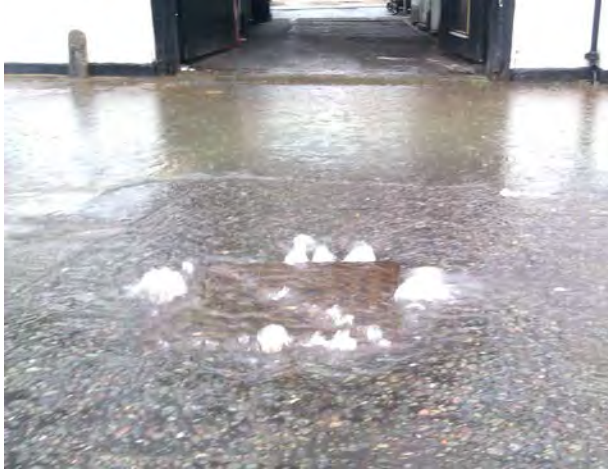
Surcharging manhole, High Street. Photo courtesy of CSP Parish Council, 16/03/14

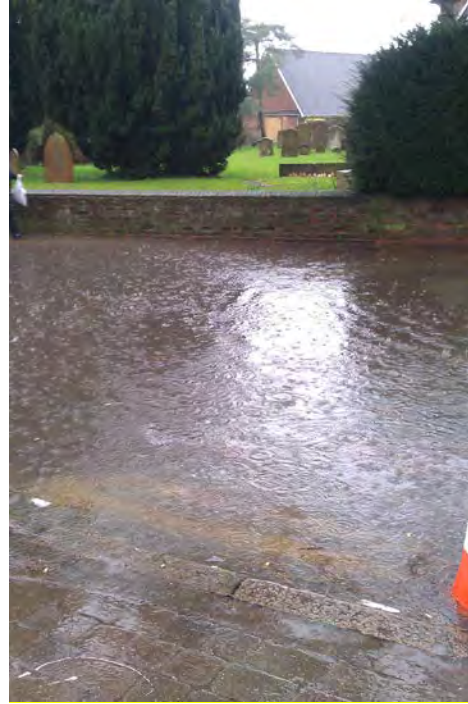
Road flooding, High Street. Photo courtesy of CSP Parish Council, 16/03/14

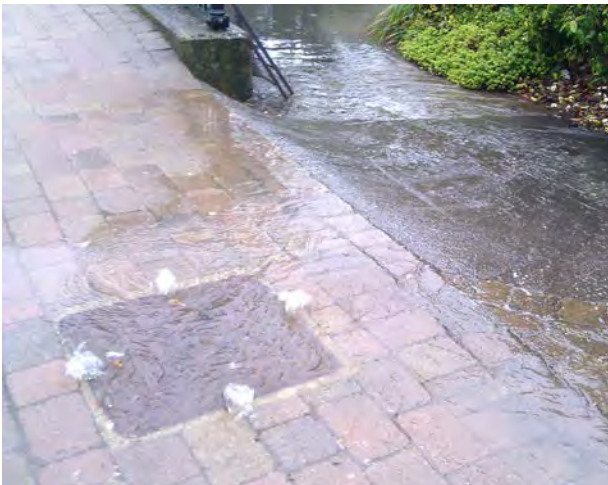
Surcharging manhole, High Street. Photo courtesy of CSP Parish Council, 16/03/14

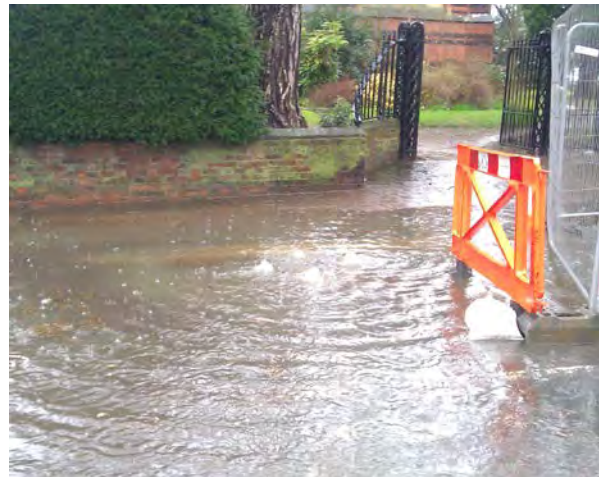
Surcharging manhole, High Street. Photo courtesy of CSP Parish Council, 16/03/14

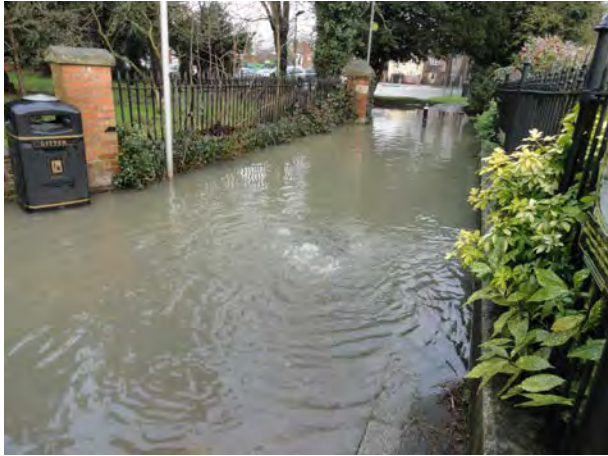
Flooded footpath to parking lot. Photo courtesy of CSP Parish Council, February 2014

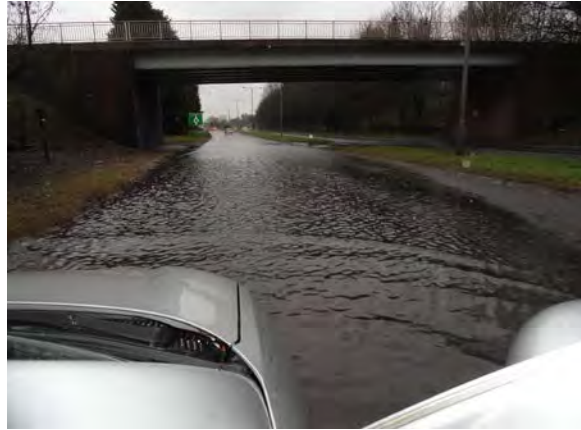
Road flooding, A413. Photo courtesy of CSP Parish Council, February 2014

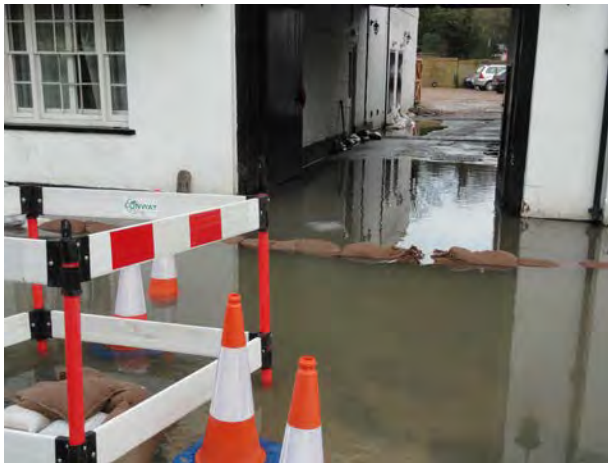
Flooded entrance to the George Inn. Photo courtesy of CSP Parish Council, February 2014

On 12 February, The George pub suffered from internal flooding with sewage-laden water again. The EA and other agencies (Thames Water and BCC) attended onsite to determine whether pumping arrangements might alleviate flooding on the High Street, but it was decided not to do this given the increased risk of flooding to residential properties downstream.

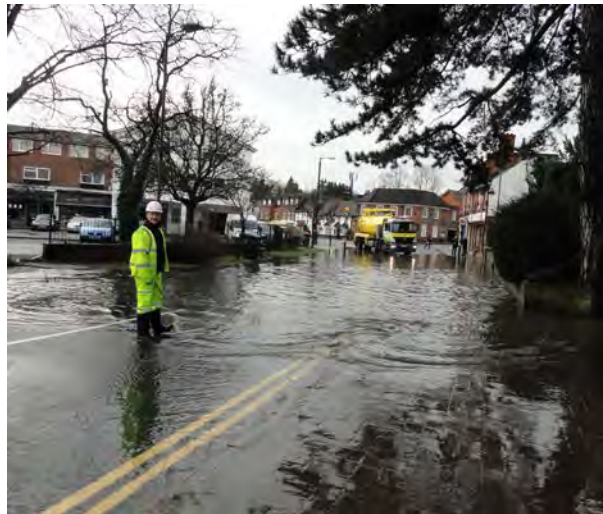
TfB tanker, High Street. Photo courtesy of CSP Parish Council, 13/02/14

On 13 February 2014, Transport for Buckinghamshire sent a tanker onsite; it left with a full load, but given the return of water to the same levels within 15 minutes, the tanker was instructed not to return after having removed a full load (1800 gallons) as it was clearly not effective enough for the volume of water to be removed. From November 2013 to 13 February 2014, the Environment Agency contacted the riparian owner three times to ask for an update on the culvert clearance work.

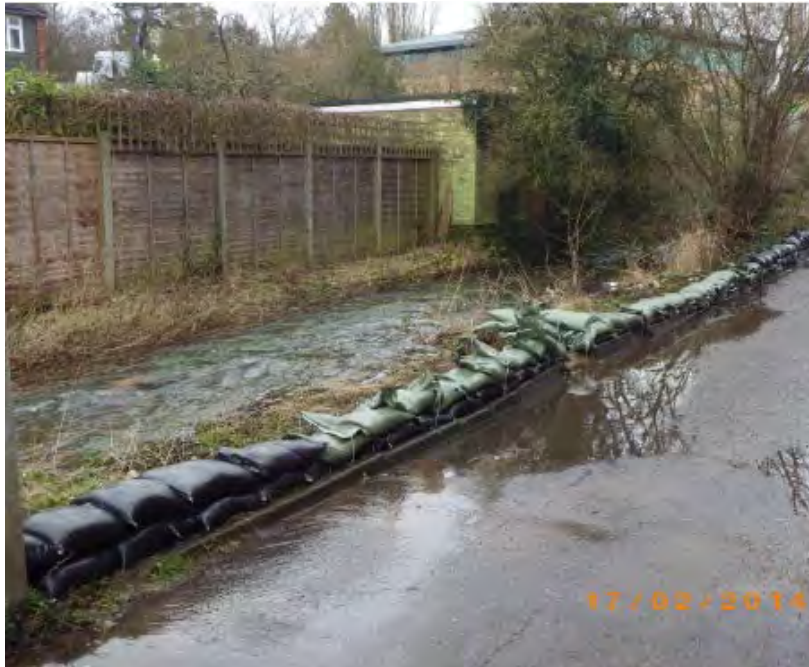
EA sandbag wall protecting industrial area and Hiljon Crescent. Photo courtesy of EA, 14/02/17

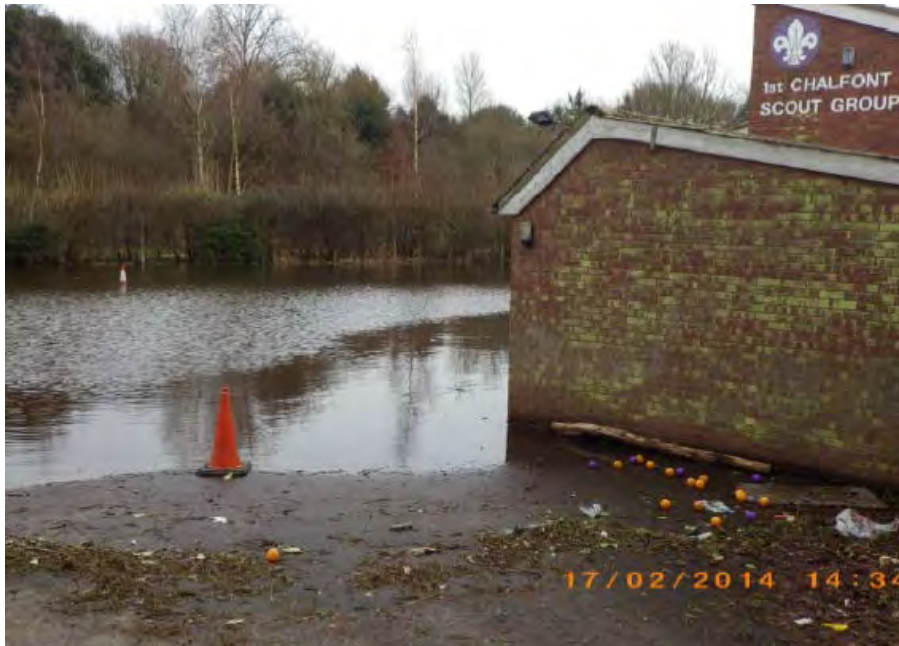
Flooding outside of the scout hut. Photo courtesy of EA, 14/02/17
