Buckinghamshire County Council

Flood Investigation Report

Leckhampstead, 9th March 2016

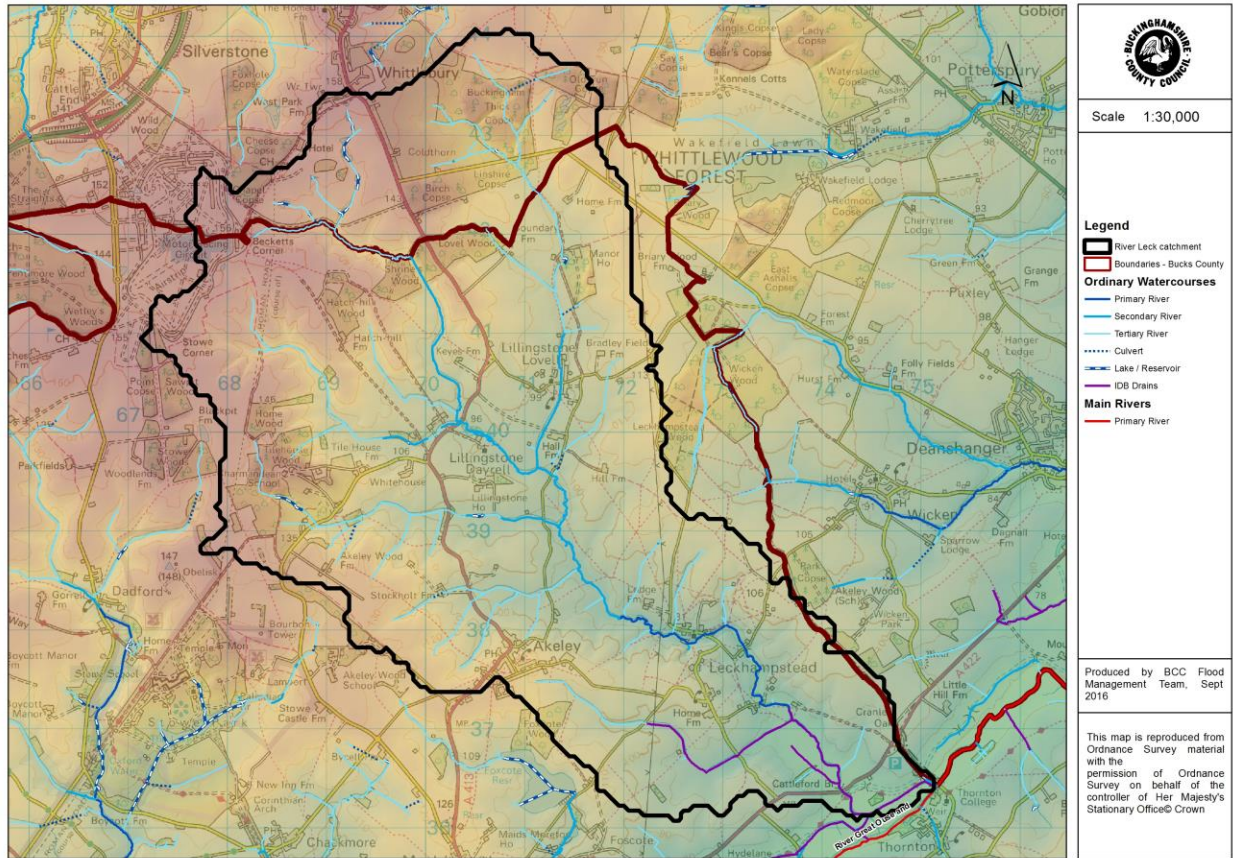
Figure 2: River Leck catchment

The River Leck is a tributary of the River Great Ouse. The Leck is approx 10km long, with headwaters in Northamptonshire near Silverstone and Whittlebury. Branches flow southwards through Lillingstone Lovell and Lillingstone Dayrell before converging downstream of these settlements, then flowing southwards through Leckhampstead before outfalling onto the River Great Ouse (as shown in Figures 2 and 3). The catchment area of the Leck is approximately 32km².

Leckhampstead is situated on clay, silt, sand and gravels along the line of the River Leck. The solid underlying geology comprises limestones, mudstones and sandstones. The valley has a relatively steep gradient for this part of Buckinghamshire, descending from 156m near Silverstone to 76m in the village of Leckhampstead (see Figure 2 for an overview of the relief of the catchment).

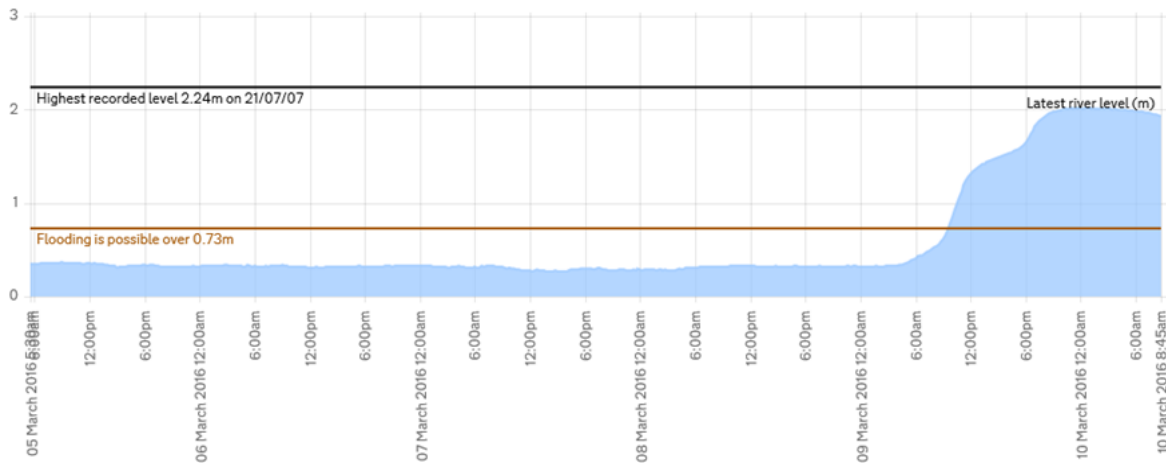
However, information from the gauges can still provide some useful background information to understand the wider hydrological conditions. The nearest gauging station, at Thornborough (SP 73483 35308), showed elevated levels on the Great Ouse from the morning of the 9th March, and a peak at approximately 01:00 on 10th March, close to record levels and well over the normal range of 0.10-0.73m (Figure 7). This reflects the prolonged heavy rainfall and wet antecedent conditions across the wider region at the time.

Figure 7: River Gauge data for the River Great Ouse at Thornborough, as of 08:45am 10th March 2016 (EA, 2016).

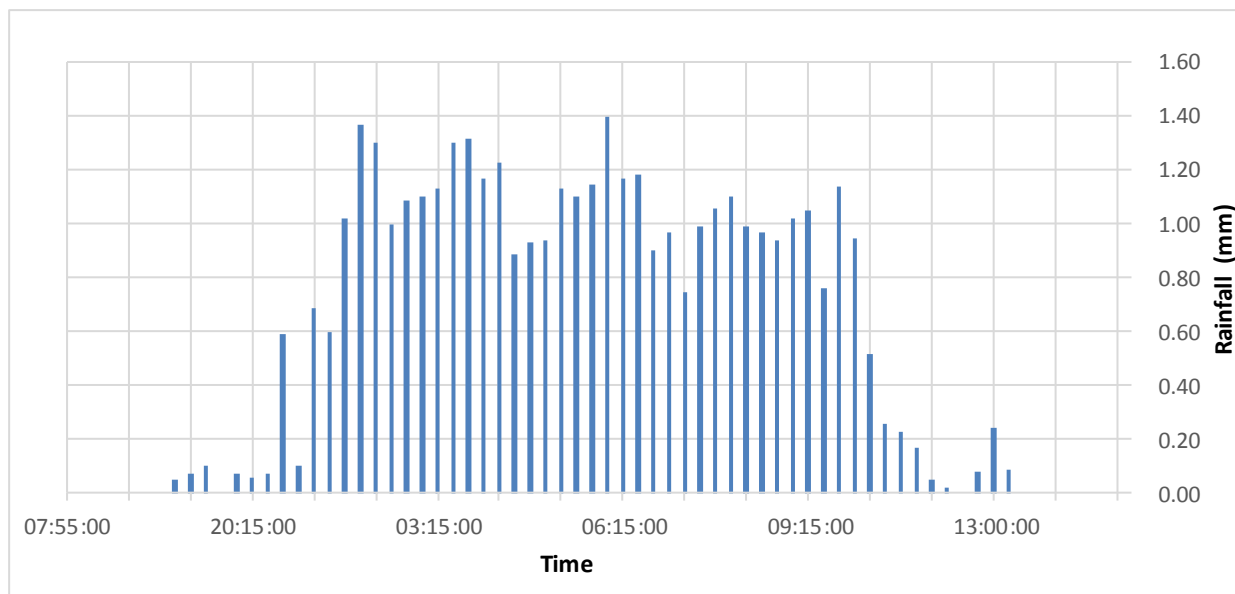
Figure 7 below gives the 15 minute rainfall interval totals from the Brackley rain gauge. The data shows that relatively high intensities of rainfall (over 0.8mm every 15 minutes) were maintained between 01:45am on 9th March to 10:00 9th March.

Figure 7: Brackley rain gauge data for the period 07:55 07/03/16 to 19:55 09/03/16 in 15minute intervals.

Between midnight and 11:00am on Wednesday 9th March, 39.7mm of rainfall³ was recorded at the Environment Agency’s (EA) rain gauge upstream of Buckingham at Brackley. This amount of rainfall is equivalent to the total rainfall that would be expected for the whole of March. BCC have calculated the probability of such a rainfall event occurring in any given year within the Leck catchment as approximately 1 in 6 (17%), using the Flood Estimation Handbook (FEH) methodology (<https://fehweb.ceh.ac.uk/>).

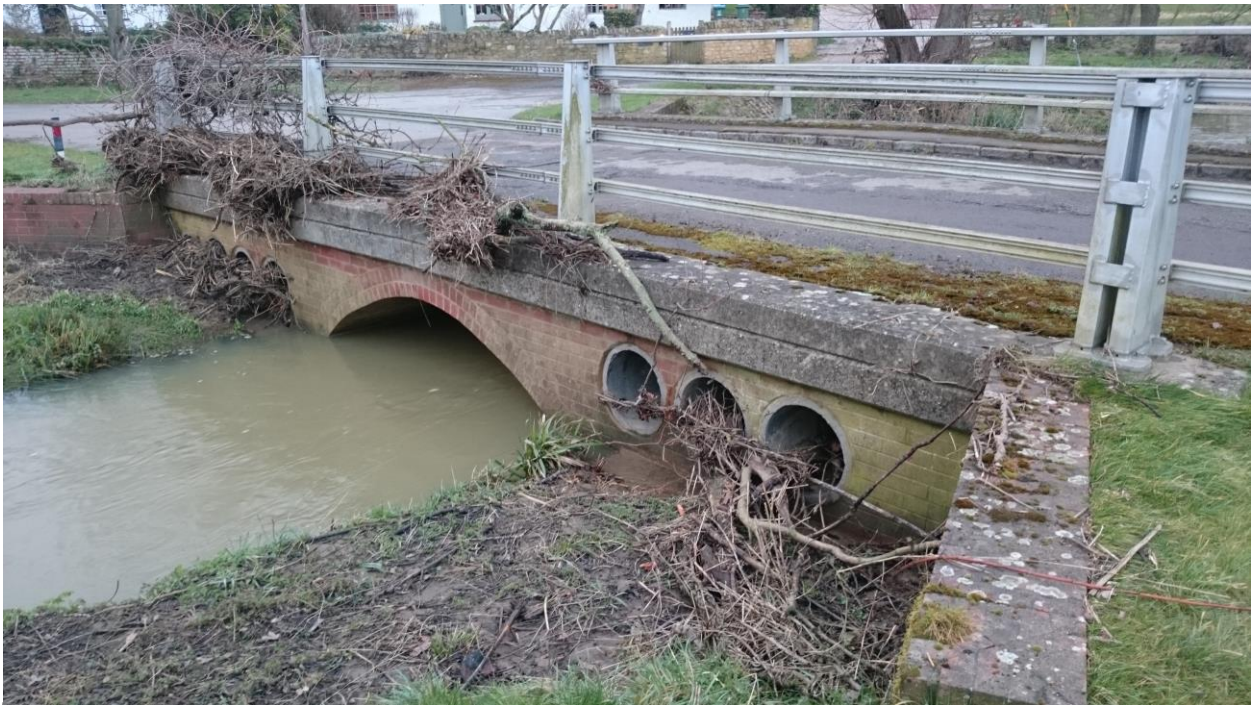
During the follow-up investigation, local residents queried whether there were any obstructions (such as debris or overgrown vegetation) upstream or downstream of Church End that may have contributed to increased water levels during this event. Debris did collect on South End Bridge, as shown in Figure 10. BCC will be assessing the degree to which channel condition affects flow conveyance and hence flood risk as part of the recently-begun River Leck Catchment Feasibility study (further details in Section 5.2). However, it appears unlikely that this would have a significant effect on higher magnitude flows such as those experienced in this event.

Figure 10: Debris build up on South End bridge at east of village, 11th March 2016 (photo by BCC).

TfB	<p>1. For TfB culverts, including South End Bridge on Church End, Limes End Bridge on Wicken Road:</p> <ul style="list-style-type: none"> - Continue inspecting culverts above 900mm in diameter in line with current codes of practice, which entail general inspection every two years and principal inspection every 6 years. - For culverts below 900mm in diameter, TfB to continue

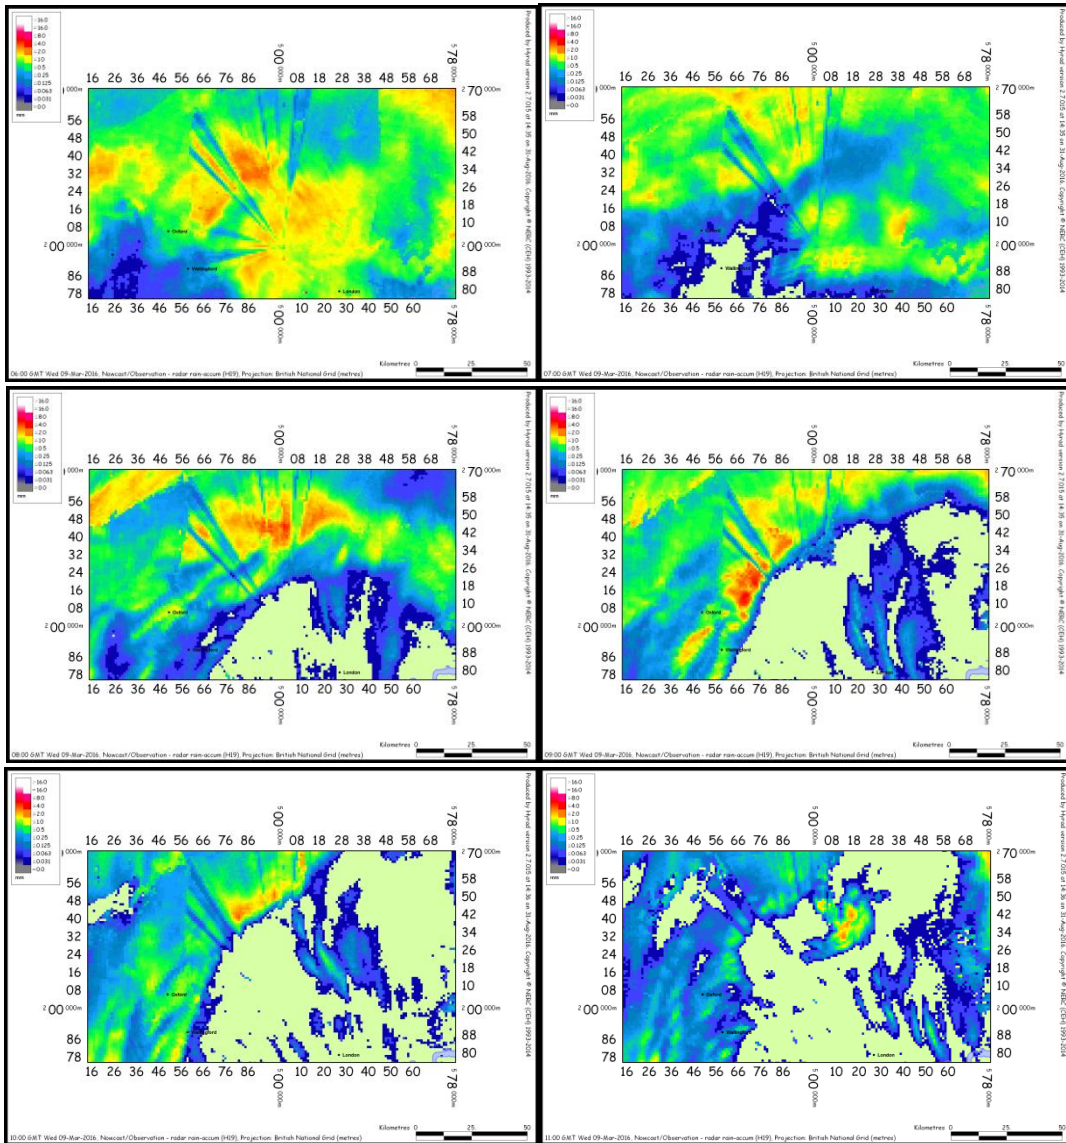
Appendix B: HYRAD rainfall radar

Area surrounding Leckhampstead 09/03/2016 00:00 – 11:00 (at hourly intervals).
Data provided by the EA.
