# Buckinghamshire County Council

## Flood Investigation Report

### Great Missenden, Sunday 27<sup>th</sup> May 2018

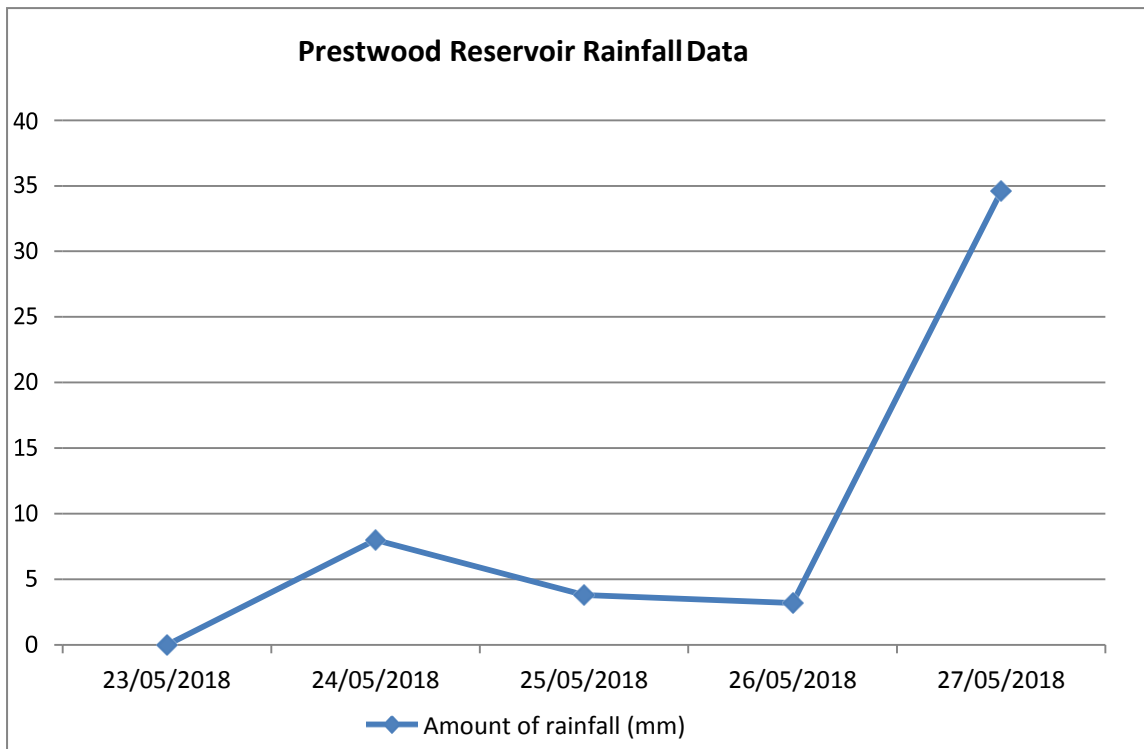
Figure 9: Daily rainfall totals from EA rain gauge at Prestwood Reservoir

The closest rain gauge is located at Prestwood Reservoir and Figure 9, shows the daily rainfall totals for the period for 23<sup>rd</sup> to 27<sup>th</sup> May 2018 at this rain gauge with the highest daily total of just under 35mm on 27<sup>th</sup> May 2018.

The explanation for the discrepancies in the daily rainfall totals (Figure 9) and the Met office rainfall radar data (Figures 10 and 11) is given below.

The Prestwood rain gauge totals did not necessarily pick up the rainfall totals that fell over Great Missenden. The gauge at Prestwood is not geographically close enough to Great Missenden, nor does it measure rainfall more frequently than a daily total so it was not able to measure the high intensity rainfall that fell in Great Missenden during this thunderstorm. The Met Office data (Figures 10 and 11) are consistent in terms of rainfall totals and return period. This data is likely to be more accurate for this event and are consistent with the local knowledge that this was a localised rainfall event over Great Missenden.

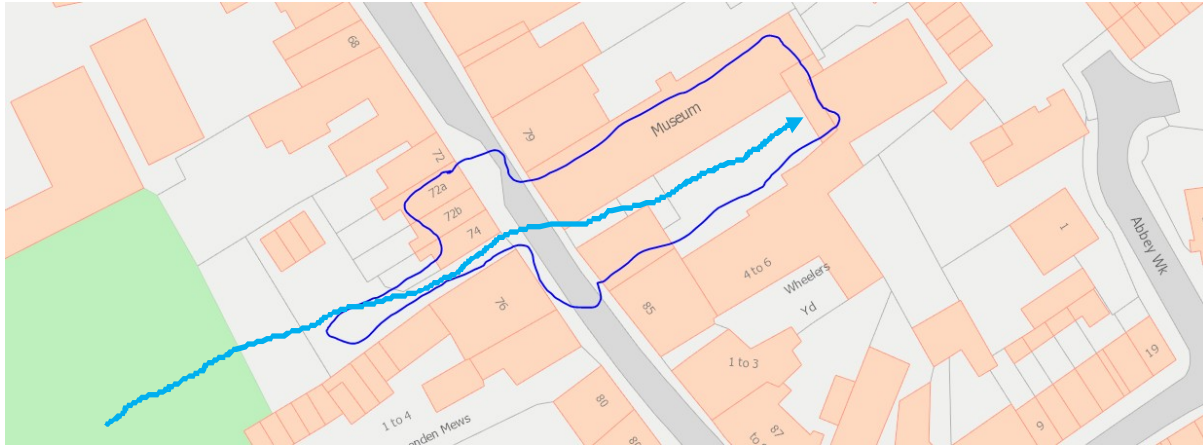
**Figure 12: Extent of Flooding along High Street Great Missenden around the museum (flow route shown)**

The flooding impacted four commercial properties around and including the Roald Dahl Museum in the centre of Great Missenden and two residential properties on Rignall Road on north western edge of the village. Figures 12, 13 and 14 show the flood extents in the three separate geographic areas that were impacted by the surface water flooding. The flow routes are unknown as the flooding occurred in the middle of the night with no witness in the village centre. The surface water flood map does suggest a couple of potential flow routes but these cannot be verified by this event. The 1000 year surface water flood map Figure 7 shows a flow route from the south west to the north east as it crosses over the High Street and flows towards the Museum and into its courtyard. The flow route for the water flowing around and into two residential properties on Rignall Road is known as it has occurred in the past as noted in the historic flooding section.

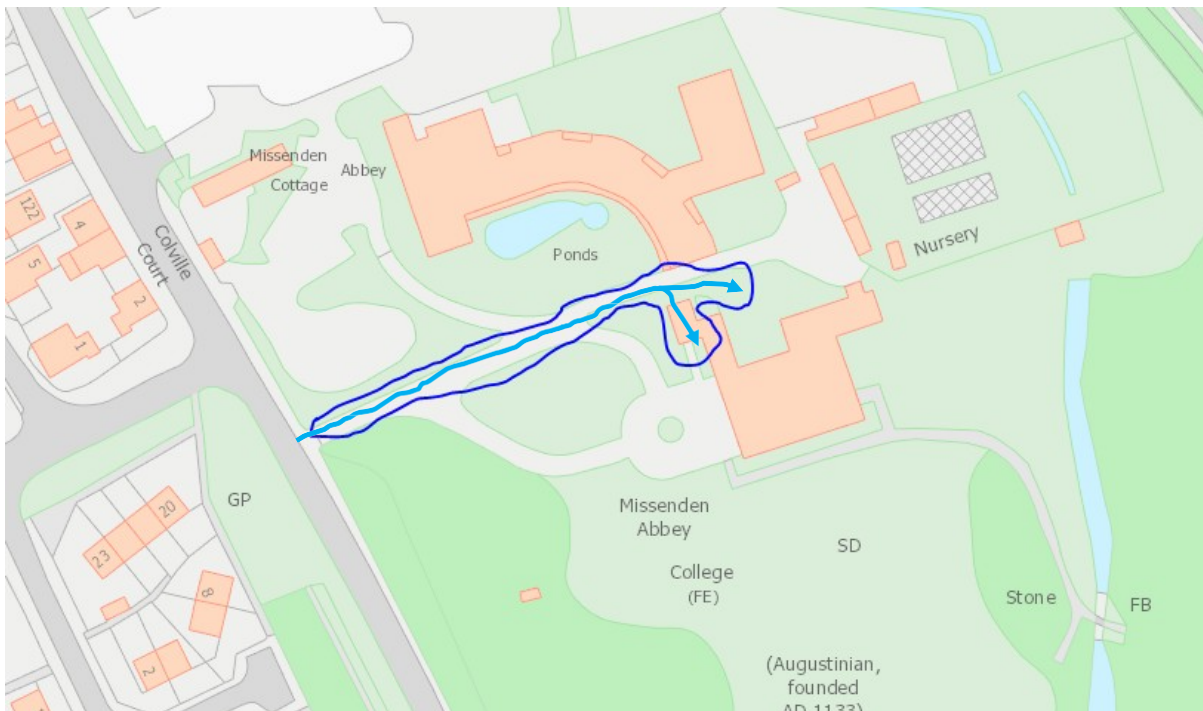
**Figure 13: Extent of flooding off London Road Great Missenden at Missenden Abbey (flow direction shown)**

The flooding at Missenden Abbey also occurred during the early hours of the morning on Sunday 27<sup>th</sup> May although the staff did not discover it until the Tuesday when they returned to work after the bank holiday. The surface water entered the main reception/lobby area through the side door and flooding approximately half of the floor area in this room to a depth of approximately 5cm. The water flowed down the drive way and around the left of the building and into the side door.

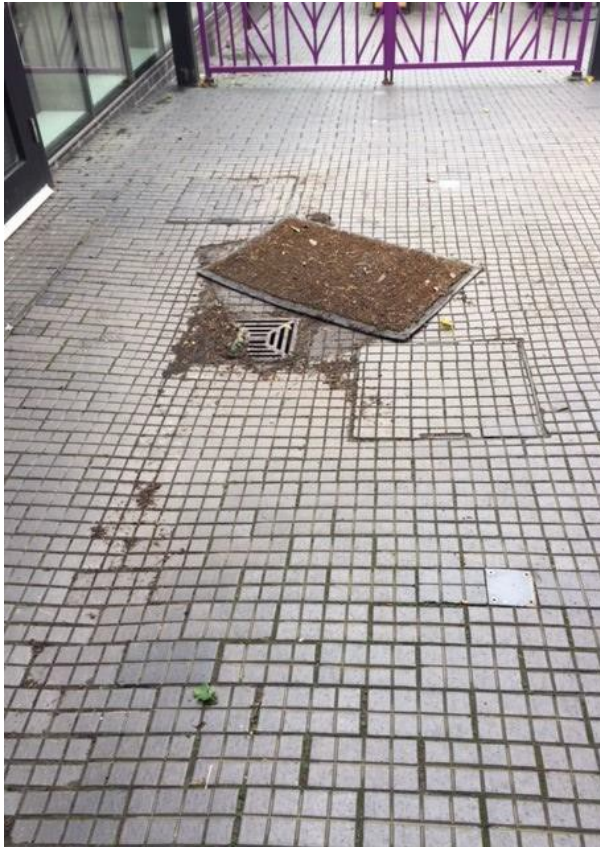
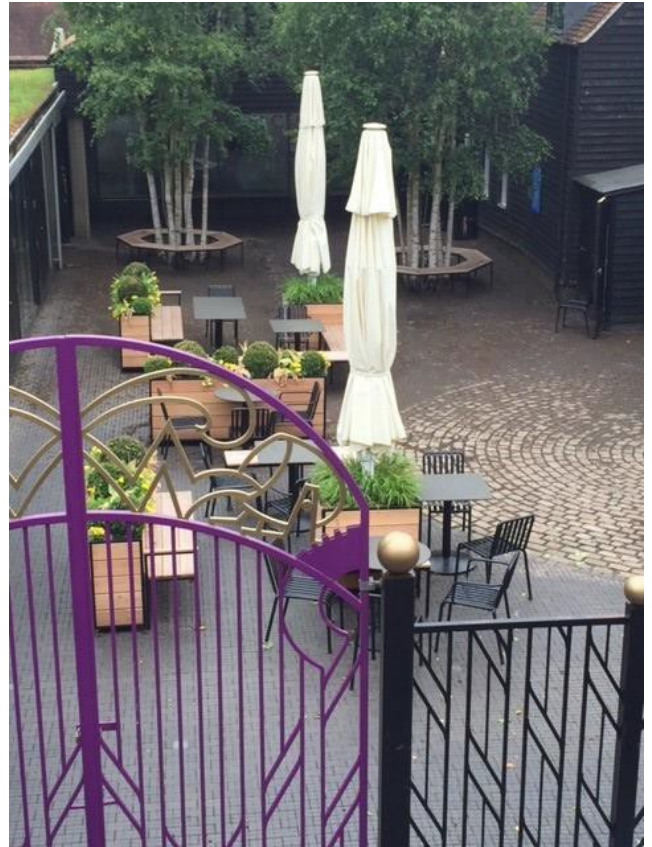
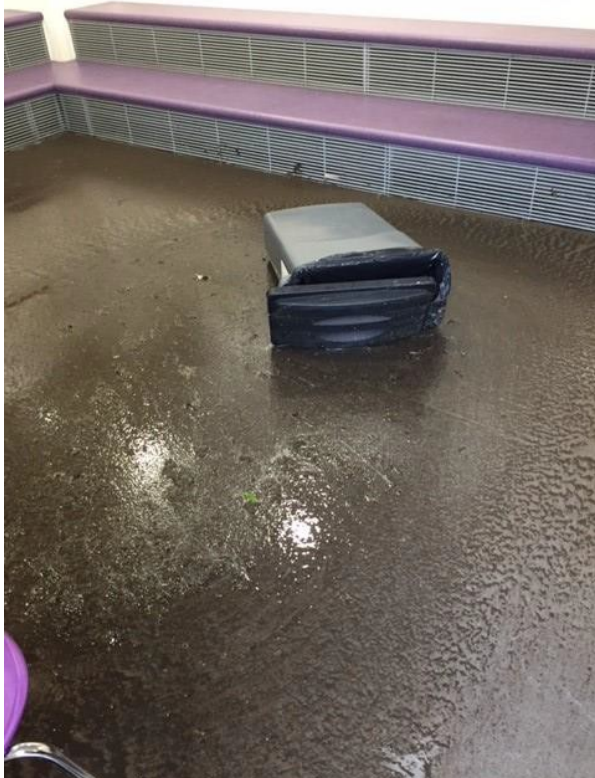
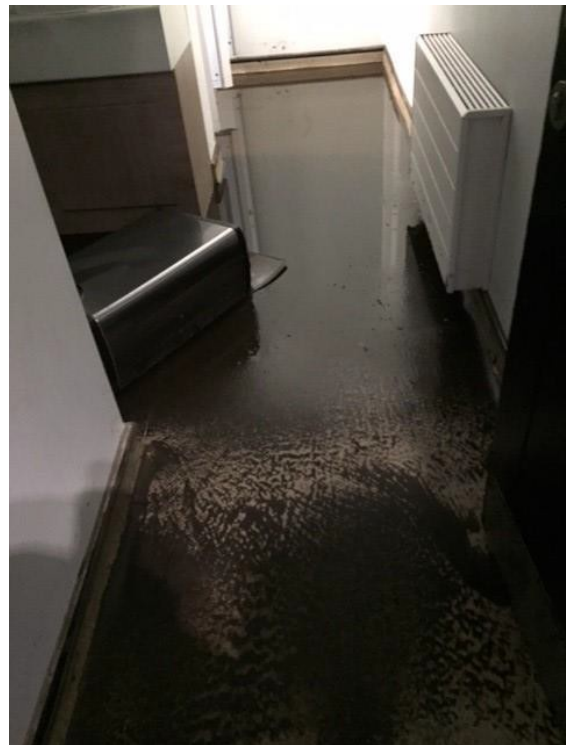
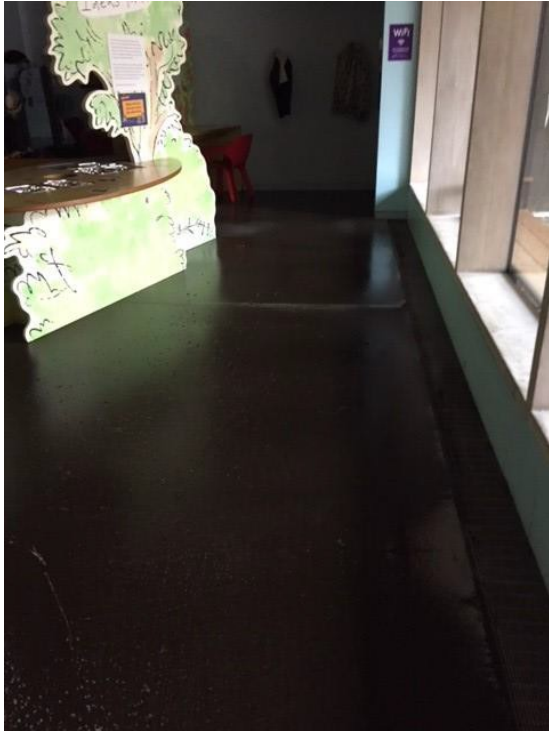
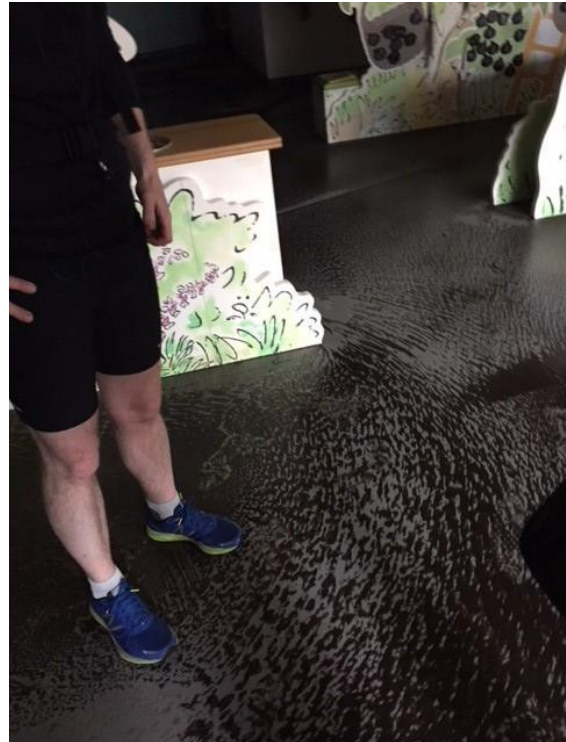
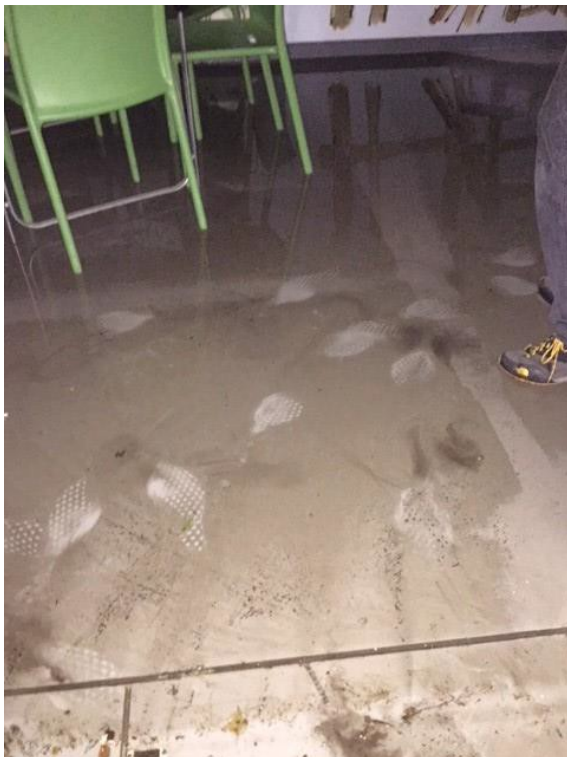
The impacts of the flooding to the museum were significant the toilets, galleries, kitchen, courtyard seating area, staff kitchen and staff room were all flooding. The store room and the DIY shop was flooded so was the staff room and stock room at the bridal shop and the reception area at Missenden Abbey was also flooded. (See photographs included in Appendix F)

**Figure F1** Museum Courtyard

**Figure F2** Museum Courtyard Seating

**Figure F3** Museum Education Room

**Figure F4** Museum Staff kitchen

**Figure F5** Museum exhibition room

**Figure F6** Museum Exhibition room

**Figure F7** Museum exhibition room

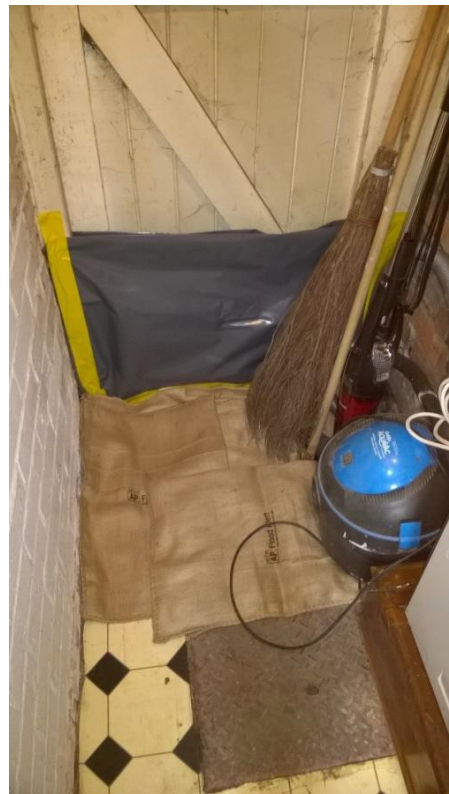
**Figure F8** Back door flood protection at Arkwrights

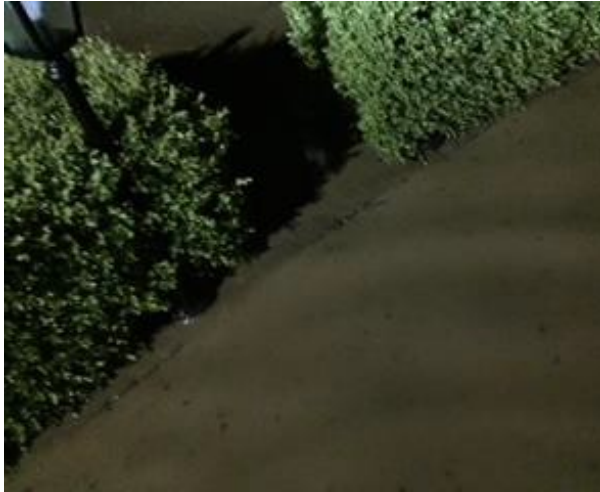
**Figure F9: Rignall Road May 2018 Flood**

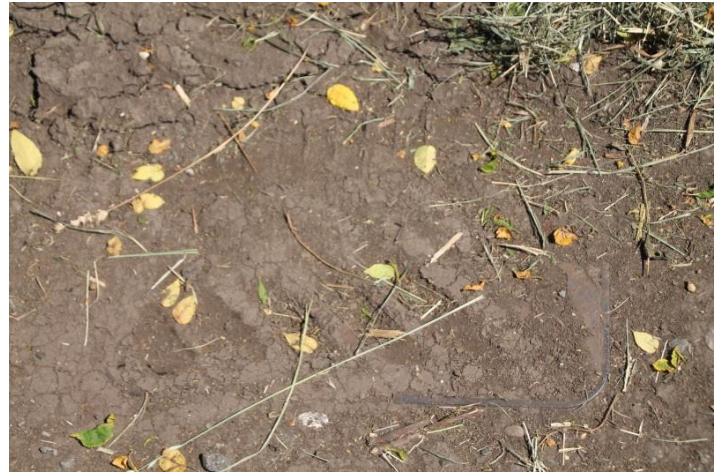
**Figure F10: Rignall Road gully after June 2016 flood event silt accumulation**

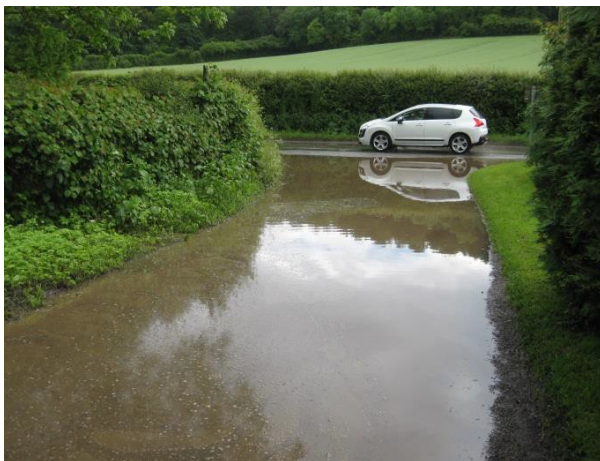
**Figure F11: Rignall Road Flooded summer 2016**

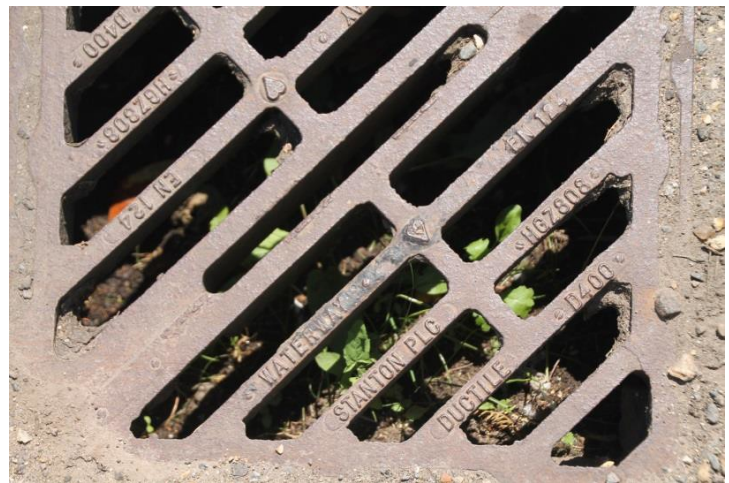
**Figure F12: Silt and plant filled gully on Rignall Road summer 2016**

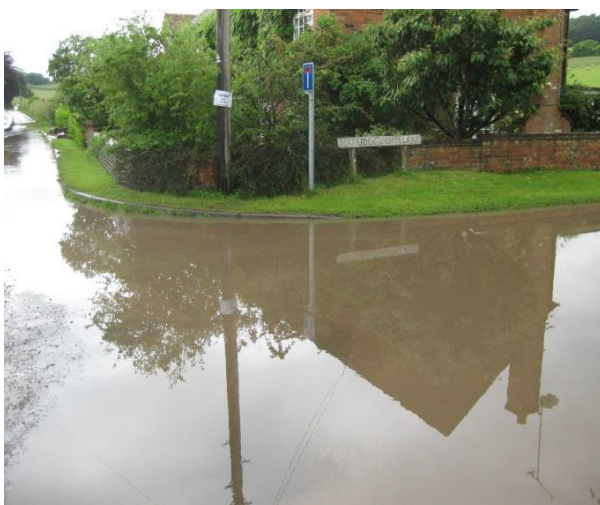
**Figure F13: Rignall Road flooding summer 2016**

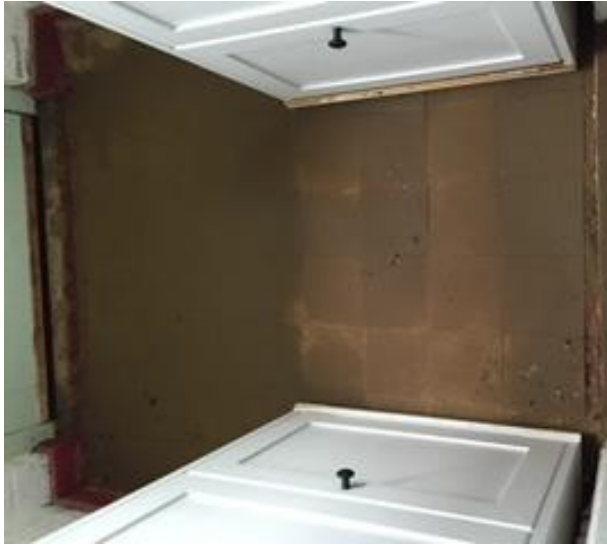
The rest of the flood damage, internal flooding to the hall way and kitchen and rear of the neighbouring property, was not discovered until the following day in the daylight once the storm had passed by. (See photographs included in Appendix F)

**Figure F14: Silt in hall way Rignall Road May 2018**

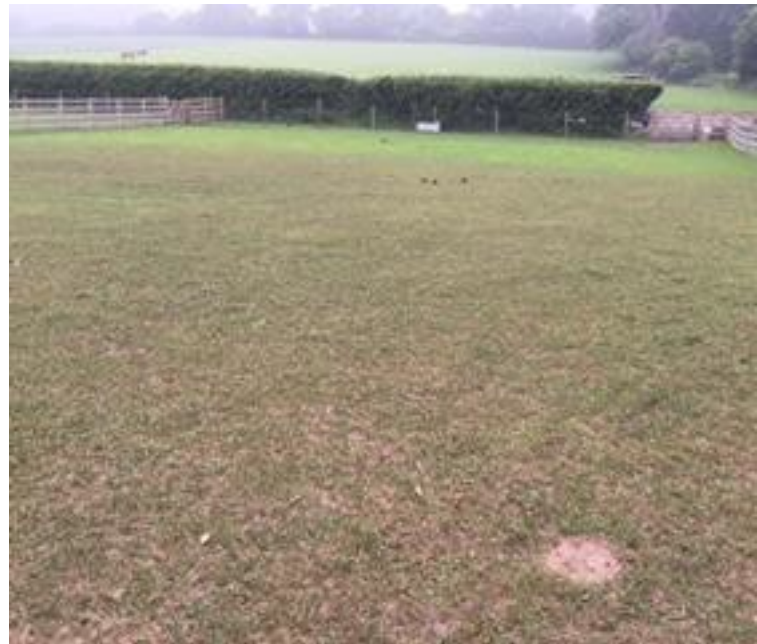
**Figure F15: Flooded paddock Rignall Road May 2018**

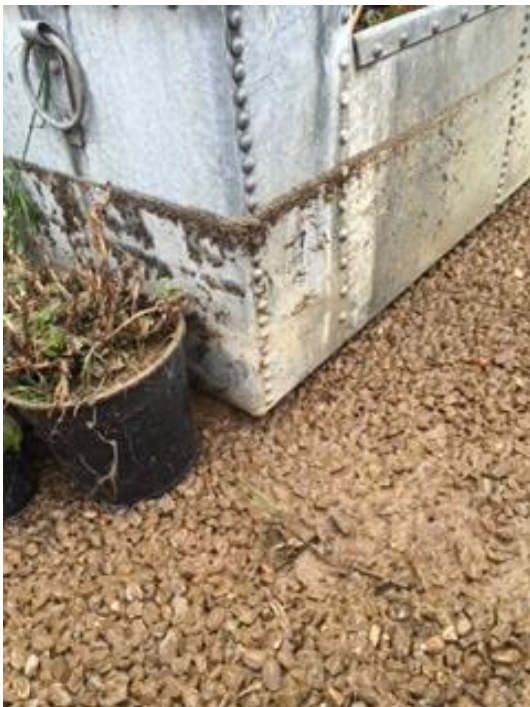
**Figure F16: Flooded drive way Rignall Road to a depth of approximately 40 cm May 2018**

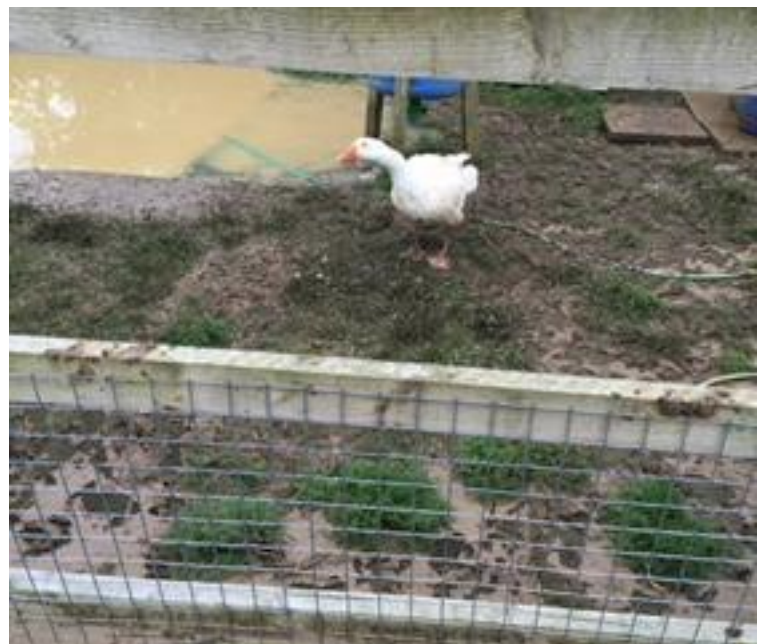
**Figure F17: Flooded duck enclosure Rignall Road May 2018**

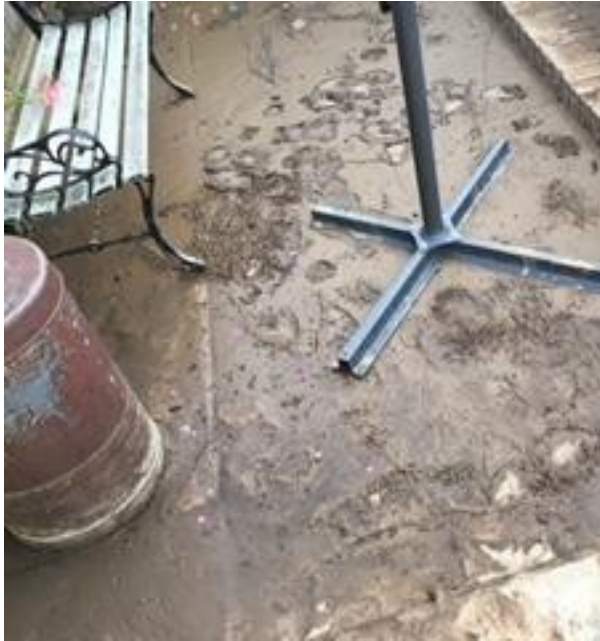
**Figure F19: Flooded patio Rignall Road to a depth of approximately 30cm May 2018**
