# Flood investigation report

## High Wycombe, July 2017

Buckinghamshire Council as Lead Local Flood Authority has a duty to investigate flood incidents as detailed within Section 19 of the Flood and Water Management Act 2010.

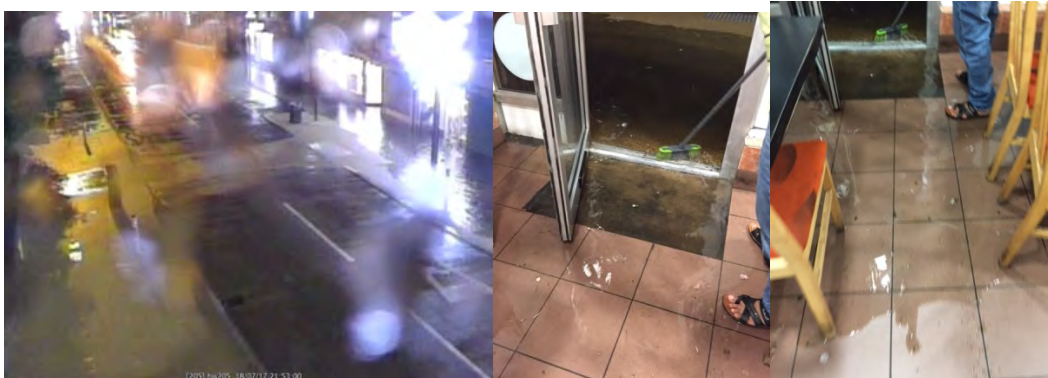
Pictures 1, 2 and 3 - 18/07/2017 21:53 – Desborough Road

In the Desborough Road area the residents of properties which were flooded identified that the water flooded the footway, rose above the door thresholds and entered properties. This was further evidenced by a review of CCTV for the area which highlights flooding started at approximately 21.40hrs, and that the flood water had drained and cleared by 22.10hrs.

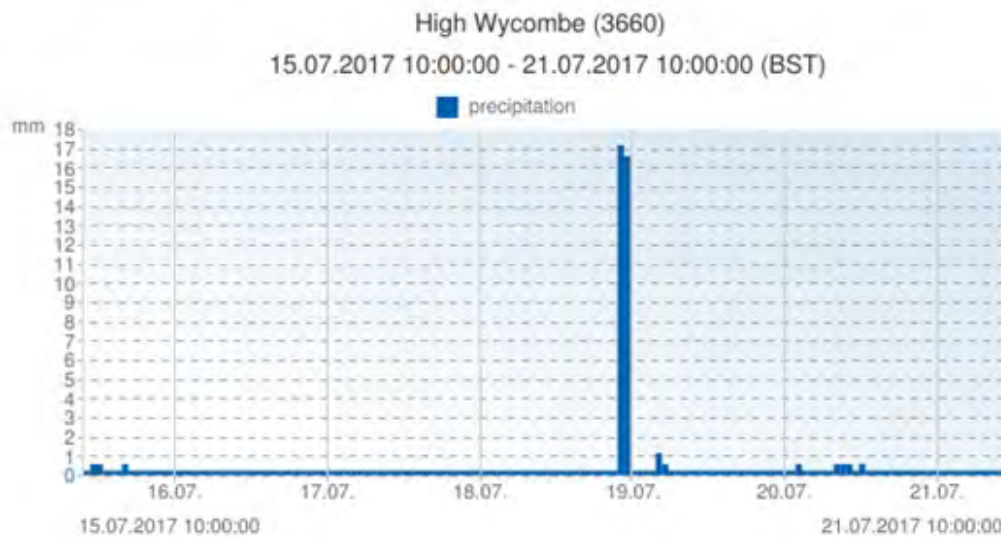
**Figure 3 - Rainfall at Walters Ash, High Wycombe on 19<sup>th</sup>/20<sup>th</sup> July 2017**

**Weather conditions** – On the evening of July 18th 2017 there was heavy rainfall over the High Wycombe area. The nearest weather station to the centre of High Wycombe is Waters Ash in Buckinghamshire, approximately one mile away from the site. This weather station recorded 16.8mm of rainfall between 23.00 on 18<sup>th</sup> July 2017 and 00.00 on 19<sup>th</sup> July 2017 and 16.4mm between 00.00 and 01.00 on 19<sup>th</sup> July 2017, see Figure 3. Over the two hour period 33.2mm fell which statistically equates to a rainfall event 1 in 13 year event over a 2 hour period.

The rainfall reported in the Desborough Road area and caught on the CCTV cameras occurred earlier in the evening than that recorded at the Walter's Ash rain gauge station. This discrepancy is understandable as the sites are a short distance apart.

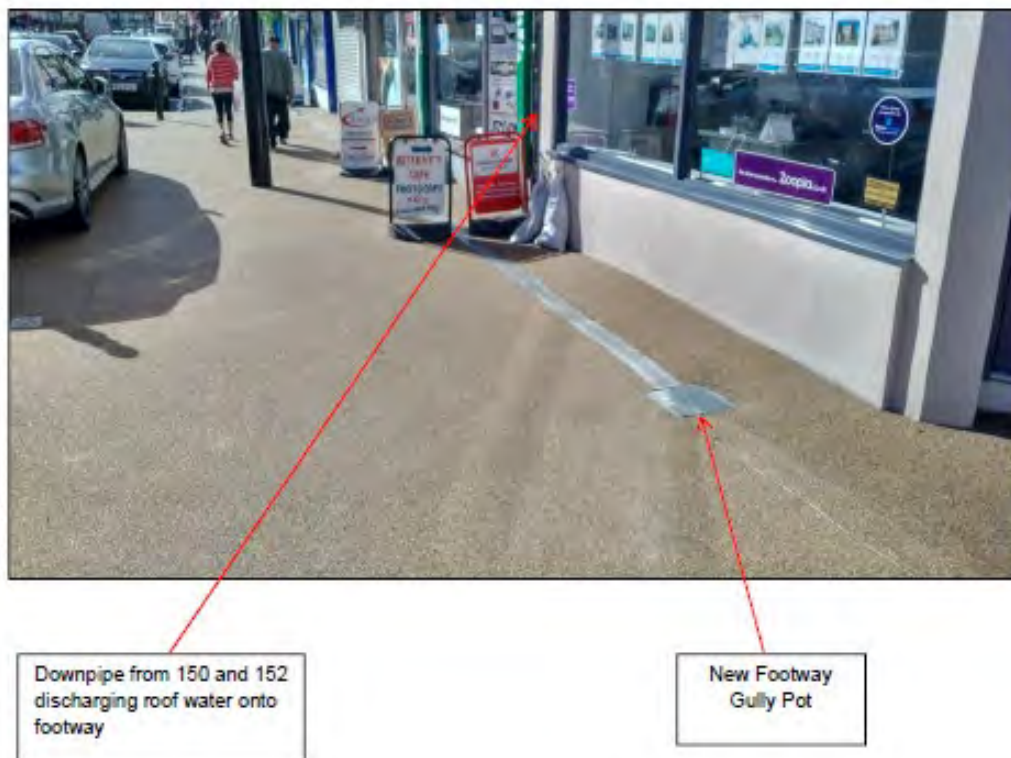
**Figure 5 - New Design of footway drainage and downpipe**

The new design and construction of the drainage system is compliant to a 1:100 + 10% storm capacity. The design increased the drainage from the shop thresholds to the drainage

channel by reducing the footway by an additional 36mm, therefore increasing capacity and flow. This coupled with the design of a 150mm wide granite channel with a long fall of 65mm over 14m. A new footway chamber was included which outfalls directly to the 450mm road surface water carrier approximately 4.6m into the carriageway (Desborough Road). It should also be noted that this area also takes additional rain water from the roofs of 150 and 152 Desborough Road which discharges onto the footway via a downpipe. Figure 5 shows the design.

Downpipe from 150 and 152 discharging roof water onto footway

New Footway Gully Pot

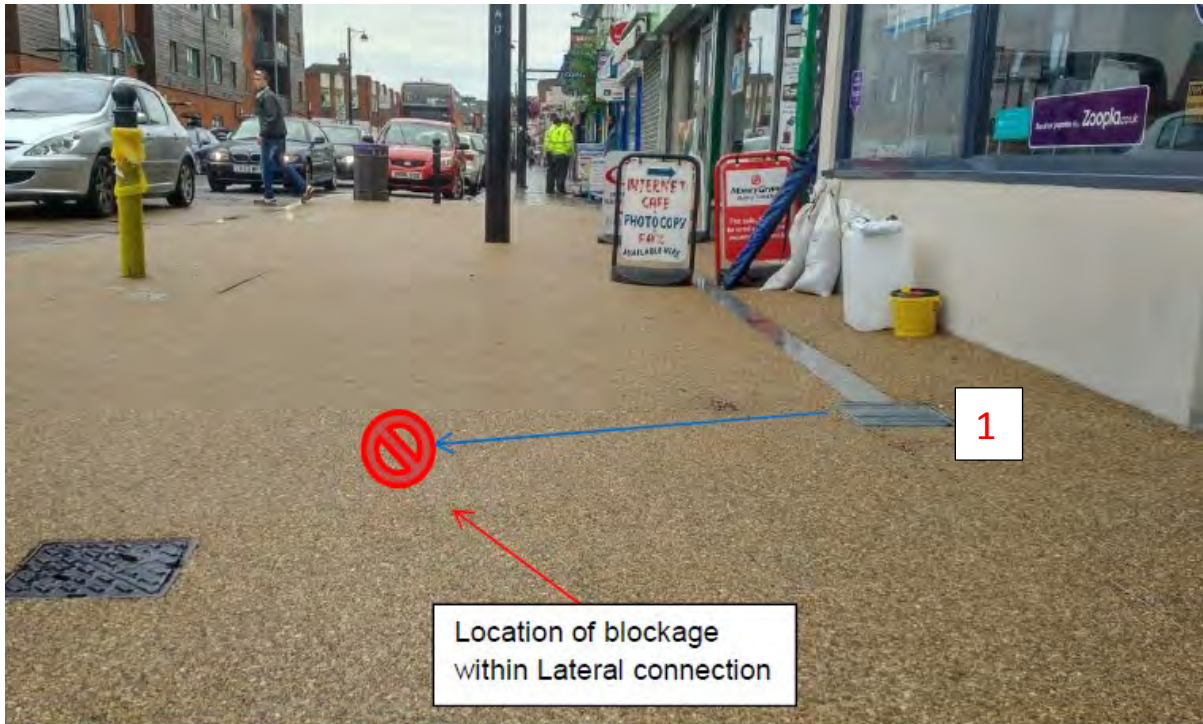
**Figure 6 - Location of blockage in Desborough Road footway**

On 27<sup>th</sup> July 2017, as part of the investigation into the flooding a physical examination of the footway chambers took place. It was found, after rodding, that the gully [1] as identified in Figure 6 was blocked with concrete at approximately 0.8m along the lateral. The blockage was removed and the drain then ran clear and free into the 450mm surface water carrier drain under Desborough Road.

A further visual inspection of the footway gully pot was then undertaken and concrete blockage was found on the entry into the lateral connection. The excess concrete was cleared and the pipe discharged freely without any backing up.

Along Desborough Road and particularly at the junction of Desborough Road and Westbourne Street, road improvements had been carried out and completed in June 2017. The design of the road and footway drainage should have been able to take the 1 in 13 year rainfall volumes and intensities. On investigation in this location, there was a blockage in the lateral connections from the footway to the main surface water carrier in the

carriageway. This was identified as the cause of the flooding as the designed drainage was reduced in capacity and was not able to discharge the rainfall and runoff.

- 1) Regular highway drainage inspection and cleansing especially at the junction of Desborough Road and Westbourne Street.
- 2) Assess the capacity of their assets, identify any areas with insufficient capacity for draining runoff from the highway and, where this leads to flood risk to properties, consider improvement works – especially in the Desborough Road area of High Wycombe.
- 3) Install real-time monitoring cameras or alarm systems to alert them to any blockages/ maintenance issues.

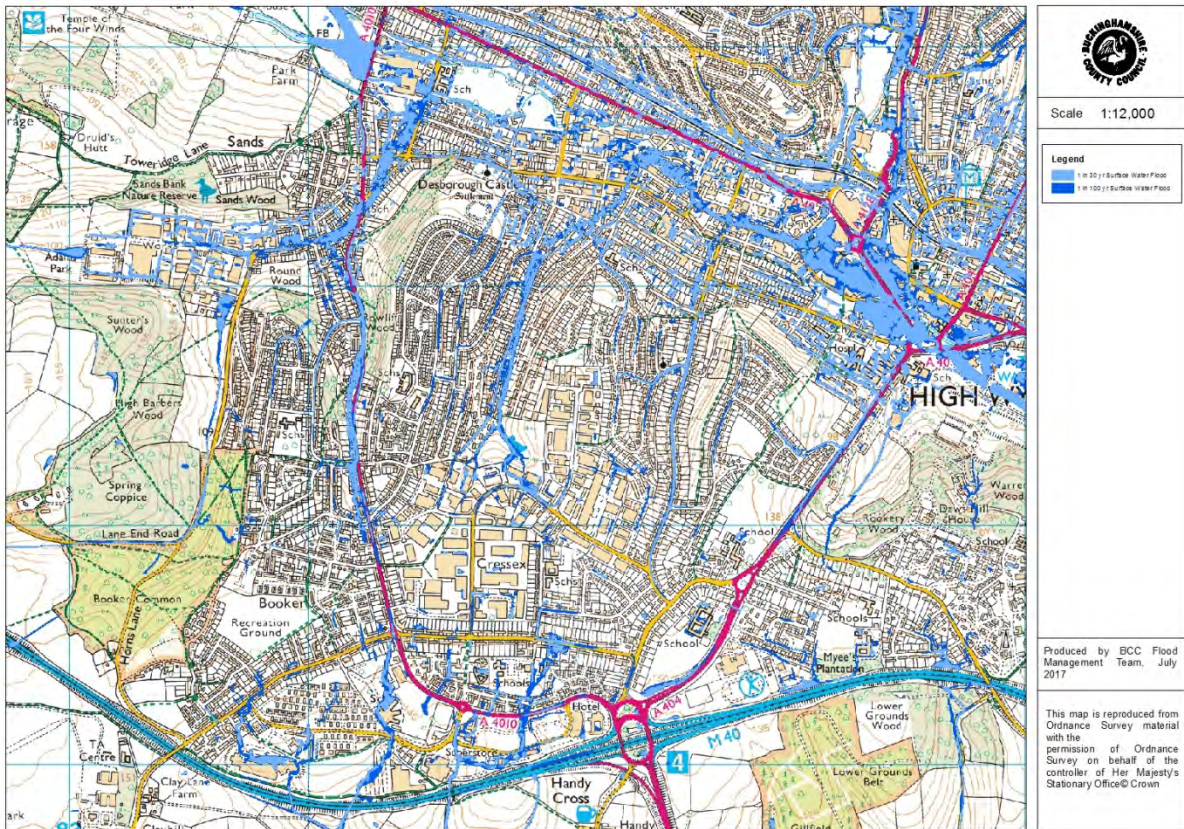
**Figure 8 – Surface Water Flood Map showing 1 in 30 and 1 in 100 year flood events**

Figure 8 shows an extract from the surface water flood maps with the 30 year and 100 year flooded outline shown. This dataset is based on the Environment Agency's Updated Flood Map for Surface Water. Nearly all reported internal flooding locations are in areas that are indicated to be at risk of surface water flooding. Figure 1 shows the locations which were flooded and Figure 8 shows the overlain surface water flood maps and the areas which were flooded.
