# Gawcott Section 19 Flood Investigation

Final Technical Report

**Buckinghamshire  
Council**

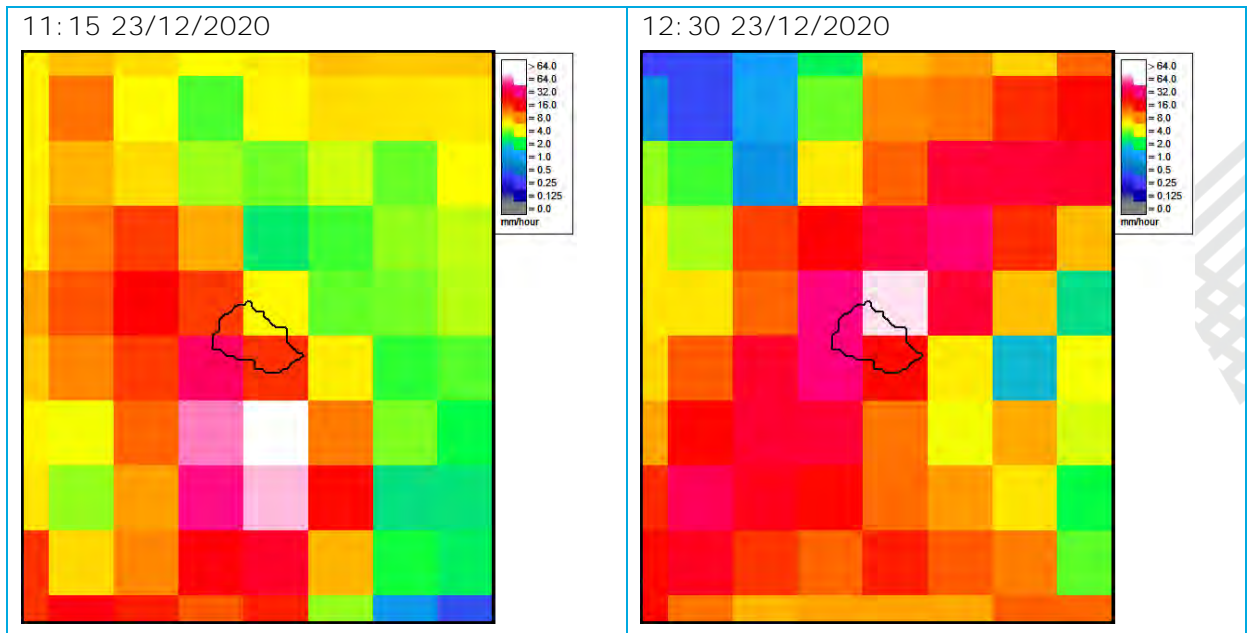
Figure 6-1: HYRAD (radar) rainfall for the Gawcott area

The HYRAD radar rainfall data shows that for the majority of the event the storm passed in a northerly direction across the catchment. After about 17:00, as the weather system turned, the storm passed in a southerly direction.

The images below show the HYRAD observed radar rainfall for the Gawcott catchment (red boundary line in the centre of the image). Colours show rainfall rate at the time shown. Total HYRAD radar rainfall for the storm event was 46mm.

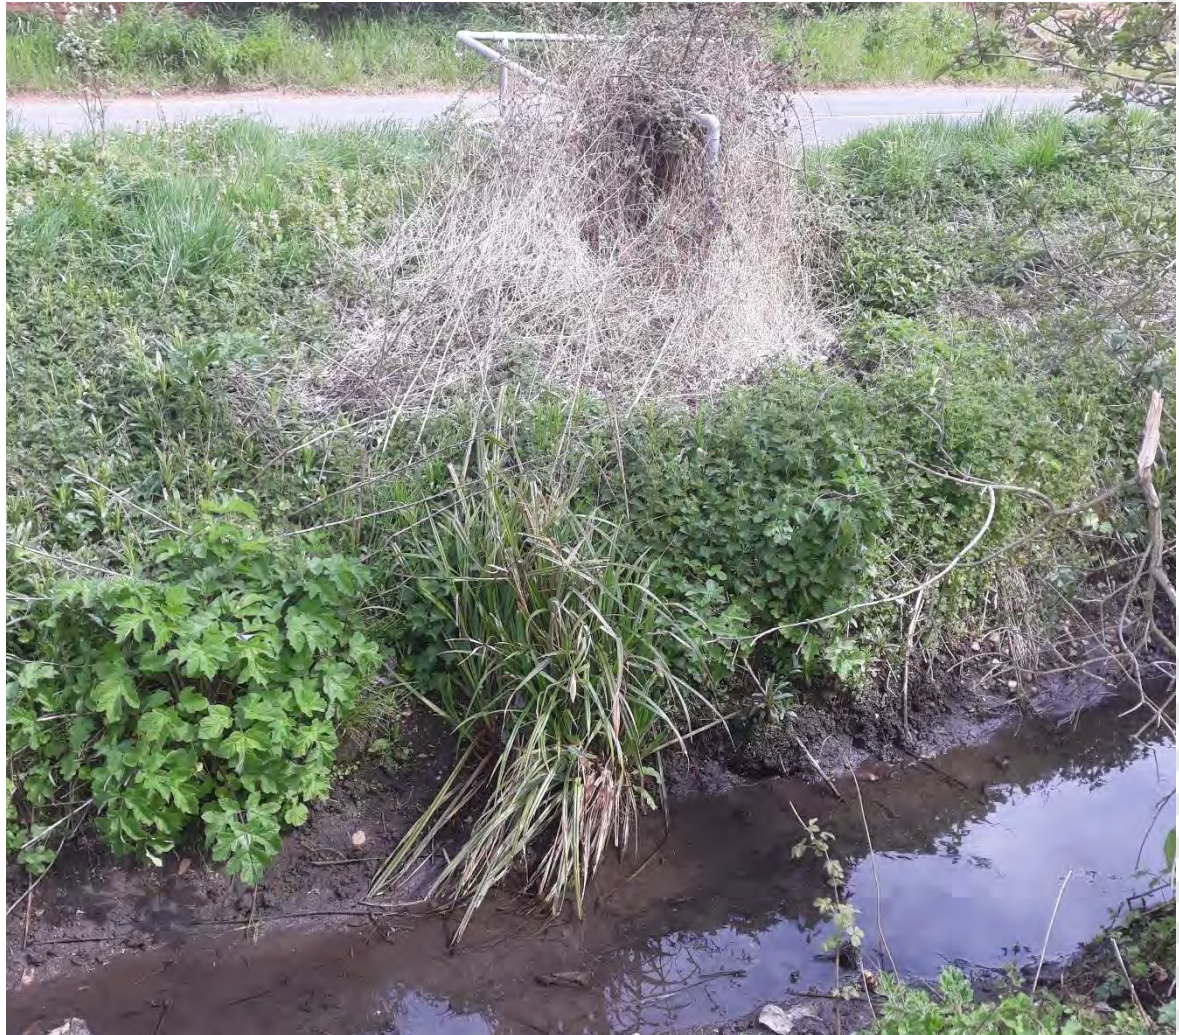
Figure 8-2: Open channel along Preston Road. Photo taken on site visit on 6 May 2021

culvert outlet into the open channel was not surcharged during the event, with the open channel being only one half to one third full. Given that the culvert was surcharging further upstream, this indicates that water was being throttled upstream by restrictions or blockages within the culvert barrel rather than backing up from high water levels in the open channel.

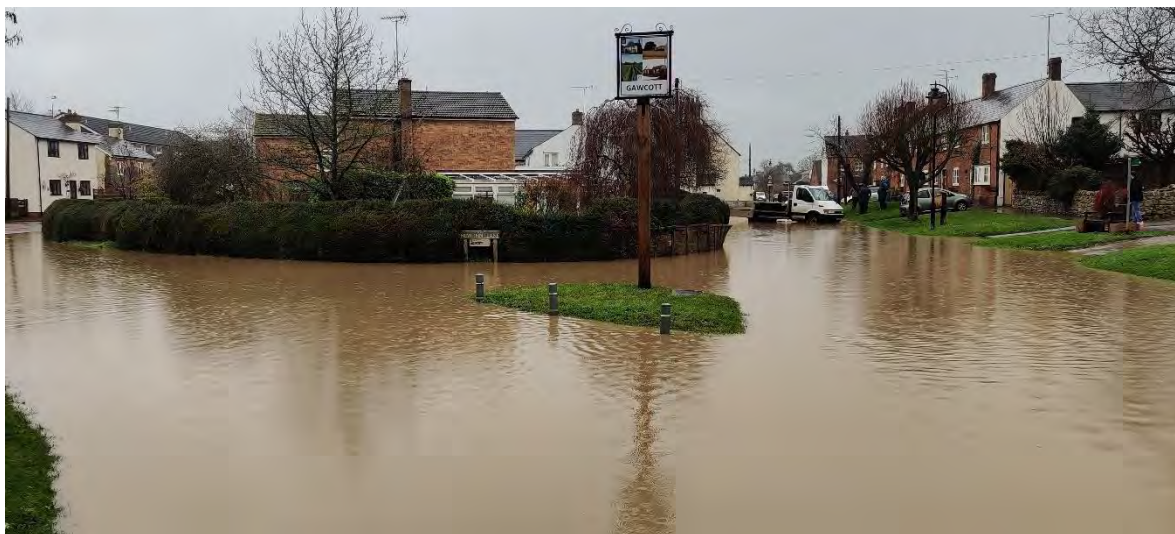
Figure 8-5: Flooding on Main Street, Gawcott during the event

Highway flooding was significant along Main Street and New Inn Lane. As a result, Buckinghamshire Council in its role as Highway Authority ordered a road closure after 18:00 on the day of the event.

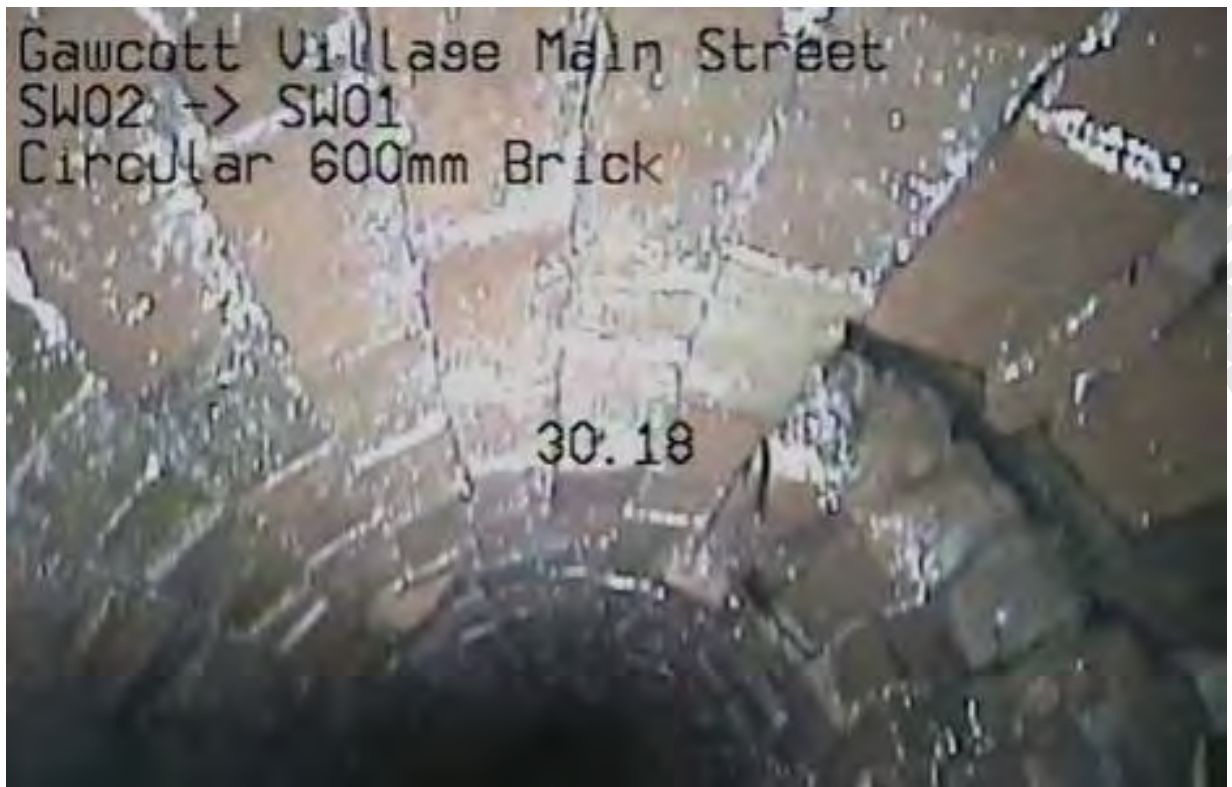
Figure 9-1: CCTV survey - hole in wall of culvert

The survey recorded one Grade 5 defect, associated with a hole in the culvert (shown in Figure 9-1), close to the Methodist Chapel between manholes SW01 and SW02 (Figure 9-5 for locations). Although not recorded as a graded defect, a further similar hole of similar severity in the wall of the culvert was identified from the CCTV footage, between the outfall and SW01. There are a small number of sections with less severe defects.

As of the date of this report, a scheme is being developed as a high priority by Transport for Buckinghamshire with the aim of making these defects safe. It is beyond the remit of this investigation to provide further information on this developing project – Transport for Buckinghamshire may be able to provide further information.

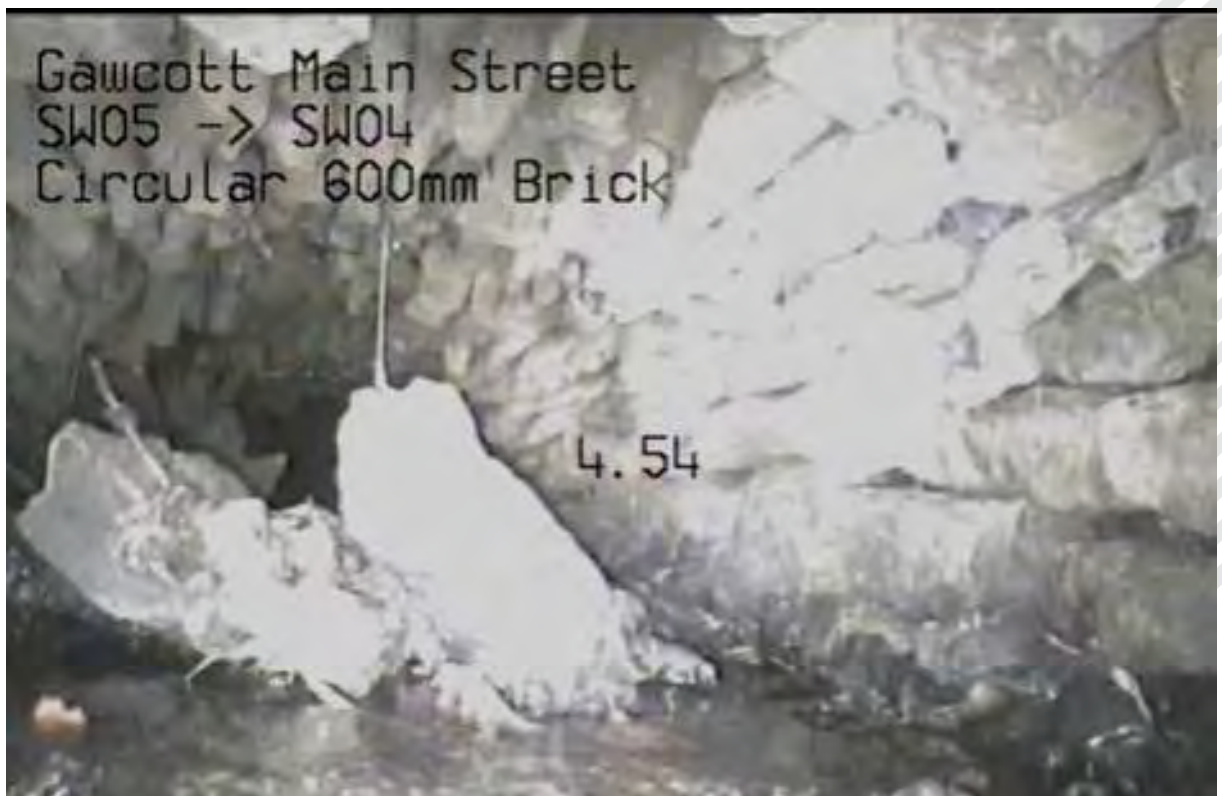
Figure 9-2: CCTV survey - masonry in base of culvert, 40% blockage.

A total of 12 Grade 5 defects were identified, which represent significant losses in the cross-sectional profile of the culvert. For example, Figure 9-2 shows a partial blockage by fallen masonry. Several pipes have been placed directly through the culvert which also result in a loss of cross-sectional area within the pipe – for example, as shown in Figure 9-3. In many cases, this also restricted the survey, as the camera was unable to pass the obstruction. Although not stated as a graded defect, there is also substantial decrease in pipe capacity between Outfall1 and SW01, shown in Figure 9-4.
