Buckinghamshire County Council

Flood Investigation Report

Chalfont St Giles, March to April 2014

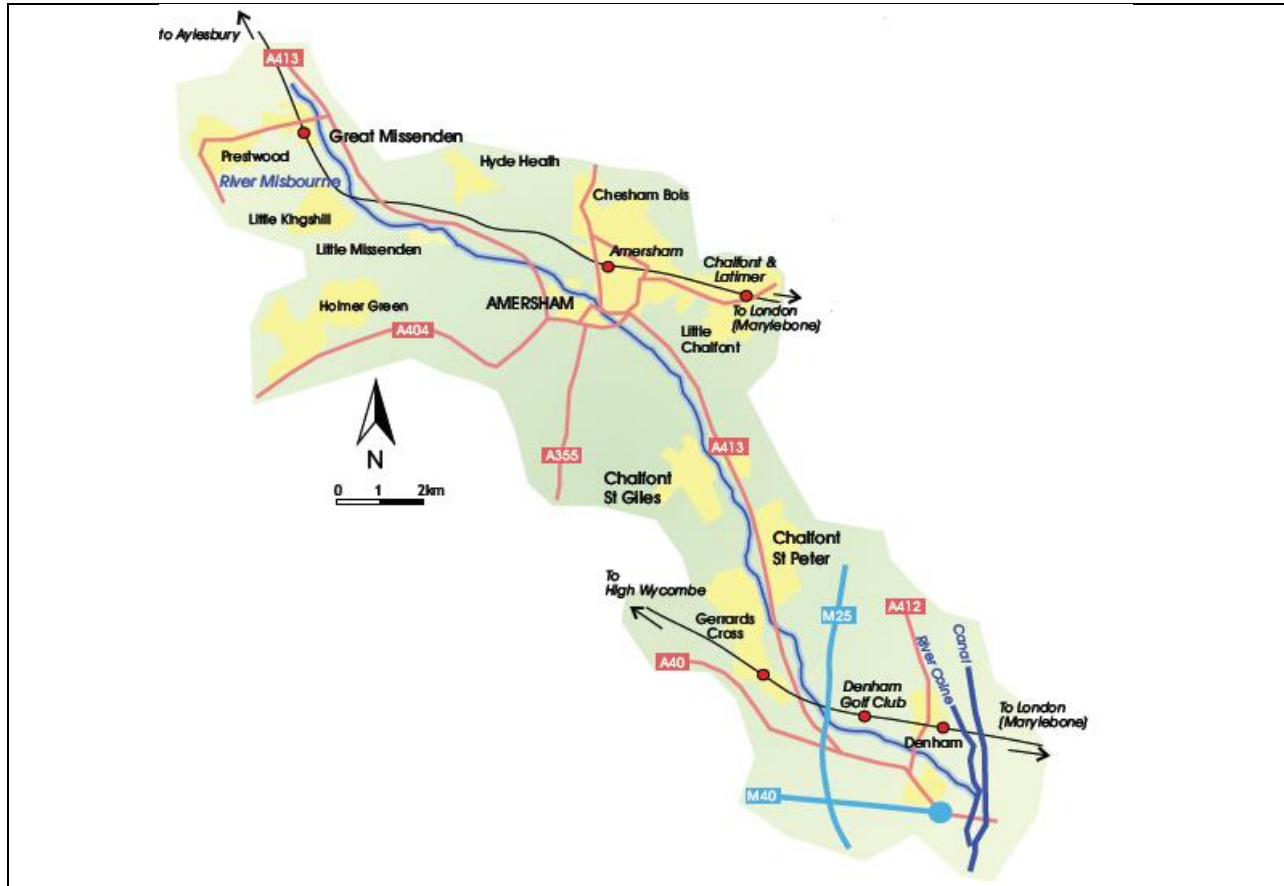
Figure 2: The River Misbourne (Source: Chilterns Chalk Streams Project)

The River Misbourne is a main river that flows through Chalfont St Giles, as shown in Figure 2. It is a chalk stream that flows for 17 miles (27 km) from Mobwell Pond just north of Great Missenden to its confluence with the River Colne, which itself is a tributary of the River Thames. Apart from a small section in Great Missenden, the River Misbourne is classed as a main river. The Environment Agency (EA) is the RMA for the main river section, as defined in section 4.3. The Environment Agency has powers to work on main rivers and the sea to manage flood risk.

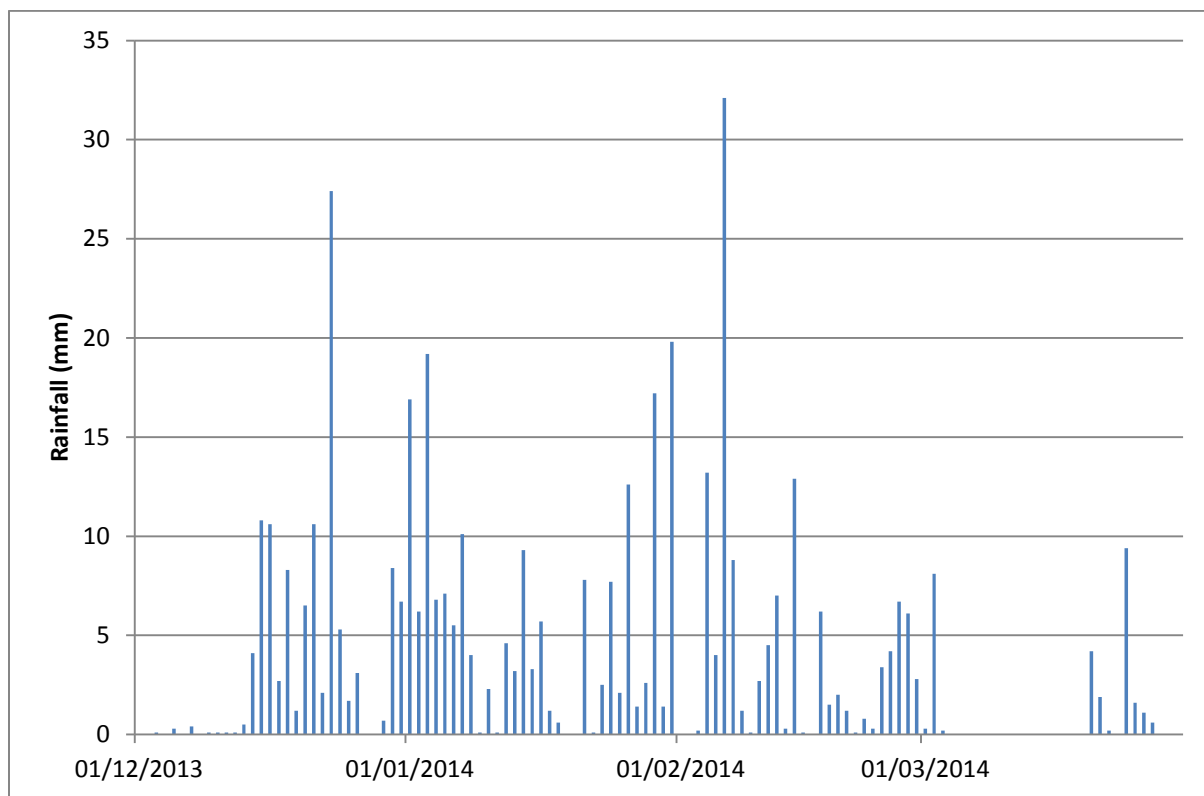
Figure 7: Daily rainfall totals as recorded by the Environment Agency rain gauge at Little Chalfont (Environment Agency, 2014)

The period between December 2013 and April 2014 received long periods of above average rainfall especially during January and February, as shown in figure 7. The above average rainfall lead to groundwater recharge within the chalk aquifer. The result of the rainfall and groundwater levels was groundwater flooding and fluvial flooding of the river Misbourne. As the river Misbourne is a chalk stream it derives the majority of its flow from the chalk aquifer therefore when groundwater levels are high so are stream flows.

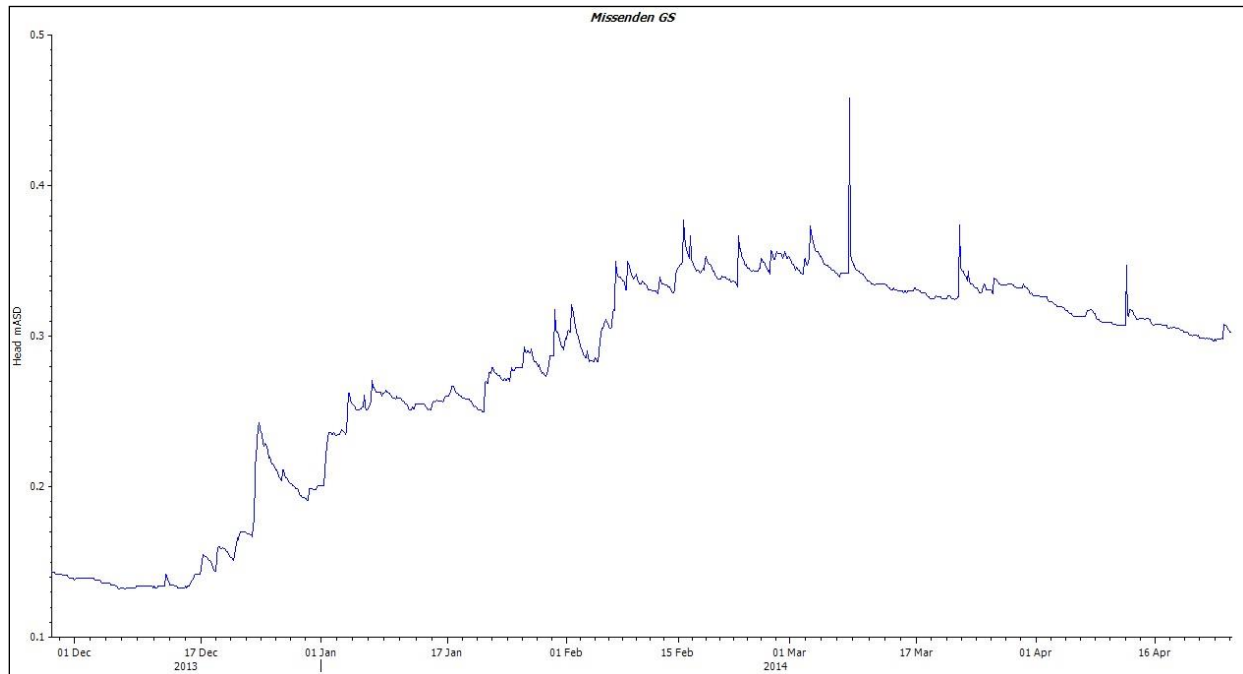
Figure 8: River Misbourne hydrograph, as per Little Missenden gauge measurements, December 2013 to April 2014 (Environment Agency, 2014)

The EA's nearest telemetered river level gauge is at Little Missenden (SU 9342198458, approximately 11 km upstream of the centre of Chalfont St Peter). Figure 8 shows the river levels for December 2013 to April 2014.

The Little Missenden gauge has been in operation since October 1993. The EA's records for the gauge show that the entire event (the three months leading up to March 2014) is listed as number 1 of the top 10 levels ever recorded at this site. The peak level of the event was on 08 March 2014, at 459mm, although there were other peaks in river levels during the event in question, for example on 07 and 08 February 2014.

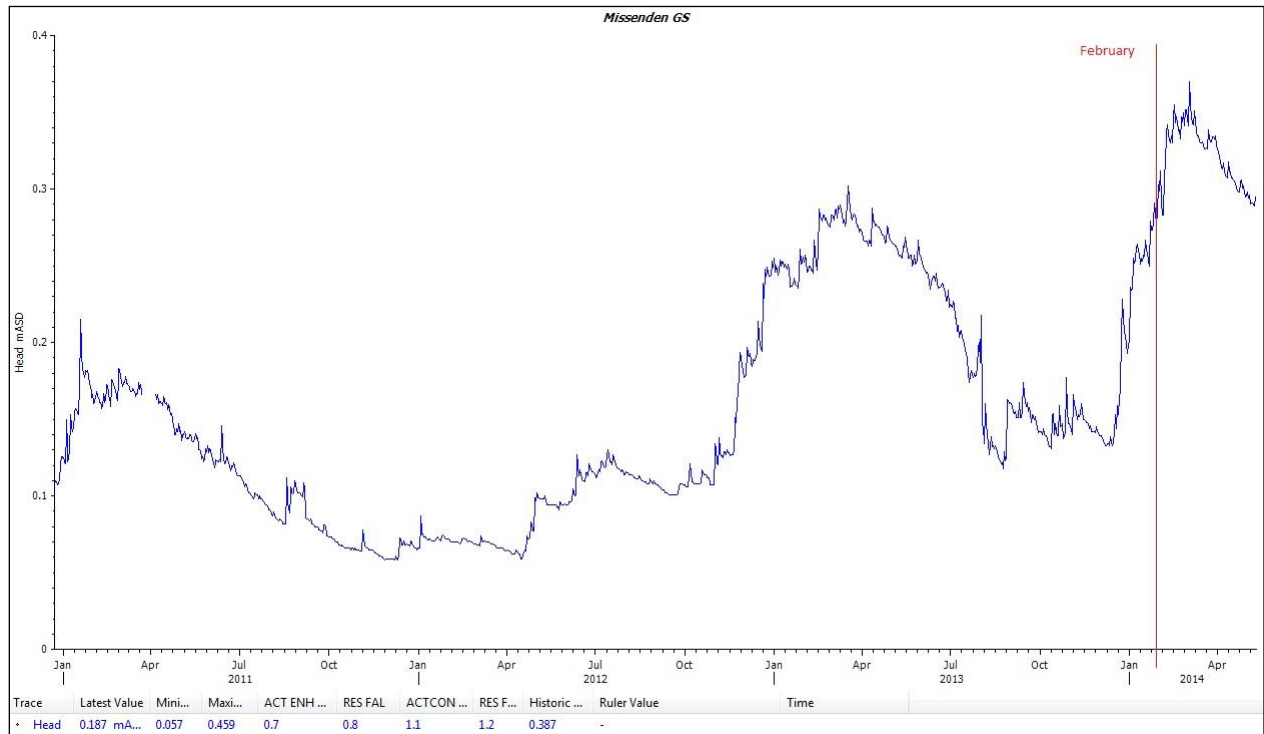
Figure 9: River Misbourne hydrograph, as per Little Missenden gauge measurements, January 2011 to April 2014 (Environment Agency, 2014)

The measurements from the Little Missenden gauge give an early warning of high flows upstream of Chalfont St Giles. Due to the distance upstream this gauge will only give a relative river levels in Chalfont St Giles. However, Figure 9 – the hydrograph for the past three years – can give an indication of levels in the area. It shows the high levels of February/March 2014, with similar levels recorded in March/April 2013. As a note, river levels in the area vary in the period analysed by 443mm (the difference between the lowest and the highest recorded levels).
