Buckinghamshire County Council

Flood Investigation Report

Bishopstone, Aylesbury

24th December 2013 – 14th February 2014

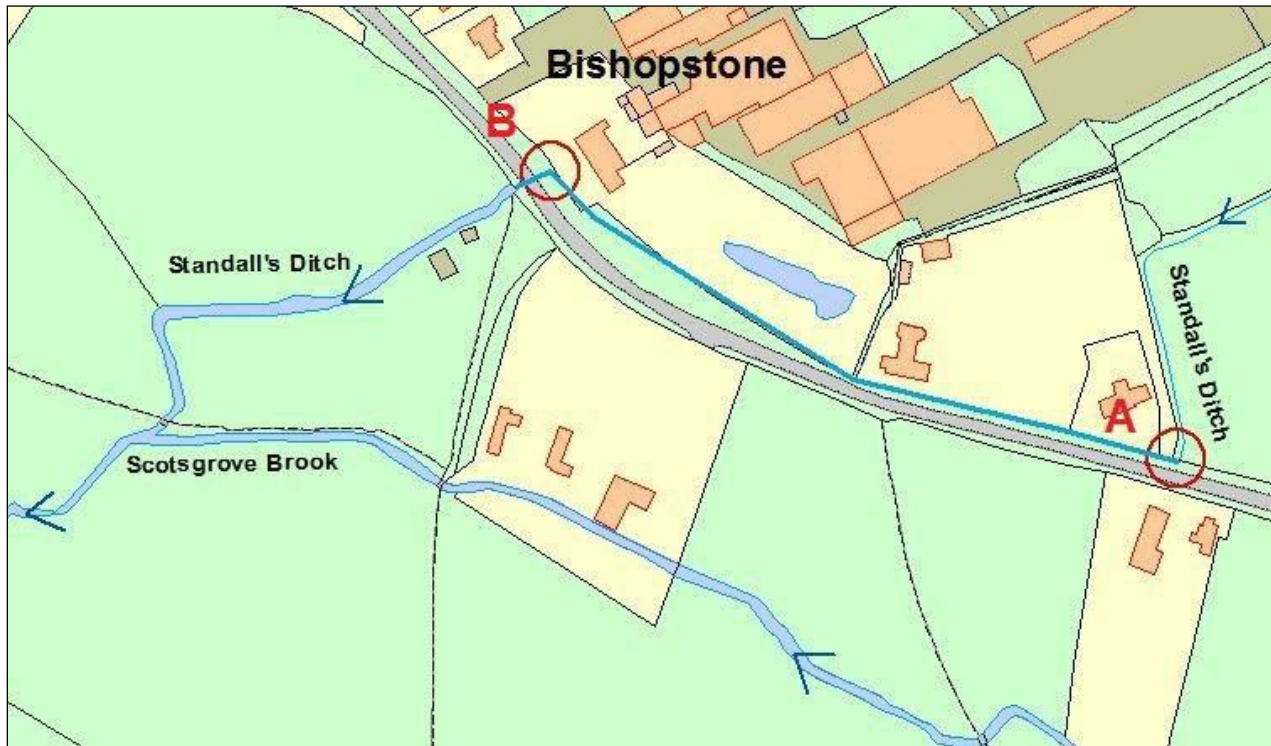
Figure 2 Map showing main river names and direction of flow in Bishopstone, Aylesbury

Standall's Ditch appears to have been altered in the past where it flows through Bishopstone. This is evident due to the two right angled turns it makes, once as it enters the village (A) and turns to follow the road, and again just before it goes in to a culvert under the road (B) and exits Bishopstone, both turns have been marked on Figure 2 with a red circle.

The main river, Standall's Ditch, was breached where it makes a ninety degree turn (see A, figure 2) to follow the highway as it enters Bishopstone; the water that flowed out of the river at this point used the highway as a second flow path, making its way into the village and to the lowest spot. It is also assumed that surface water flowing off the fields from the southeast of Bishopstone was of a large volume and too much for the highway ditches to convey, therefore more flood water made its way on to the highway.

- Standall's Ditch has unnatural ninety degree turns (see figure 2, points A and B), causing fast flowing water to breach the watercourse.
- The culverts under access drives in Bishopstone (section between points A and B, figure 2) are undersized which reduced the flow that Standall's Ditch can convey and caused water to back up.

- The outfall of the main culvert under the road (point B on figure 2) is a 300mm diameter pipe which is smaller than the 600mm diameter inlet pipe, reducing the flow that can be conveyed through.

- Standall's Ditch appears to be silted up downstream of the culvert (at point B on figure 2), not allowing the flow to get away fast enough and causing the flood water to back up.

- Downstream of the culvert (point B, figure 2) some trees had fallen in to the watercourse, contributing to the back up of water and reducing the conveyance flow.

The highway drainage and the culvert under the road (see B, figure 2) did not have any obstructions during the flooding event; however they were full to capacity during heavy rainfall, and therefore were unable to take the full volume of flow. The highway ditches would also have been at capacity with the volume of rainfall and runoff. On inspection after the rainfall event it appeared that the highway ditches had not been maintained properly which reduced their capacity greatly.

The section of watercourse downstream of the road culvert (for road culvert see B on figure 2) was silted up in areas, not allowing the full volume of flow to be conveyed. Due to this, water backed up in the watercourse and flowed on to the highway contributing to the flooding.

- The water levels in Standall's Ditch and Scotgrove Brook were high due to excessive rainfall.
- Standall's Ditch was very overgrown with thick vegetation in the section upstream of Bishopstone (upstream of point A on Figure 2); this would have reduced the capacity of the river.

- Prolonged rainfall caused the land to be saturated and therefore there was increased surface water entering the surface water system and river network.
- Standall's Ditch has unnatural ninety degree turns (see A and B in figure 2), causing fast flowing water to breach the watercourse.
- The culverts under access drives in Bishopstone (section between A and B, figure 2) are undersized which reduces the flow that Standall's Ditch can carry through and caused water to back up.
- The outfall of the main culvert under the road (see B in figure 2) is a 300mm diameter pipe which is smaller than the 600mm diameter inlet pipe, reducing the flow that can be conveyed through.
- Standall's Ditch appears to be silted up downstream of the culvert, not allowing the flow to get away fast enough and possibly causing the flood water to back up.

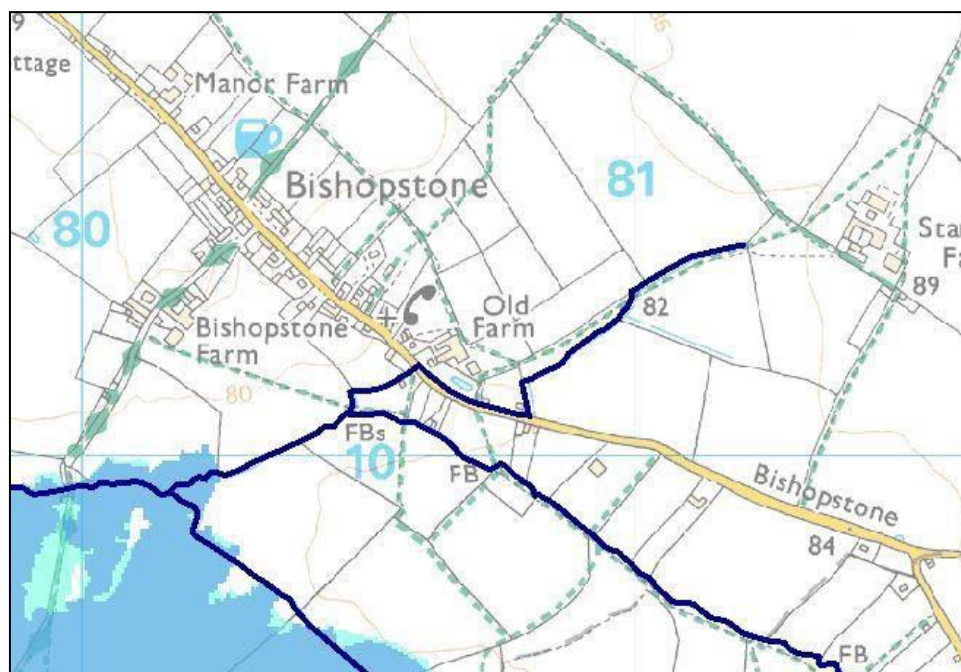
Figure 4 EA flood map showing Standall's Ditch and Scotsgrove Brook 1:100 year event (flood zone 3) in dark blue and 1:1000 year (flood zone 2) in light blue (EA, 2014)

Figures 4, 5 and 6 below show the fluvial and surface water flood maps for the village. The fluvial flood map (see figure 4) shows the flooding which would occur from the main rivers in a 1 in 100 year (dark blue) and 1 in 1000 year (light blue) event. The flood water in these situations would come from the river and flow out onto the impacted areas shown on the map. From the EA's records Bishopstone is not shown to be affected by fluvial flooding.

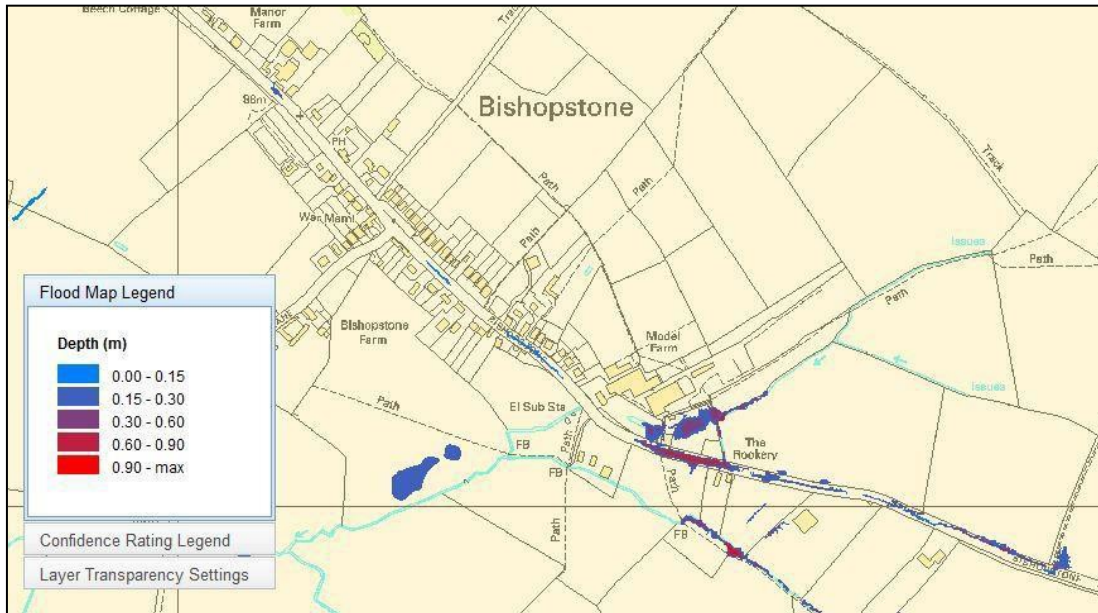
Figure 5 1:100 year surface water flood map showing predicted depth across Bishopstone (EA, 2013)

The surface water flood maps show the difference in depths of flooding in the 1 in 100 year (see figure 5) and the 1 in 1000 year (see figure 6) events for the area surrounding Bishopstone. Surface water flooding occurs when extreme or prolonged rainfall cannot infiltrate into saturated ground, or flow into the rivers and/or highways drainage due to high volumes of water.

From both figure 5 and figure 6 it can be seen that the southeast of Bishopstone is predicted to experience the most surface water flooding. The surface water flooding shown in these maps is true to the flooding which was experienced during this flood event. Although the flood event in Bishopstone was significant, it is unlikely that a 1 in 100 year rainfall event occurred locally between 24th December 2013 and 14th February 2014. This indicates that the actual flooding occurs more frequently than predicted in the maps.
