Buckinghamshire County Council Flood Investigation Report

Old Amersham, Amersham
15th June 2016

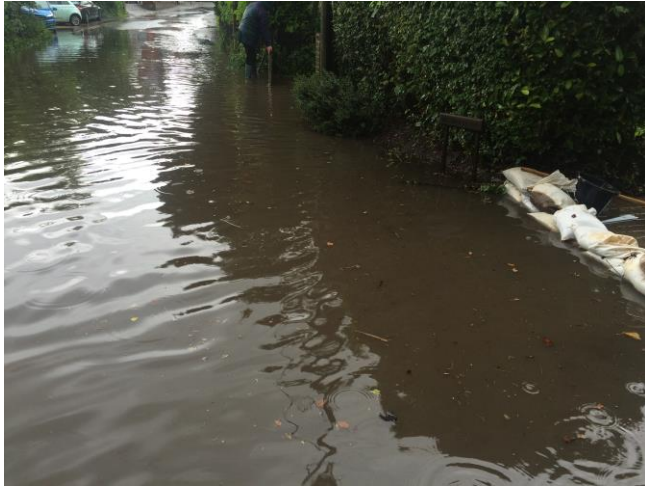
Grimsdells lane

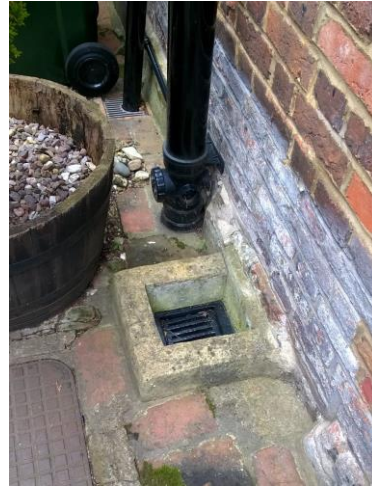
Drain outside property on High Street

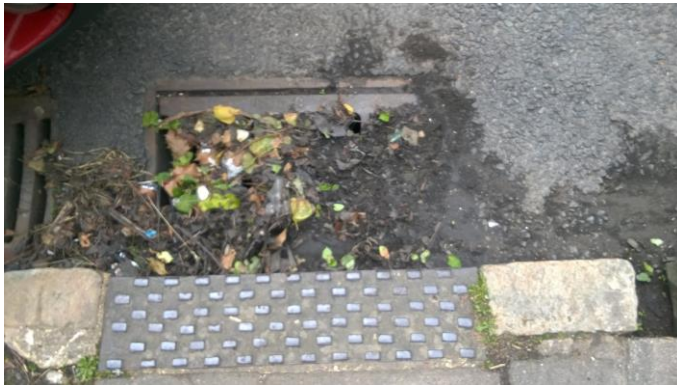
High street drains post event

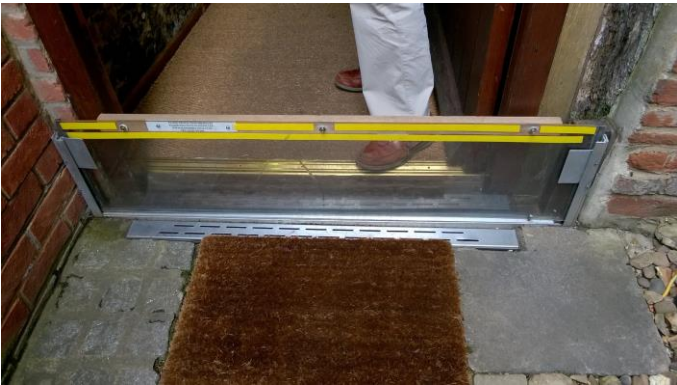
Deployed barrier at Amersham museum

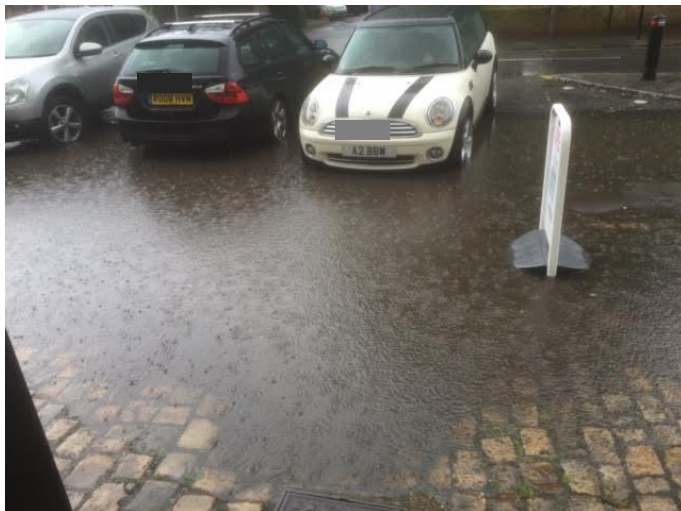
High street Old Amersham

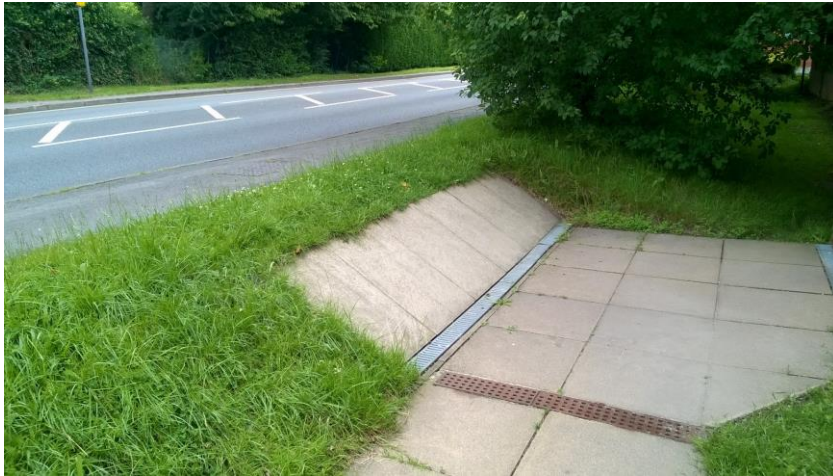
Chiltern Avenue outside Amersham Health Centre

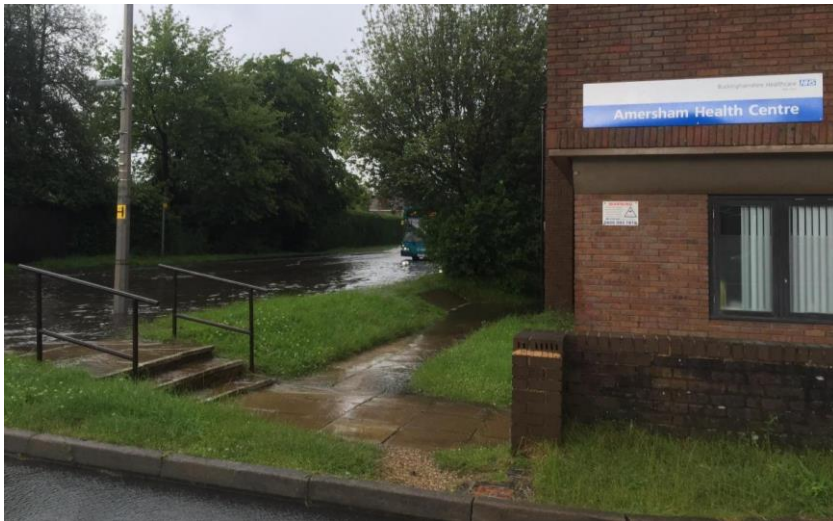
Chiltern Avenue during event (Bucks Free Press, 2016)

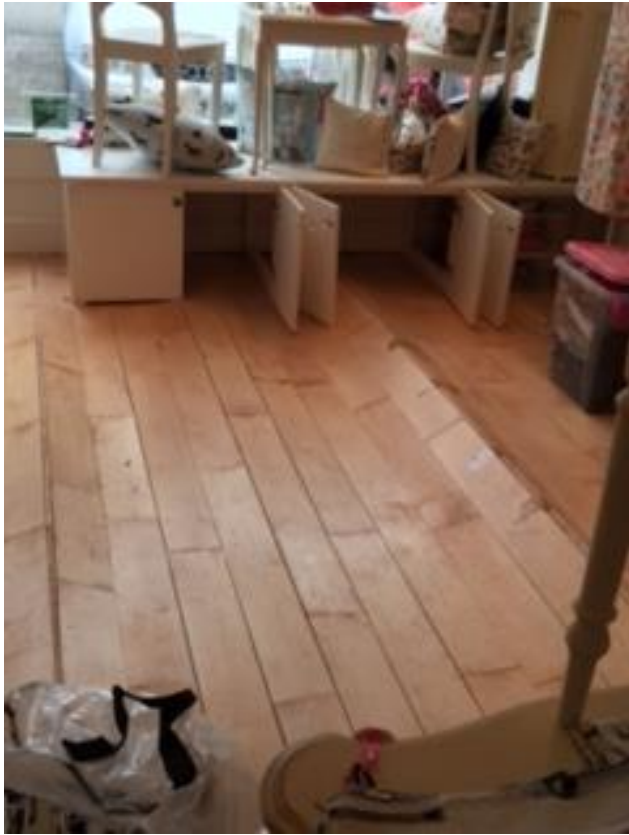
Internal flood damage to a business on High Street, Old Amersham

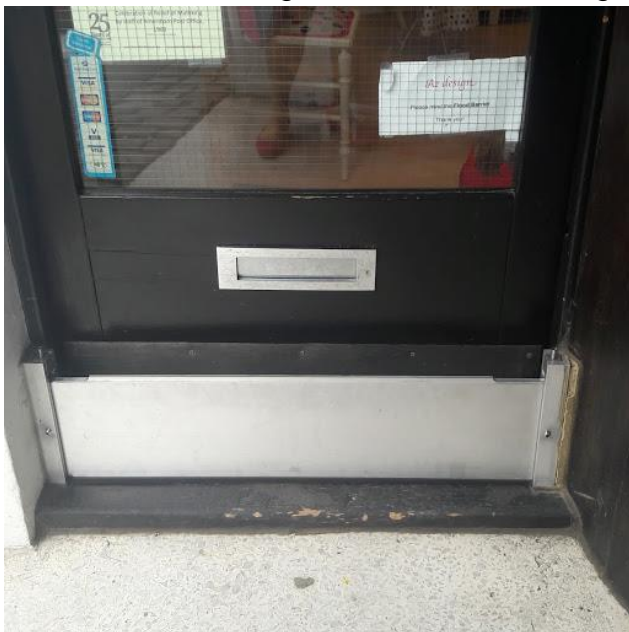
Property level protection installed as a result of the event (Anastassopoulos, 2017)
