# Buckinghamshire County Council

## Flood Investigation Report

Medmenham

January & February 2014

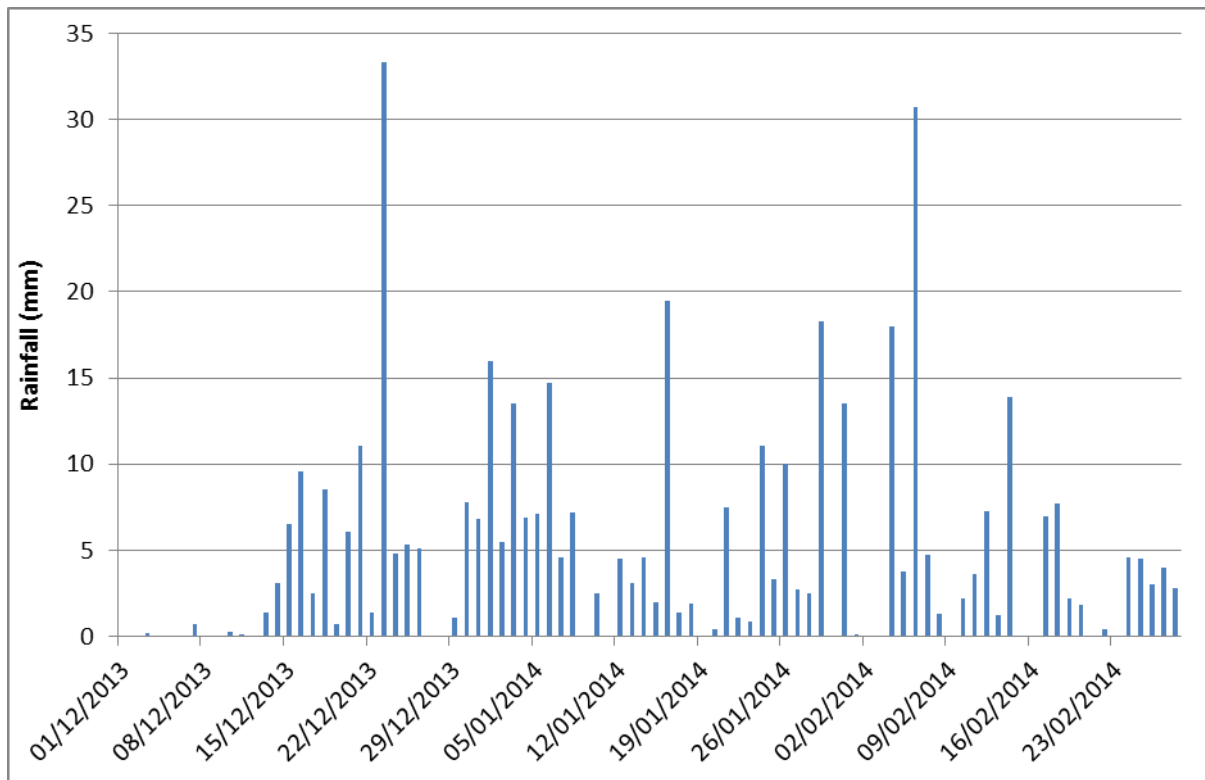
**Figure 5 Rainfall data from Hambleton**

Figure 5 shows the rainfall data from the Hambleton rain gauge nearby to Medmenham for the three month period December, January, February. This figure shows the consistently high rainfall over this period with rain on the majority of days and 6 days when the rainfall totals were over 15mm. The winter rainfall recorded in Buckinghamshire in December 2013, January and February 2014 was 420mm in comparison to 185mm average winter rainfall.

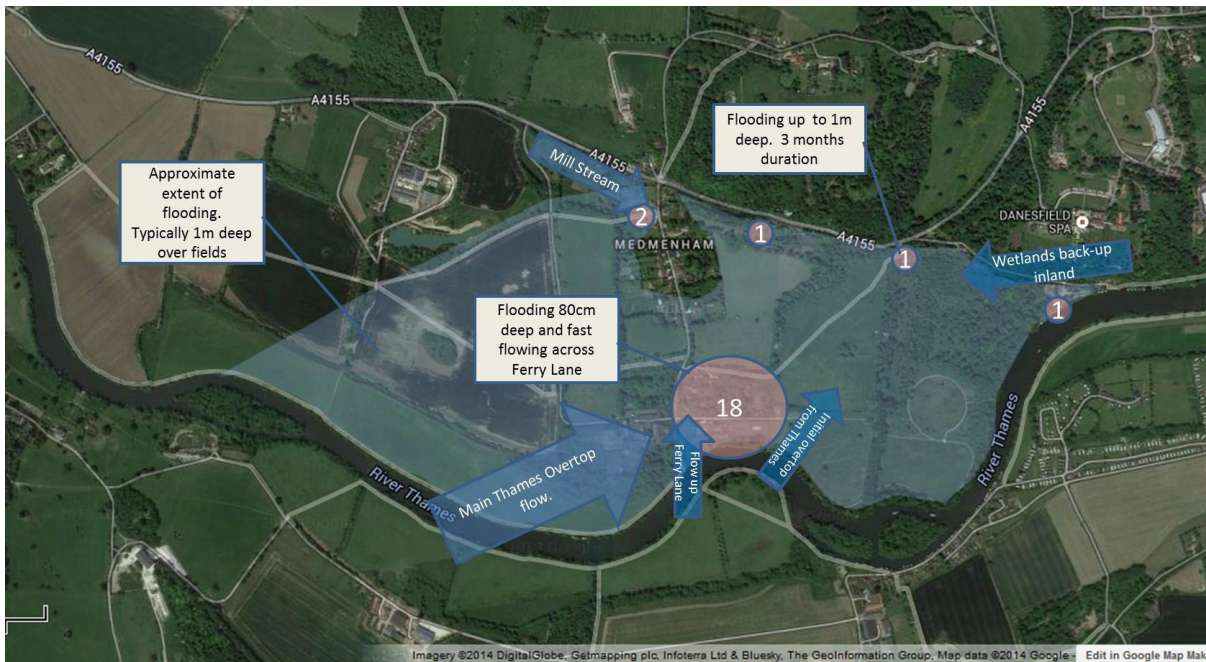
**Figure 6 Location of flooding in February 2014 in Medmenham area (Millard K. and McLeish P., 2014)**

Figures 6 and 7 show the location and the route of the flooding in January and February 2014. The numbers in the circles indicates the number of properties affected by flooding in January and February 2014.
