# Tingewick Section 19 Flood Investigation

Final Technical Report

**Buckinghamshire  
Council**

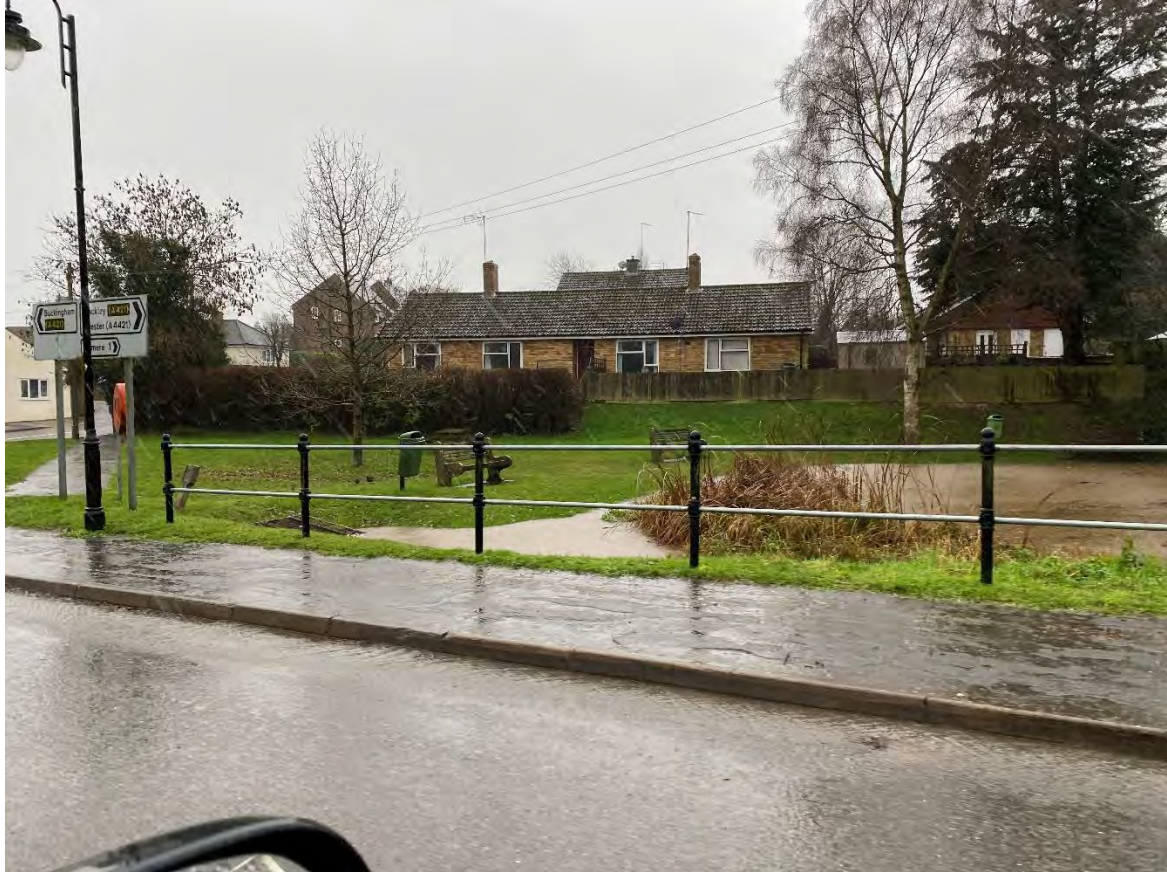
Figure 8-2: Flood of Townsend Pond at 13:40 on 23 December 2020

An image taken by a resident at 13:40 indicates that by this time water level had risen above the 300mm outlet pipe, and that water was flowing through the overflow structure (a screen allowing water to enter the 600mm culvert at a higher level than the 300mm pipe)

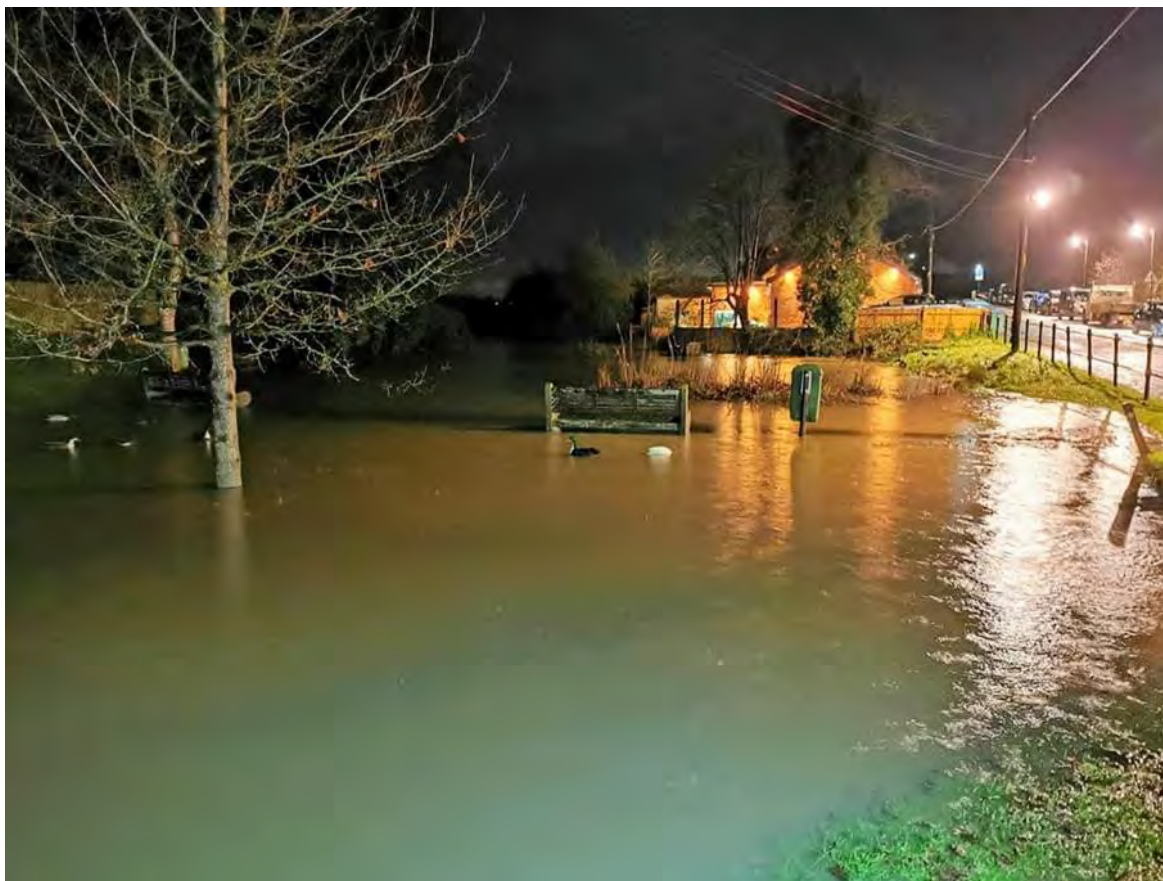
Figure 8-3: Overtopping of Townsend Pond during the evening of 23 December 2020

Residents observed that Townsend Pond overtopped at approximately 17:00. Water levels overtopped the overflow structure and the top of the embankment and this additional water started to flow down Main Street. This coincided with the second wave of rainfall and from 17:00 onwards it was noted that water levels rose rapidly, causing additional internal flooding to properties. Water is noted to have entered many of these properties through the front doors and in some cases through the floors of the property.
