Buckinghamshire County Council

Flood Investigation Report

Buckingham, 10th March 2016

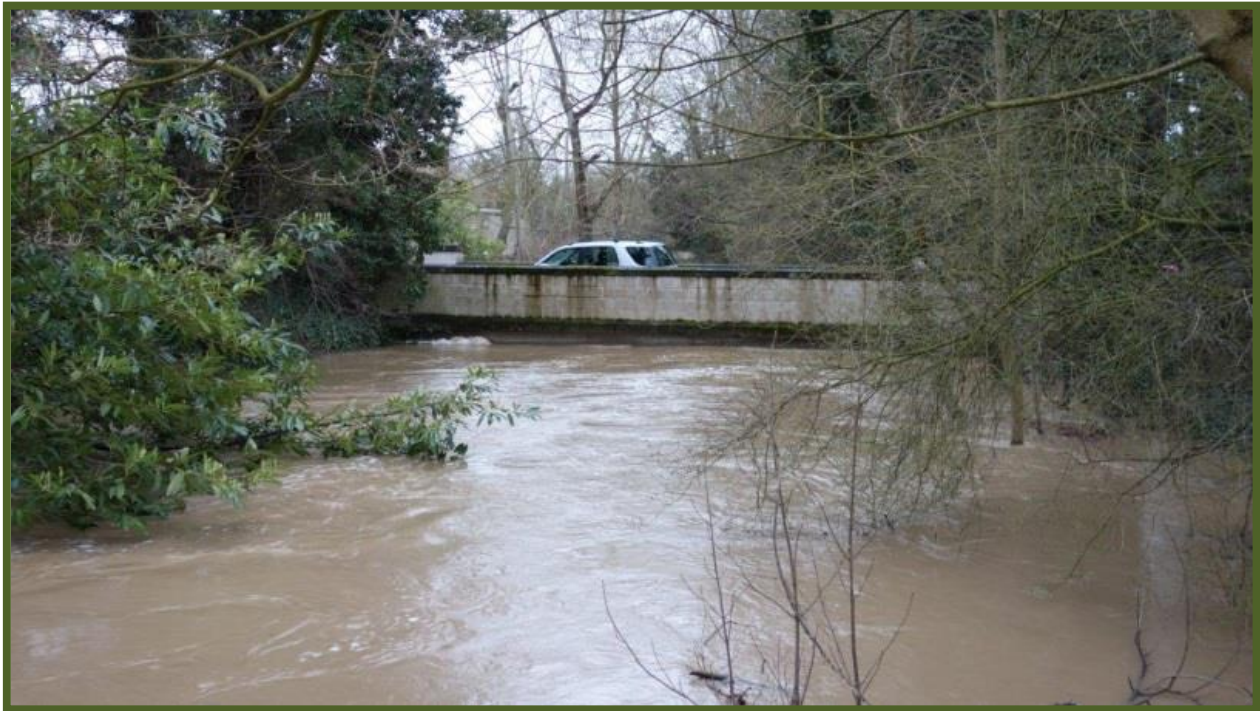
River Great Ouse beneath the Tingewick Road Bridge (provided courtesy of Mr P. Wallace)

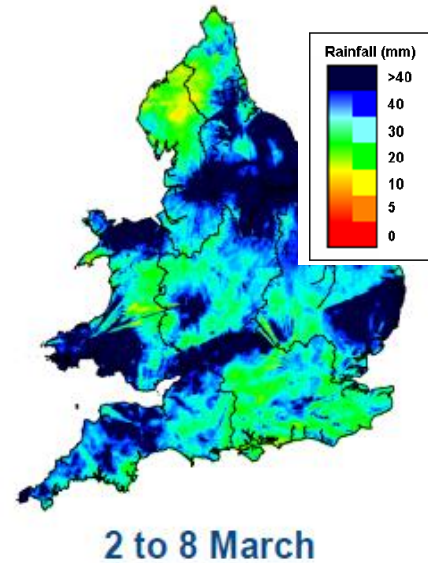
Over the period of 2-8th March 2016, weekly precipitation exceeded 40mm in many parts of the country, including in the vicinity of Buckingham (Figure 5).

Figure 5: Rainfall totals over the period 2-8th March 2016. Note that radar beam blockages caused anomalous totals in some areas, such as the linear striping in west Wales and south Midlands (EA, 2016).

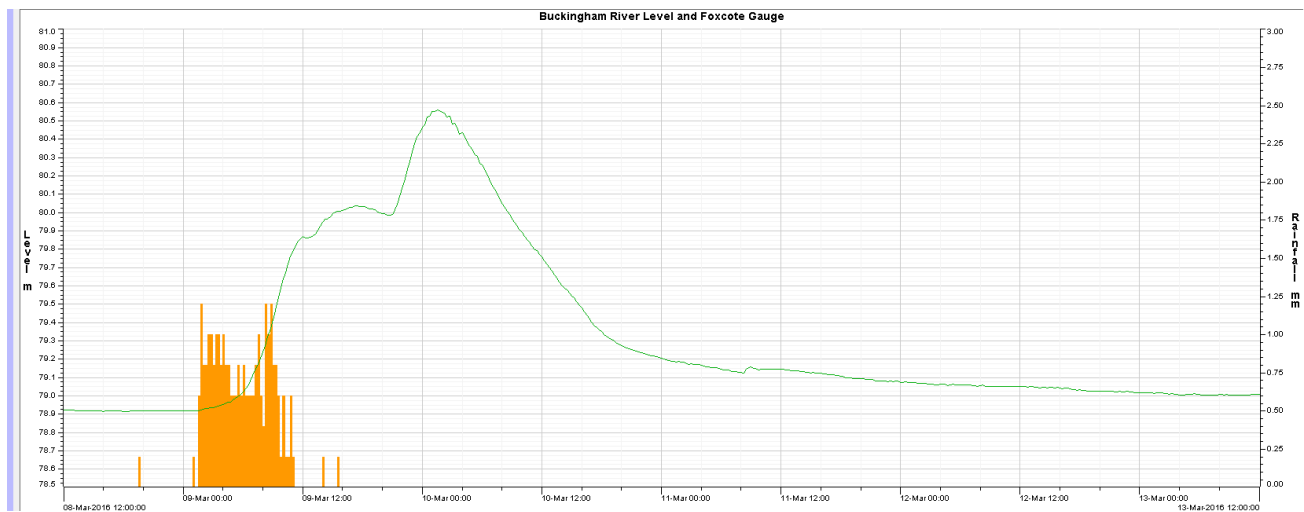
Water levels recorded at the EA's Buckingham river gauge between 8th March to 13th March, together with rainfall at the nearest EA rain gauge at Foxcote, are shown in the hydrograph in Figure 6, below.

Figure 6: Hydrograph and rainfall between 8th March to 13th March. The green line shows the level of the river level gauge at Castle Bridge, Buckingham, and the orange bars indicate rainfall at the nearest EA rain gauge to Buckingham at Foxcote (Environment Agency).

The peak river level as recorded by the gauge was 80.56 mAOD. This is only 10cm below the record level of July 2007.

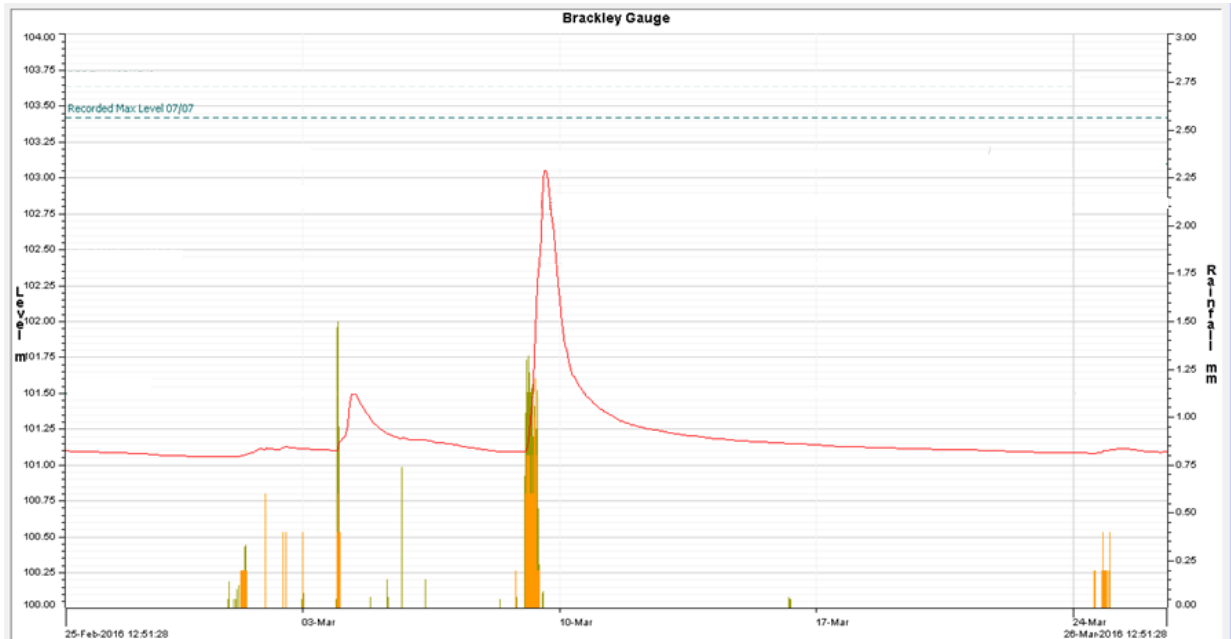
Figure 7, below, shows the hydrograph and rainfall upstream in the catchment at Brackley over the month from 25th February to 24th March 2016, showing the intense rainfall on 9th March 2016 and the subsequent rise in levels.

Figure 7: Hydrograph and rainfall at Brackley between 25th Feb to 24th March 2016. The red line shows the level of the river at the river gauge at Brackley and the orange and green bars indicate rainfall at the nearby EA rain gauge, also at Brackley (Environment Agency).

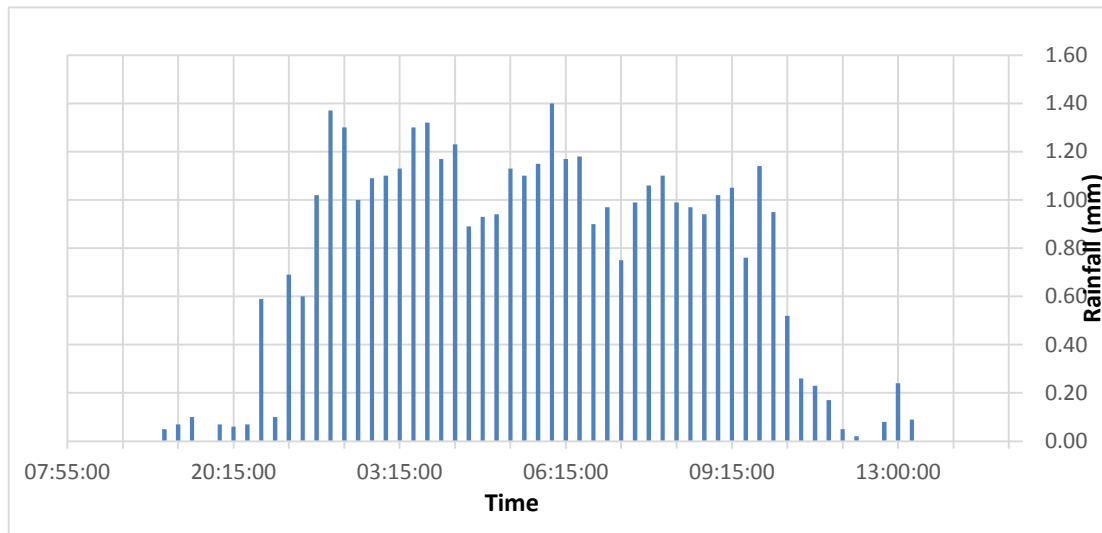
Figure 8, below, gives the 15 minute rainfall interval totals from the Brackley rain gauge. The data shows that relatively high intensities of rainfall (over 0.8mm every 15 minutes) were maintained between 01:45 on 9th March to 10:00 9th March.

Figure 8: Brackley rain gauge data for the period 07:55 07/03/16 to 19:55 09/03/16 in 15minute intervals.

Between midnight and 11:00am on Wednesday 9th March, 39.7mm of rainfall³ was recorded at the Environment Agency's (EA) rain gauge upstream of Buckingham at Brackley. Such rainfall figures are equivalent to the entire average rainfall of the month of March. BCC have calculated the probability of such a rainfall event occurring in any given year at this location as approximately 1 in 5 (20%), using the Flood Estimation Handbook (FEH) methodology.

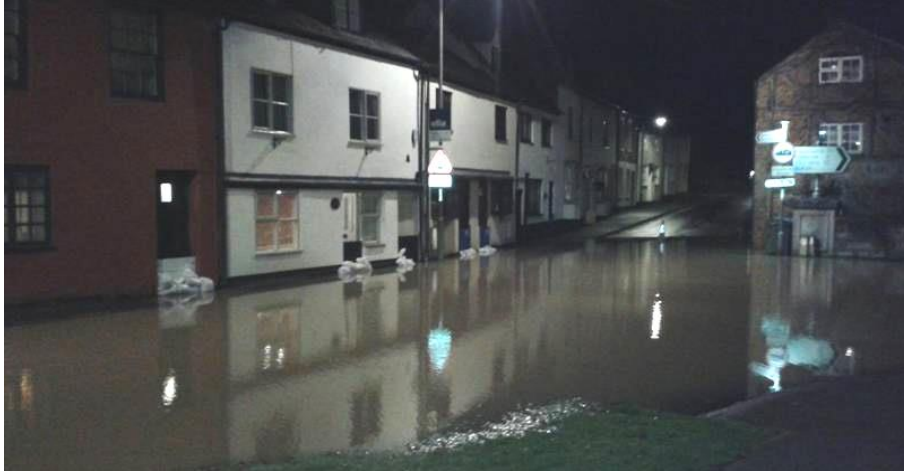
Nelson Street 10th March 2016 (photo provided by resident).

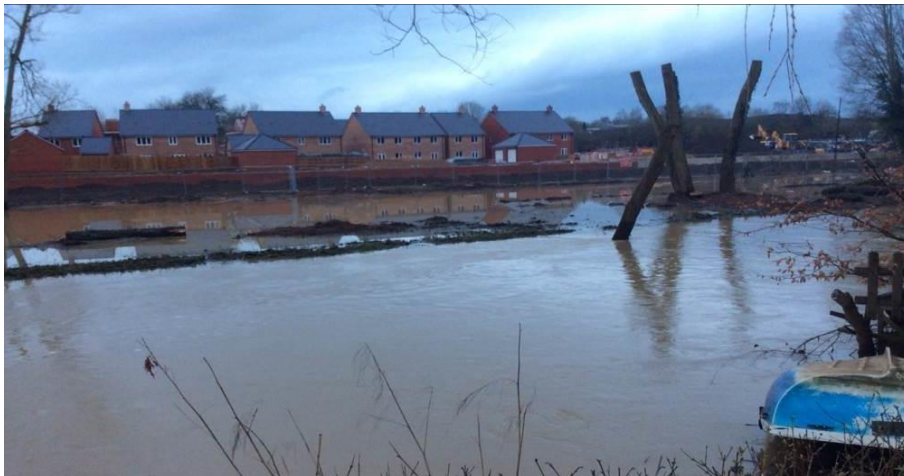
Flooding on Clarence Park site, 10th March 2016, as seen from gardens of Glynswood Road (photo provided by Mr Argles).

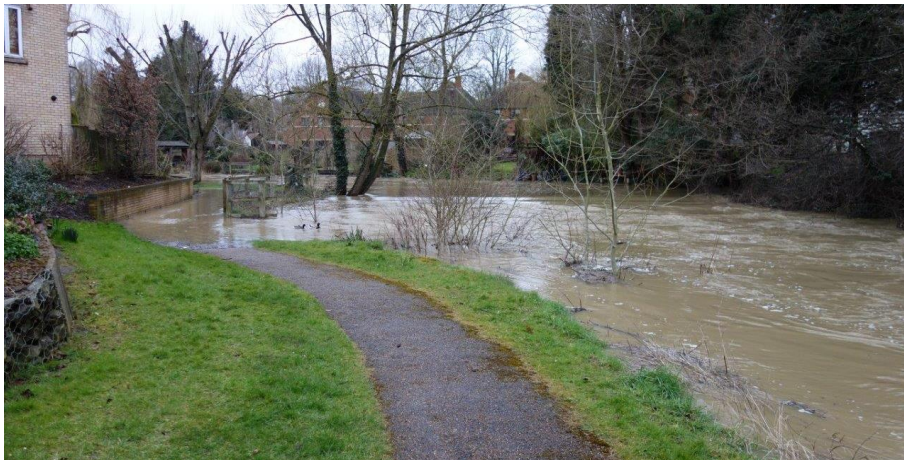
Flooded River Great Ouse adjacent to Fishers Field, 9th March 2016 (photo provided by Mr Wallace).

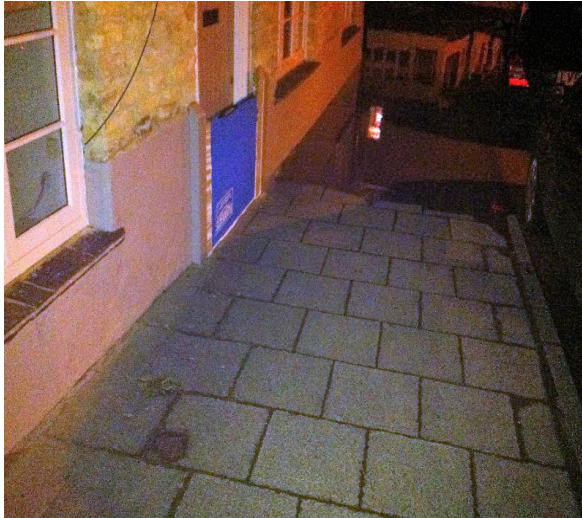
Ford Street, Buckingham at 12.15am, 10th March 2016. Property level flood protection board (blue barrier) in operation (photo provided by Buckingham Flood Action Group).

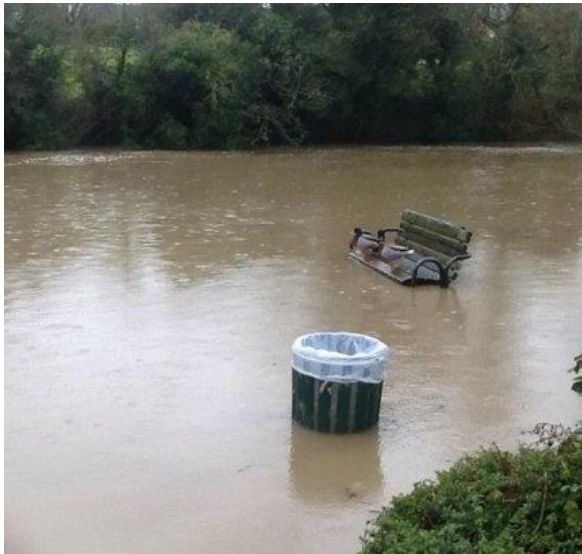
Flooded Chandos Park (photo via R Stuchbury twitter).
