Buckinghamshire County Council

Flood Investigation Report

Marlow, 9th January to 20th February 2014

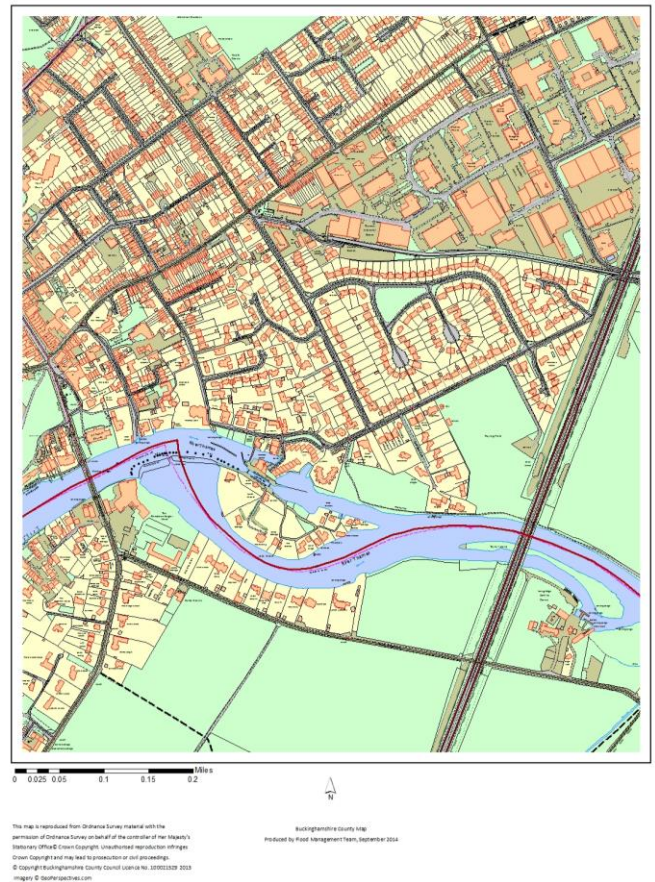
Figure 2 Area within Marlow where flooding was experienced

Marlow is located adjacent to the River Thames in Wycombe District in south Buckinghamshire, approximately 6.5km southwest of High Wycombe (Figure 1). Figure 2 shows the two areas within Marlow where flooding was experienced in January and February 2014.

a. Pound Lane Area, Marlow

b. East Marlow

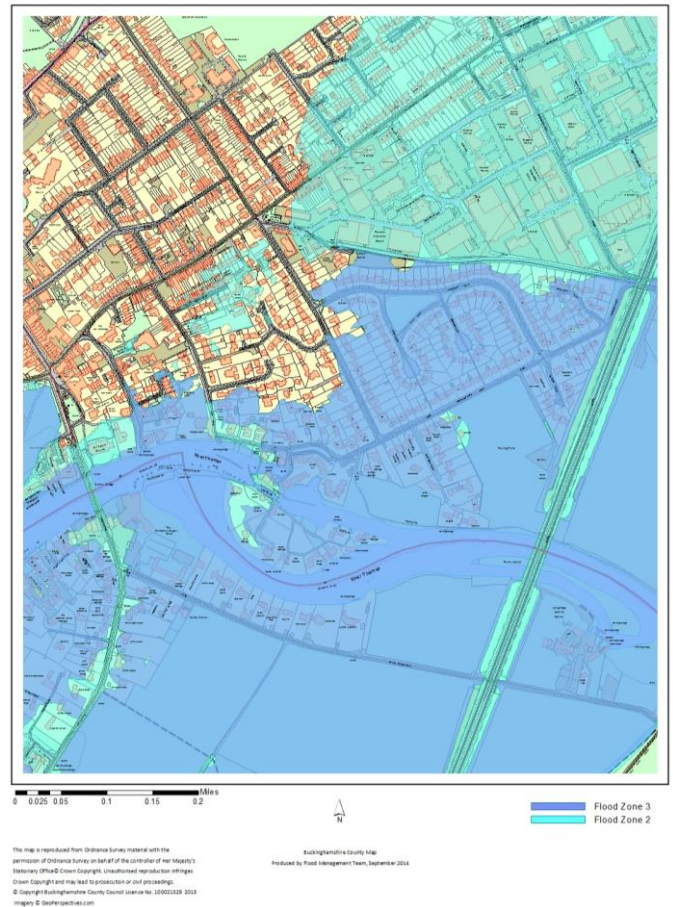
Figure 5 EA flood map showing the River Thames 1:100 year event (flood zone 3) in dark blue and 1:1000 year (flood zone 2) in light blue (EA, 2014)

The fluvial flood map (see Figure 5) shows the flooding that would occur from the River Thames in a 1 in 100 event (1% chance of occurring in a year) (medium blue) and 1 in 1000 (0.1%) (light blue). The dark line represents the center line of the River Thames. These show that the southern areas of Marlow are vulnerable to the 1 in 100 (1%) AEP flood event and that the northern part of the eastern area is vulnerable in the 1 in 1000 (0.1%) AEP flood.

a. Pound Lane, Marlow Flood Map

b. East Marlow Flood Map

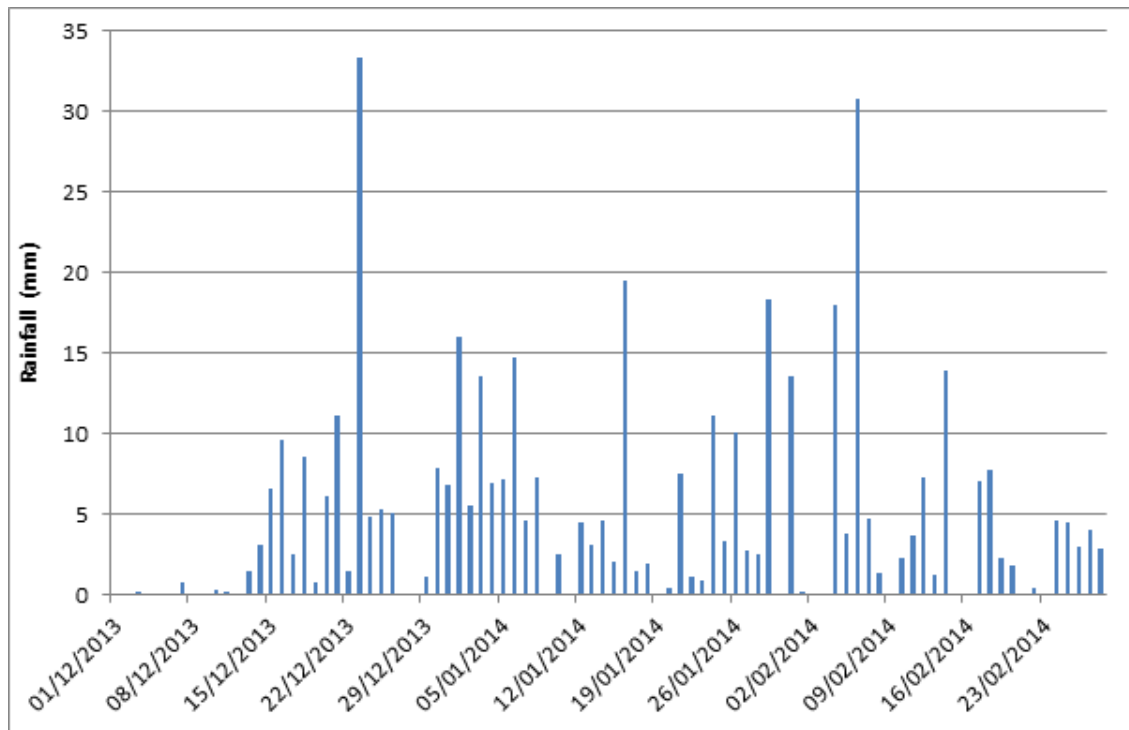
Figure 7 Hambleton Rainfall (December 2013 to February 2014)

The Environment Agency provided rainfall data for the period 1st December 2013 to the end of February 2014. This data was recorded at the Hambleden raingauge which lies approximately 8km to the west of Marlow and can be considered as representative of the rain that fell in Marlow. Figure 7 shows the daily rainfall for three months starting December 2013. This winter period was unusually wet. There were many days when rain fell and a large number of very wet days. The 23rd January and 6th February were particularly wet with over 30mm recorded on both days at the Hambleden raingauge.

To put this into context, from October 2013 to the end of February 2014, the area received 193% of the long term average rainfall. February 2014 was unusually wet receiving 334% of the long term average rainfall for February making it the wettest February on record in the area (Environment Agency, 2014).

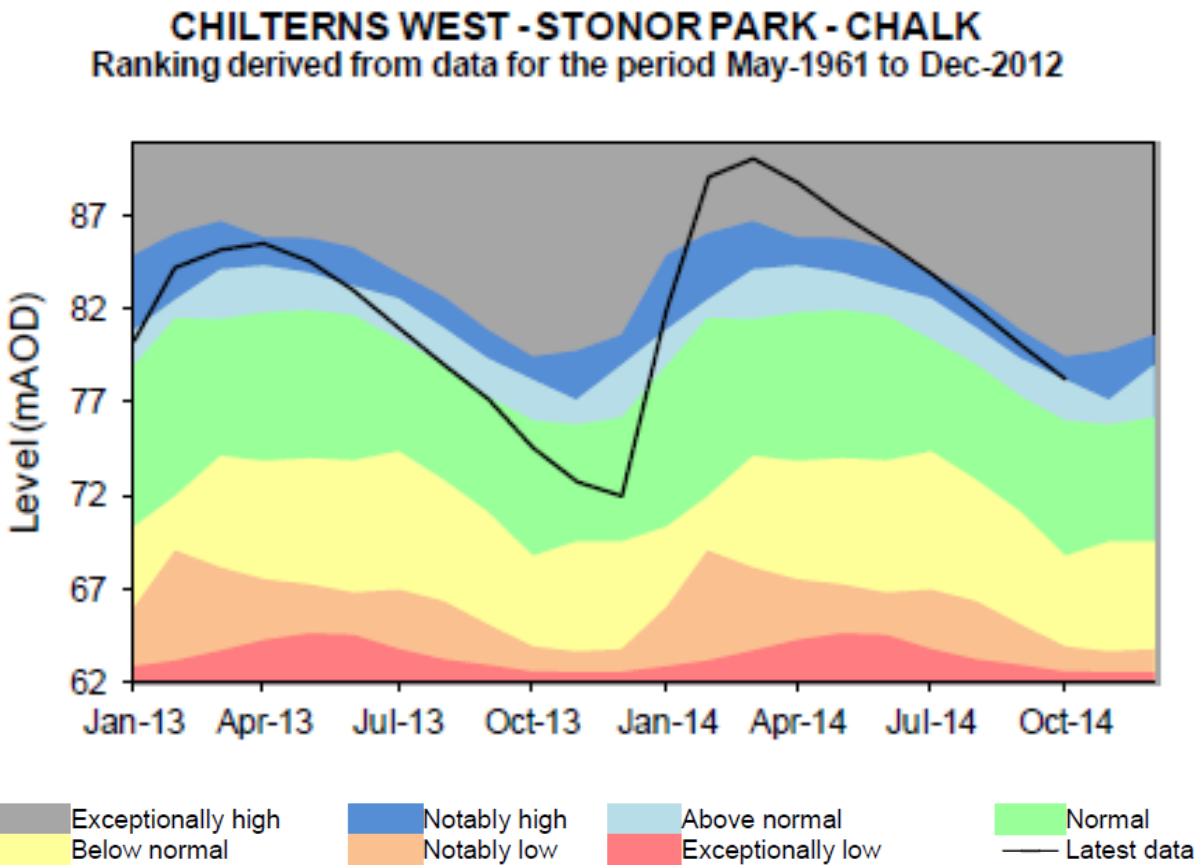
Figure 8 Groundwater levels in the Chilterns (From EA Monthly Water Situation Report, South East Water Situation Report (October 2014))

Groundwater levels started rising in December 2013 in the Chalk aquifer underlying the Chilterns as is normal in the late Autumn. However, the exceptional rainfall allowed water levels to rise within the Chalk to unprecedented levels as measured at the observation borehole at Stonor (this borehole is considered representative of the Chilterns). By the new year, groundwater levels at Stonor had reached new highs and continued to rise throughout January (Figure 8). The water held within the Chilterns Chalk flows south to the River Thames and can, in unusually wet years resurface through the gravels on which Marlow is built.

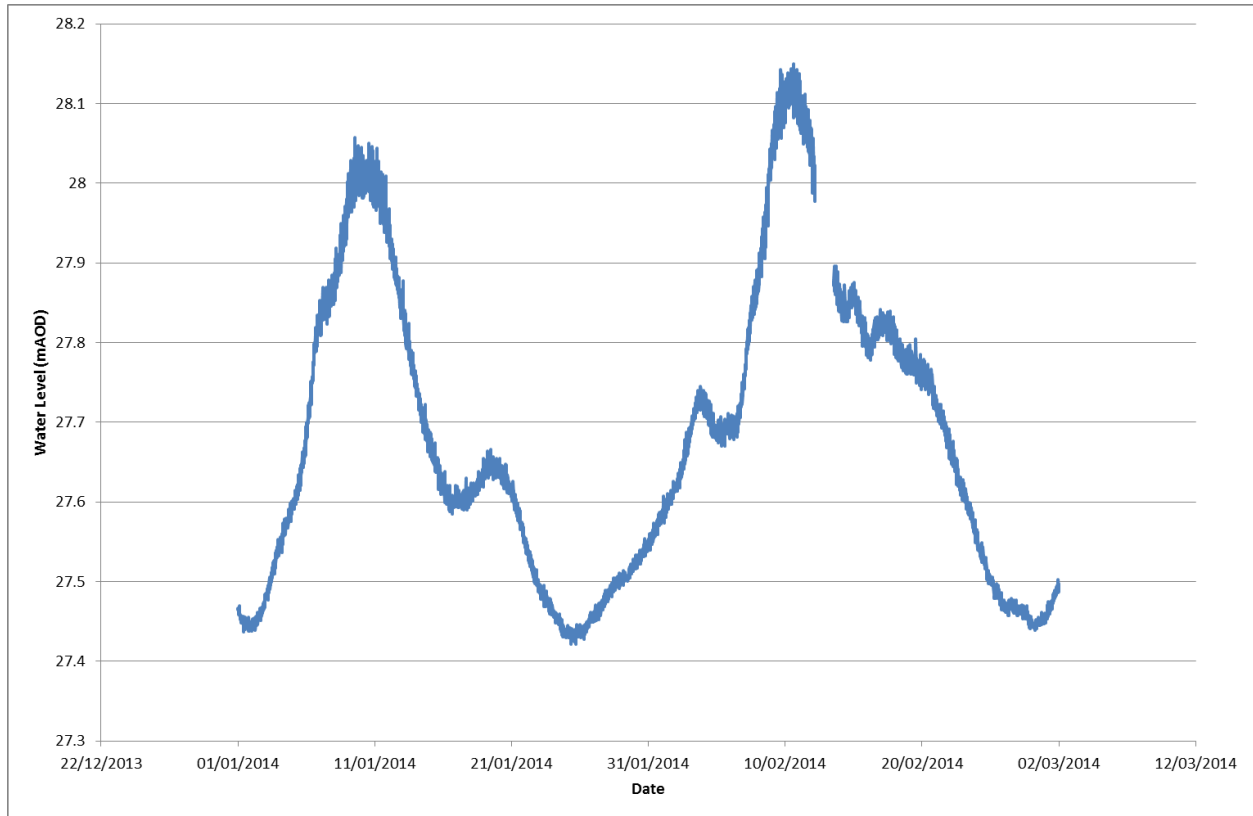
Figure 9 River Thames water levels measured upstream of Marlow lock

The unusually wet weather occurred across much of the catchment of the River Thames that drains to Marlow. Water levels in the River Thames peaked on the 10th January 2014 and then steadily dropped. However, following further rainfall in February 2014 the Thames rose to a higher peak between the 9th and 11th February 2014 in Marlow. Figure 9 shows the water levels in the River Thames as measured upstream of Marlow Lock.

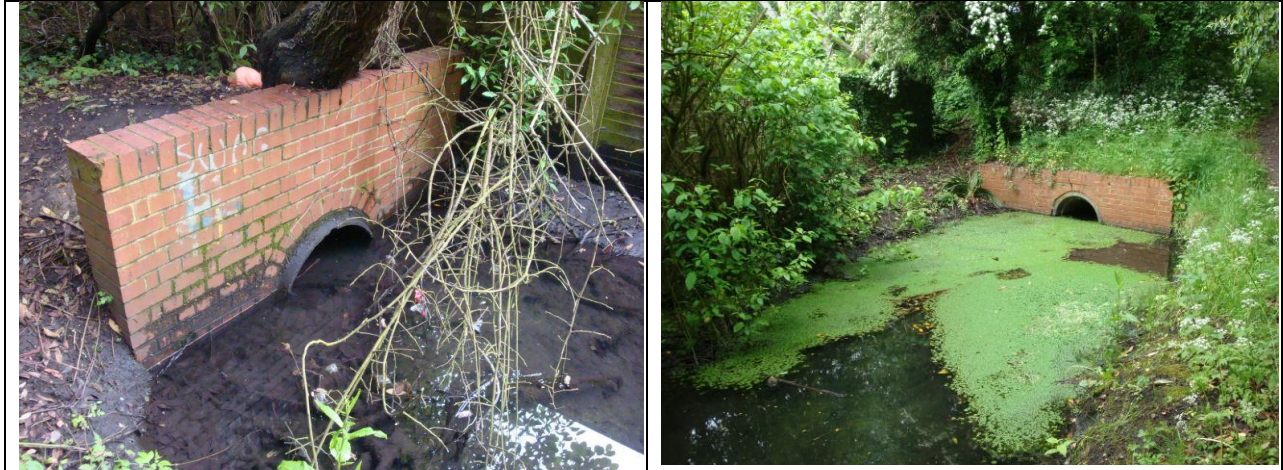
Figure 10 Newt Ditch culvert (29-05-2013)

No reports have been identified of any failure of pumps or temporary blockages of watercourses, drains or culverts immediately prior to or during the January and February floods. No reports have been received of any blockages in the River Thames and at the Lock at Marlow. However, a photograph of culverts on the Newt Ditch taken months before the floods shows very significant sediment deposition (Figure 10) suggesting that there may be a permanent blockage.

The section of pipe between the end of Dedmere Road and the open section is known to be half full of silt, with excessive root growth which cannot be cleared by jetting. The large catchment draining through this culvert in its current poor condition is suspected by the highway engineers to be the greatest local flood risk in Marlow, after flooding from the River Thames.

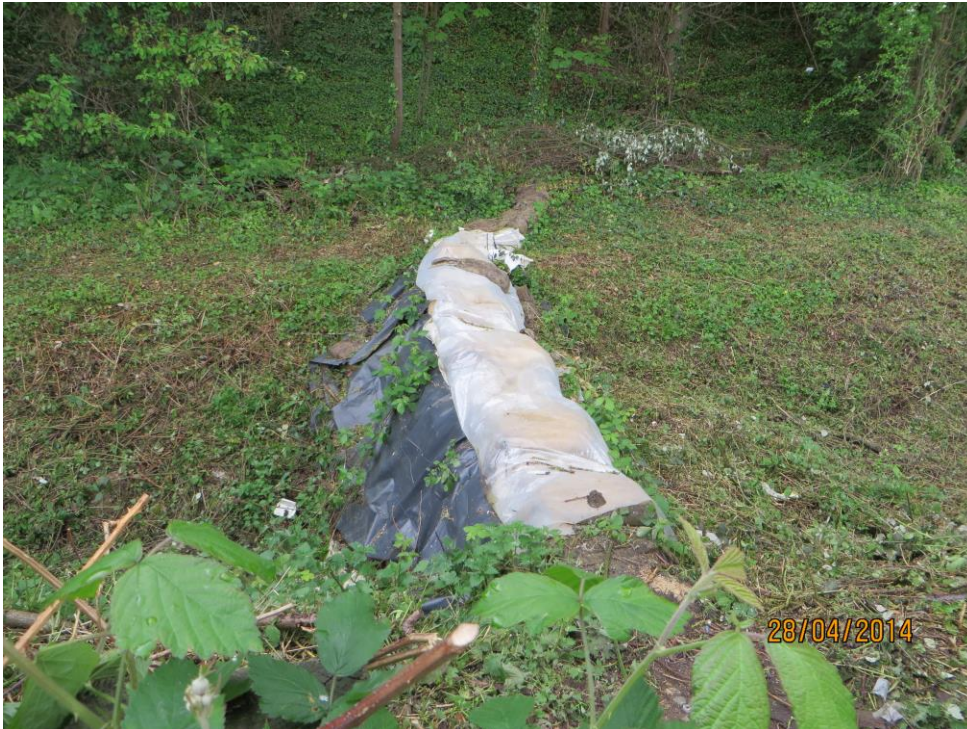
Figure 12 Informal bund on the A404 ditch

However, residents were able to limit the number of properties flooded by pumping the water back over an informal bund in the A404 drainage ditch. This bund prevented the River Thames backing up the ditch and flooding properties in Firview Close (Figure 12). The residents reported a problem with the sewer system but not of contaminated flood water.
