Buckinghamshire County Council

Flood Investigation Report

Monks Risborough

February 2014

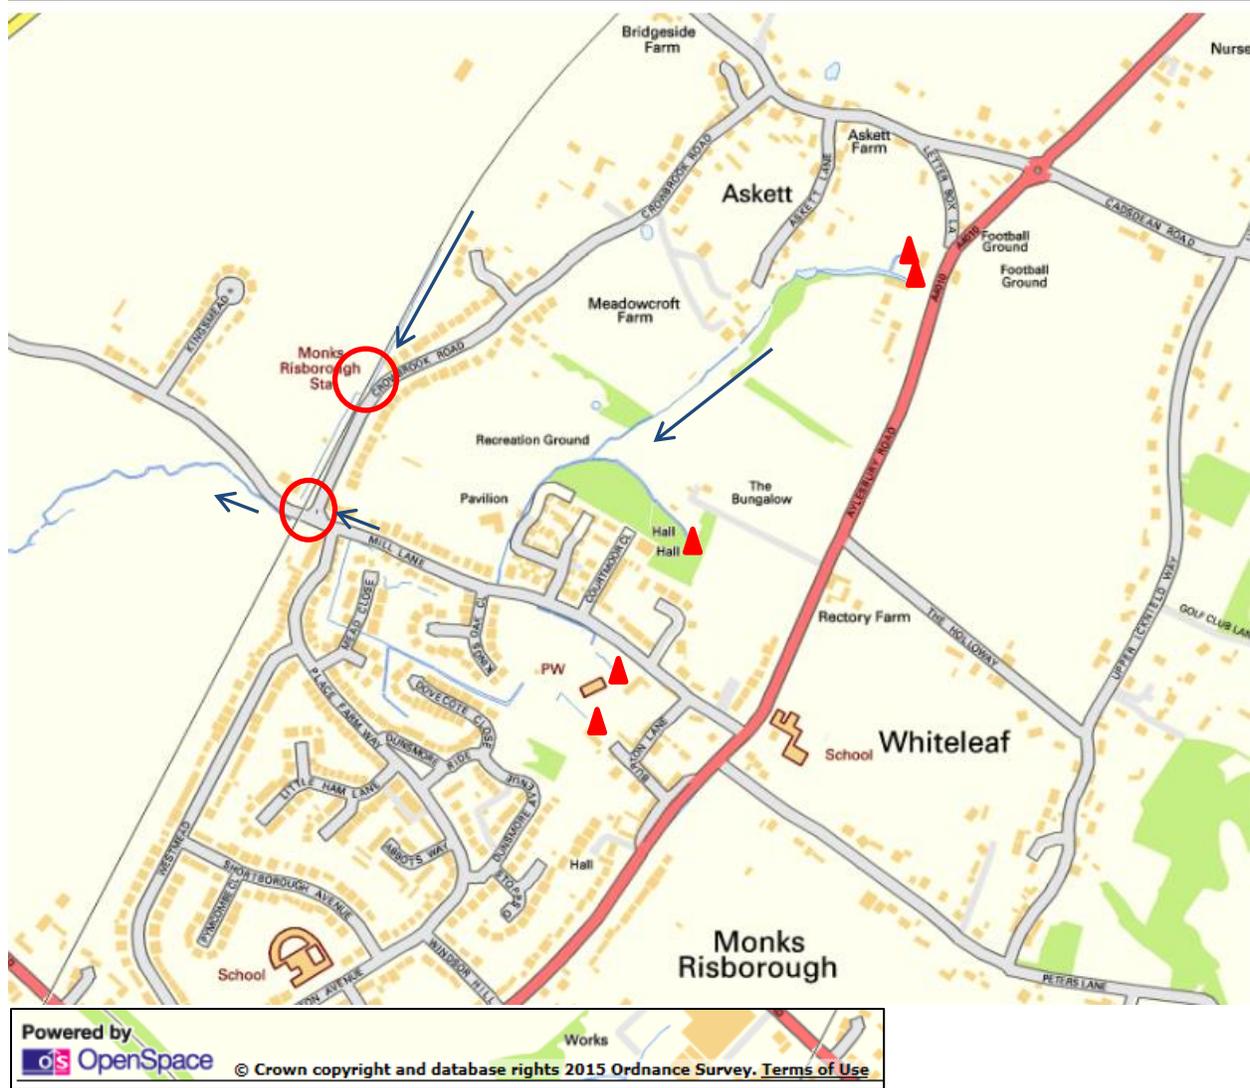
Figure 2 Overview of Monks Risborough Drainage System

Generally, the springs within the village originate at approximately 110mAOD and flow westwards. However, they are constrained to only two locations where they can pass beneath the railway embankment (Mill Lane and at the railway station) as shown in Figure 2.

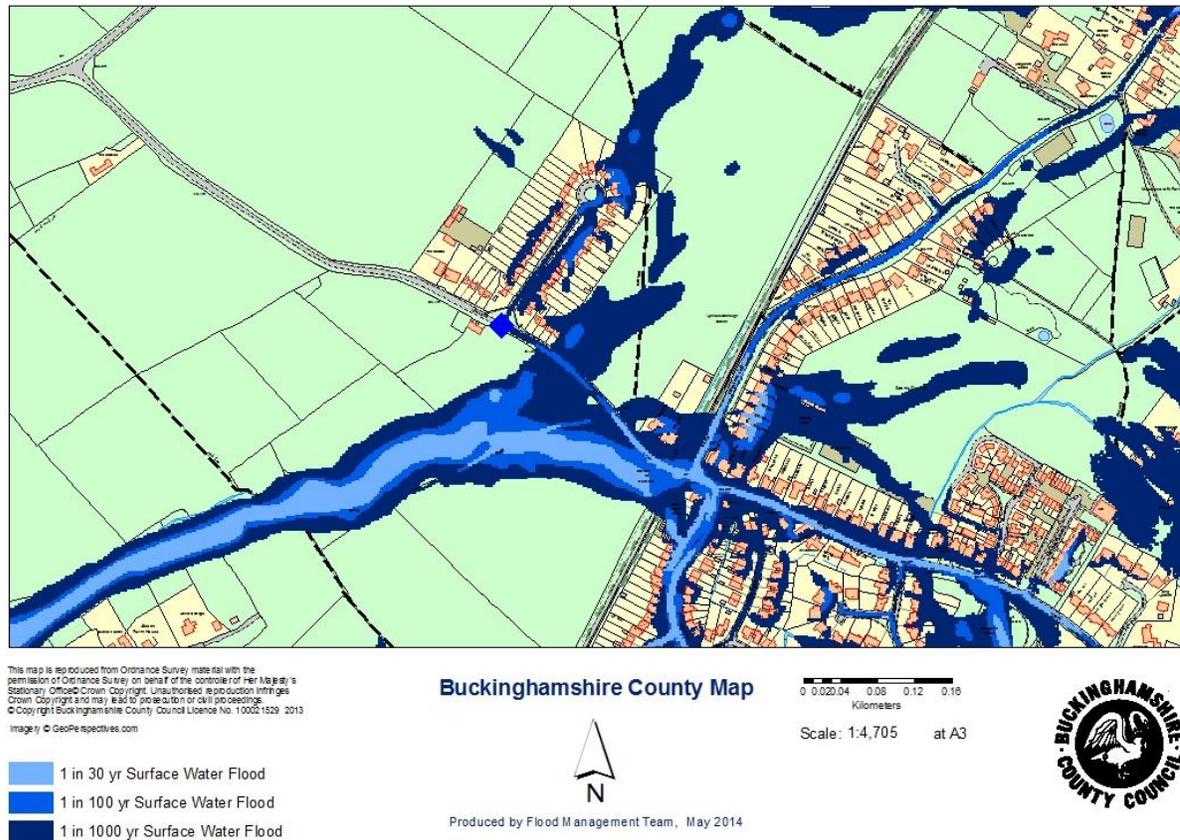
Figure 4 Environment Agency Risk of Flooding from Surface Water

From Figure 4, it can be seen that the Mill Lane/Crowsbrook Road and the Kingsmead

areas of Monks Risborough are predicted to experience surface water flooding. The geographical extent of the surface water flooding shown in the map is very similar to the flooding which was experienced during the February 2014 flood event.

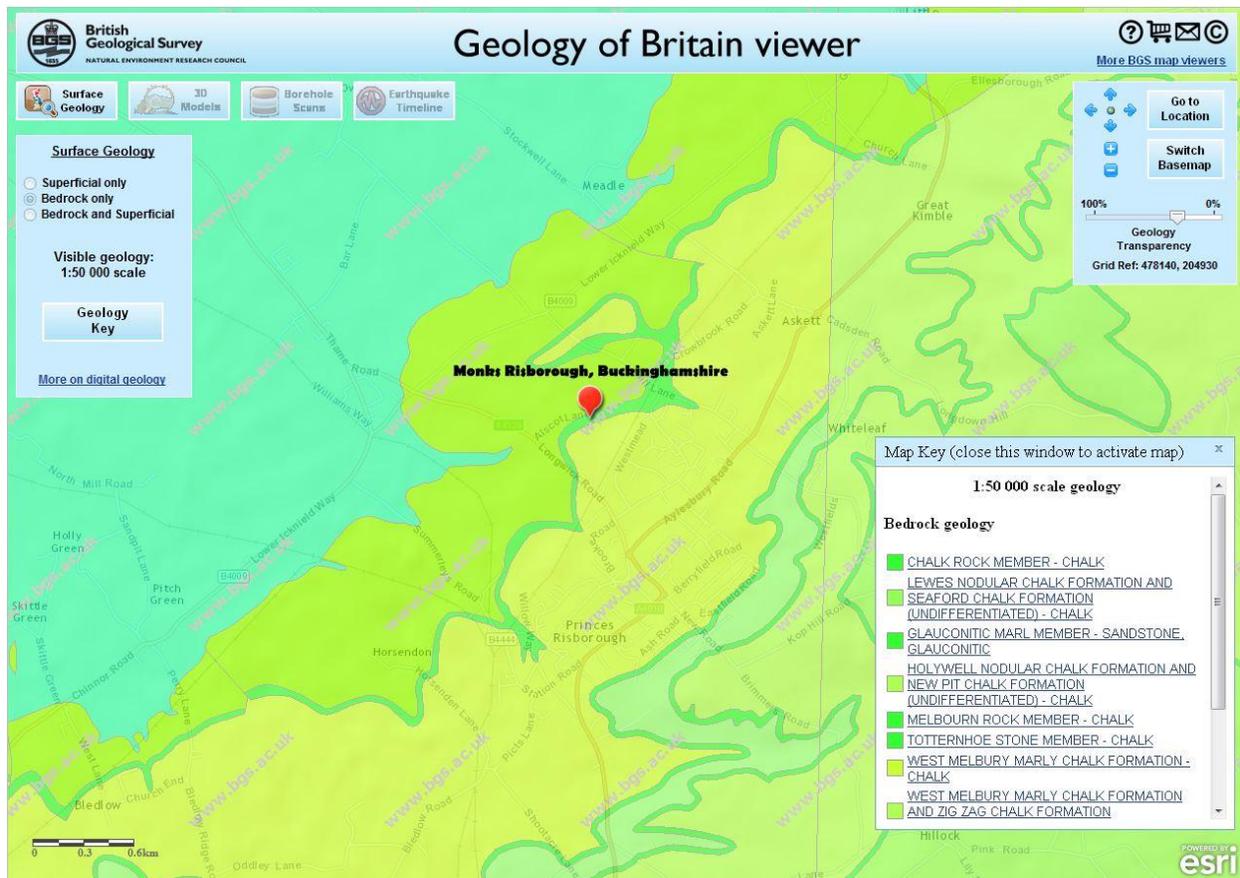
Figure 5 Geology of Monks Risborough Area (BGS online map, 2014)

Monks Risborough is located on the junction of the Chalk and the Upper Greensand. It is at this junction that the springs emerge in the village. In this area there are also superficial Head Deposits comprising clay silt and gravels. Figure 5 shows the local geology. The Environment Agency states that groundwater is close to the ground surface in this area. As a consequence, this makes the area vulnerable to groundwater flooding. Groundwater flooding can occur when water levels in the underlying Chalk and Greensand rise and water emerges at the surface. It can emerge as increased flows from existing springs, from new springs or from diffuse sources. Where watercourses draining these areas have insufficient capacity or are obstructed and in those areas where there is no defined watercourse, flooding from groundwater can occur.

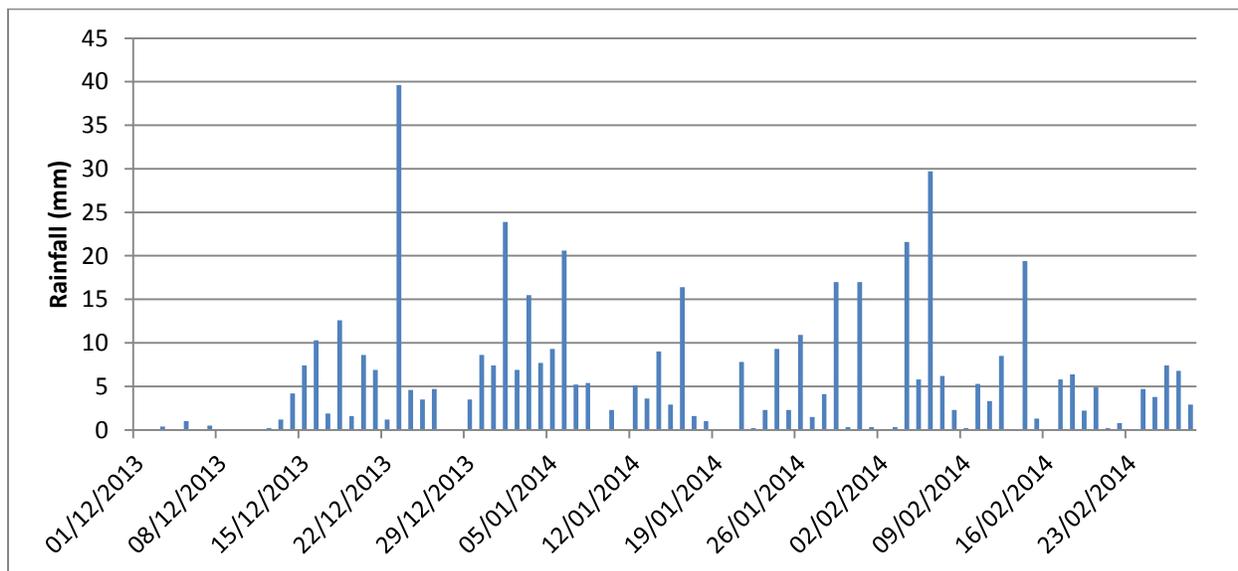
Figure 6 Prestwood Rainfall Totals 1st December 2013 to 28th February 2014

The Environment Agency provided rainfall data for the period 1st December 2013 to the end of February 2014. This data was recorded at the Prestwood Raingauge which lies approximately 3km to the south east of Monk's Risborough and can be considered as representative of the rain that fell in the vicinity of the village. Figure 6 shows the daily rainfall for three months starting December 2013. This winter period was exceptionally wet. There were many days when rain fell and a large number of exceptionally wet days.

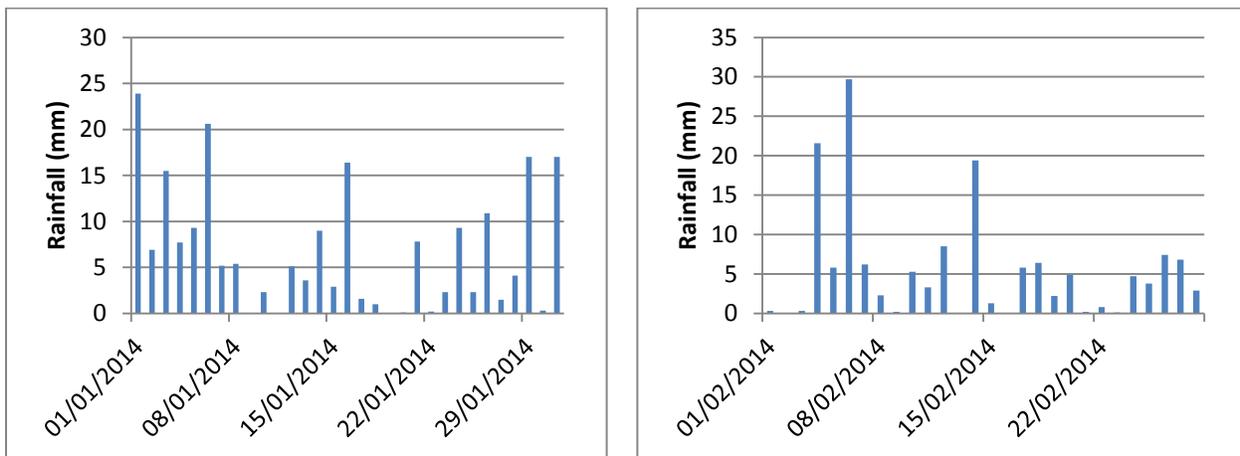
Figure 7 Prestwood Rainfall January and February 2014

The wet period continued into February with almost 30mm recorded on the 6th and almost 20mm on the 14th (Figure 7). Flooding arose in response to the rainfall on the 6th and lasted for approximately three weeks.

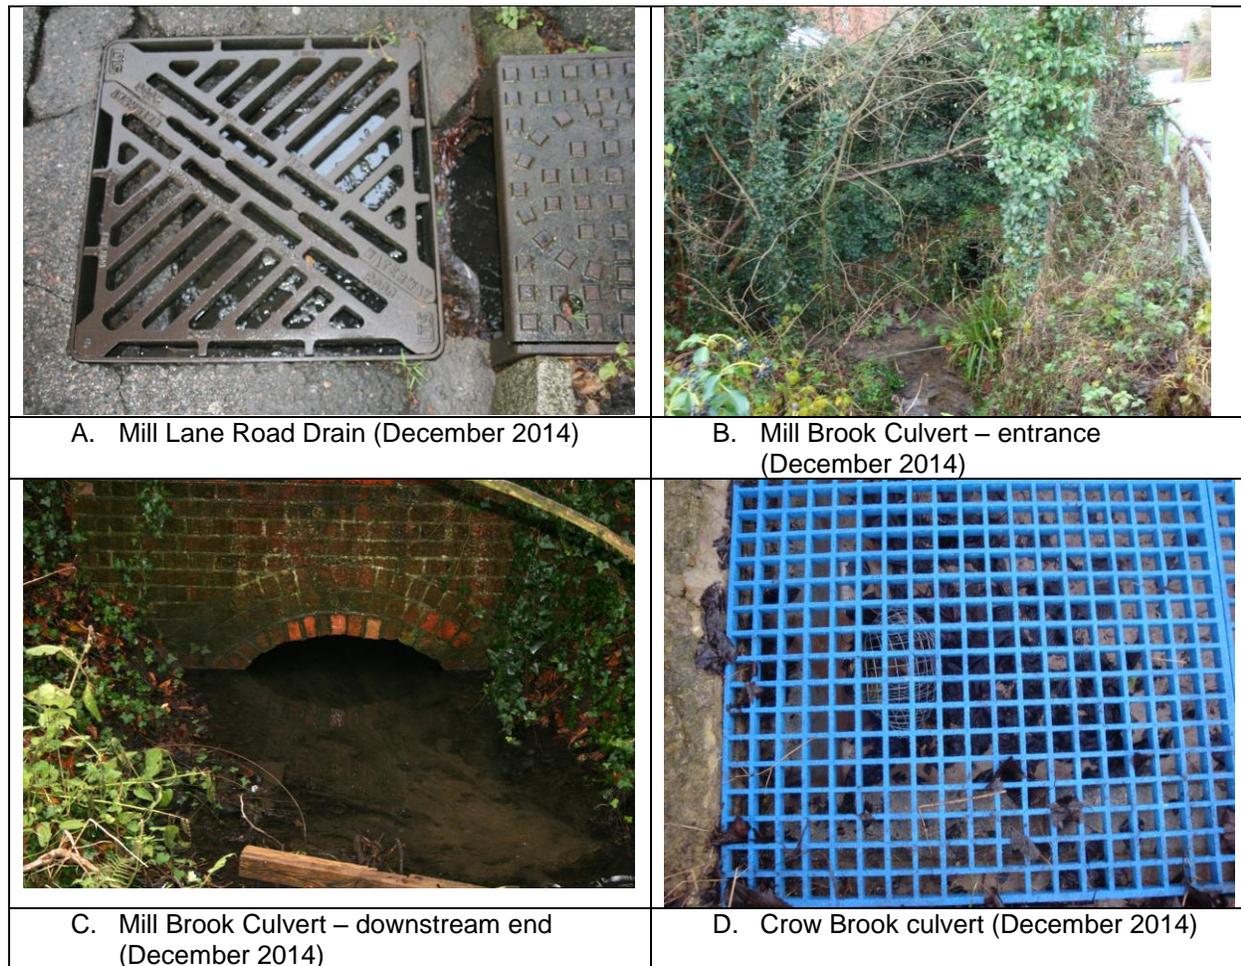
Figure 8 Condition of structures

- The road drain beneath the Mill Lane railway bridge was blocked and had water visible at almost road-grill level (Figure 8A).
- The watercourse that passes under the railway through a culvert in Mill Lane was partially obstructed with vegetation and the culvert heavily silted up and appears to have a much reduced capacity (Figures 8B and 8C)
- There have been recent works associated with the drainage under the railway station in Crowbrook Road (Figure 8D).

- The highway drain in the road beneath the railway bridge was completely blocked at the time of the site visit (December 2014) and may have been blocked at the time of the flood.

- The culvert taking the Mill Stream beneath the railway is heavily silted and has reduced capacity
- The section of the Crow Brook watercourse running alongside the railway that is visible from the road appears to be poorly maintained.

- The culvert beneath the railway in Crowbrook Road was reported by residents to have been blocked at the time of the flood. At the time of the site visit a new culvert structure has been built.

Authority/Stakeholder	Recommended actions
TfB	<ul style="list-style-type: none"> • Clear the highway drain under the railway at Mill Lane and undertake regular and frequent maintenance checks • Investigate drainage network throughout Monks Risborough and carry out cleansing of all gullies, culverts and highway drainage throughout as part of the ongoing maintenance schedule.

Network Rail	<ul style="list-style-type: none"> • Enlarge the Crowbrook Road culvert under the railway station and maintain at design capacity.
Thames Water	<ul style="list-style-type: none"> • Work with other RMAs to address potential infiltration problems. • Share the outcomes of their information gathering exercise for catchments affected by infiltration problems with other RMAs.
Riparian Landowners	<ul style="list-style-type: none"> • Ensure that the watercourses are maintained in a suitable manner. The guidance given in the EA's 'Living on the Edge' booklet regarding riparian owner responsibilities should be followed. Especially in the vicinity of the railway bridge. • Undertake clearance of vegetation with guidance from relevant RMAs.

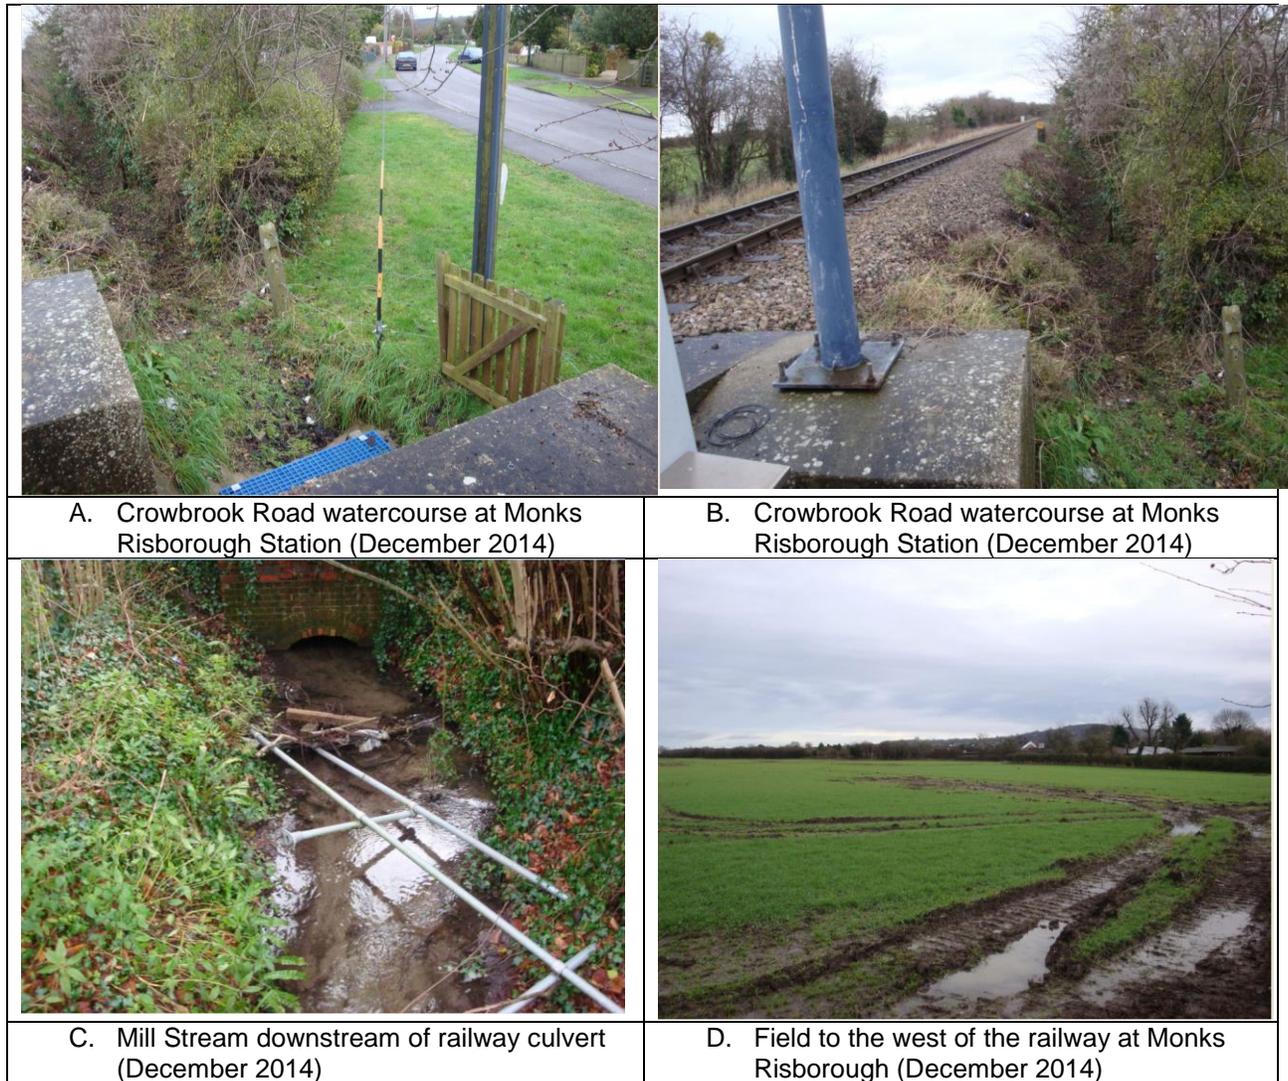
Figure 9 Condition of watercourses

It was not possible to access the majority of the Crow Brook watercourse running parallel to the railway line. From the railway bridge the route of the watercourse appeared heavily congested with vegetation although there was evidence of recent maintenance in the vicinity of the station (Figures 9 A and B).

and had reduced capacity due to silt accumulation. The railings from the footbridge crossing were lying in the watercourse (Figure 9C)

The field between Kingsmead and the railway line was water logged (Figure 9D)

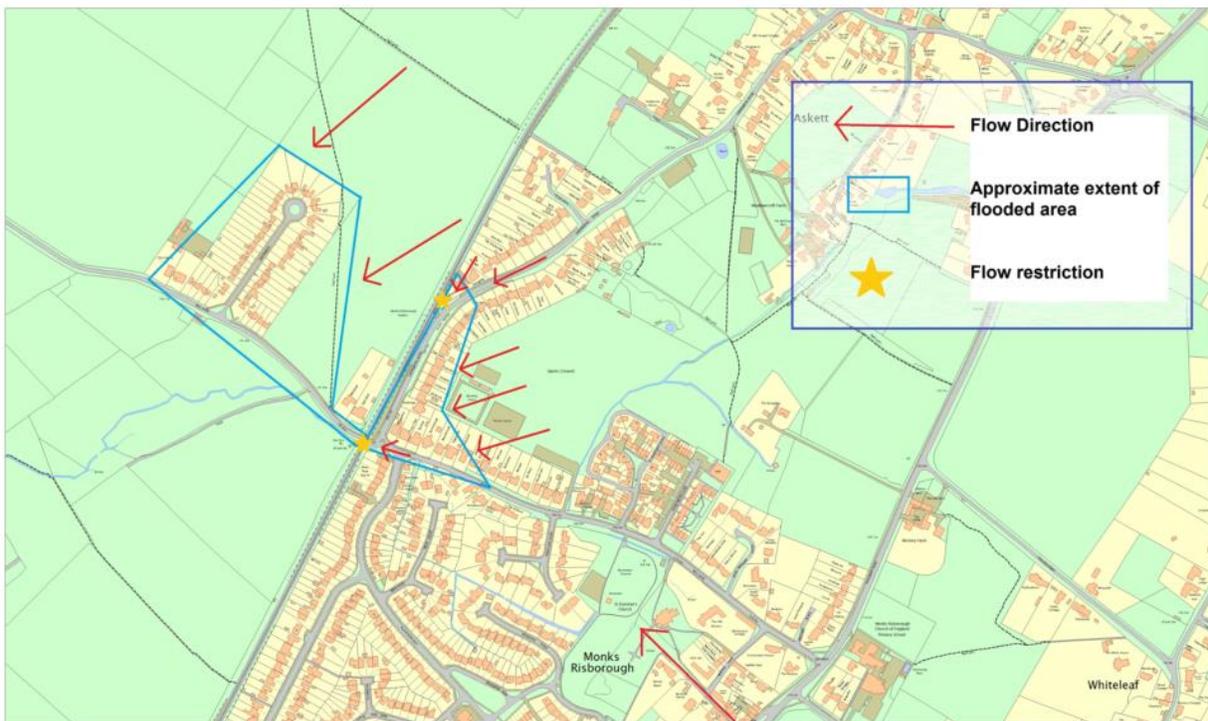
Figure 10 Overview of Flood Mechanism

West of the railway line at Kingsmead and Mill Lane, surface water runoff from surrounding farmland probably in addition to excess flow from the Crow Brook caused internal flooding (to at least the height of floorboards) and to gardens and to both Kingsmead and Mill Lane roads. More extensive internal flooding is likely to have been experienced without the mitigation measures undertaken (e.g. bailing out water, sandbags and digging of trenches).

Runoff and groundwater flowed off the Molins sports ground and flooded towards the south into the rear gardens and garages of properties in Mill Lane (east of the railway) and Crowbrook Road. In both areas water levels came close to causing internal flooding of residential properties. At least one property lost power supply as a consequence of the flooding. Flood depths in February 2014 of between 3” (0.07m) and 5” (0.13m) in rear gardens were reported by residents at the junction of Crowbrook Road and Mill Lane.

Surface water also flowed down Peters Lane, Burton Lane and past the church with the church reported to being close to flooding internally.

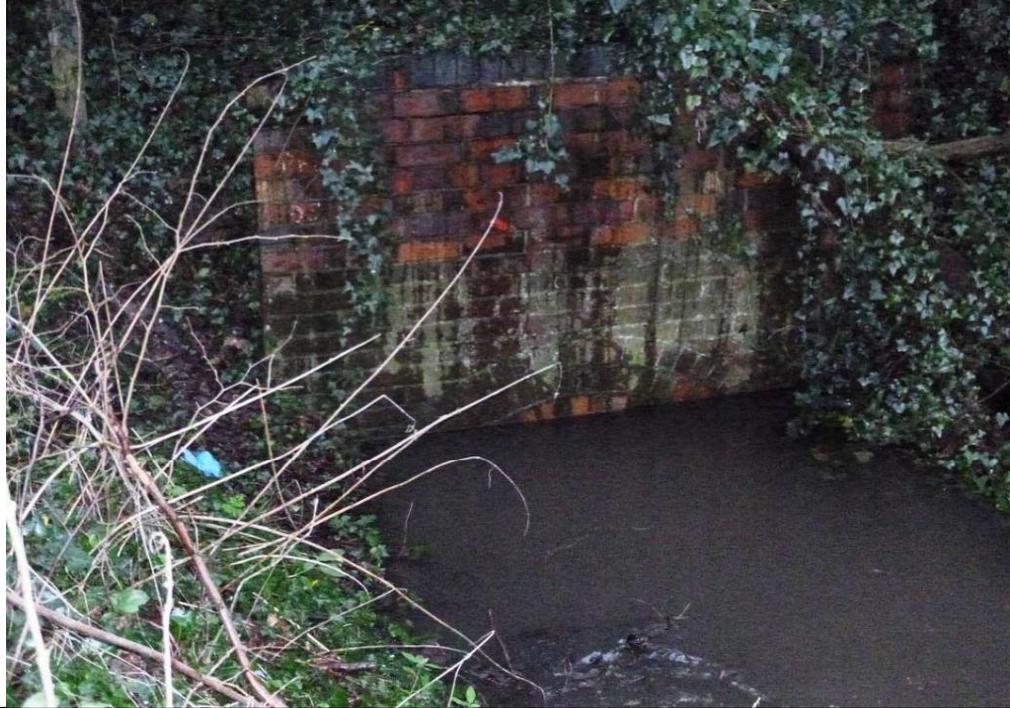
<p>February 2014</p> <p>Mill Lane railway bridge culvert</p> <p>Courtesy Wycombe DC</p>
