# Ickford Section 19 Flood Investigation

## Final Technical Report

**Buckinghamshire  
Council**

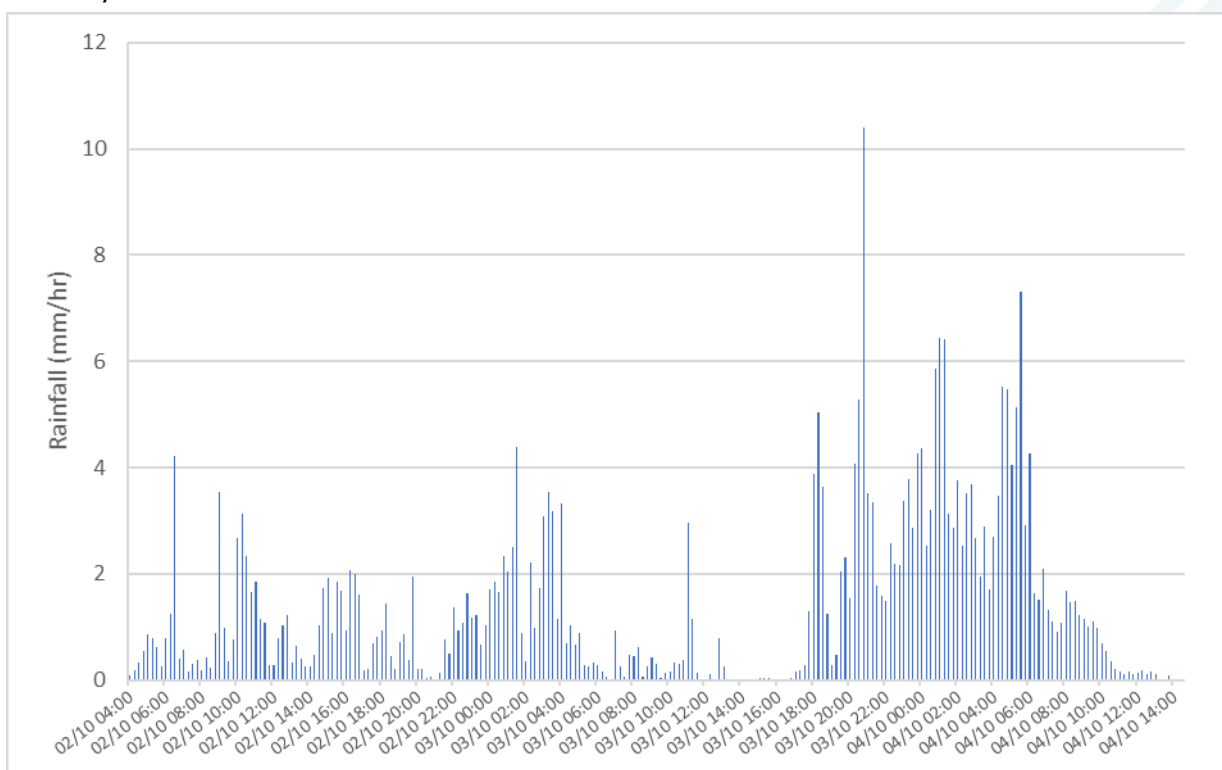
**Figure 6-1: Recorded rainfall at the Wheatley R22 gauge**

As can be seen in the graph above, the rain fell in two waves. The first, a less intense and longer period, from 04:00am on 2<sup>nd</sup> October until 13:00 on 3<sup>rd</sup> October, in which 32mm of

rain fell over 32 hours (2-year return period). During the second wave, from 16:45 on 3<sup>rd</sup> October until 14:30 on 4<sup>th</sup> October, 50mm of rain fell over 22 hours (8-year return period). HYRAD observed radar rainfall data from the Met Office shows that for the first wave of the event the storm passed in a westerly direction across the catchment. After about 17:00, as the weather system turned, the storm remained generally stationary.

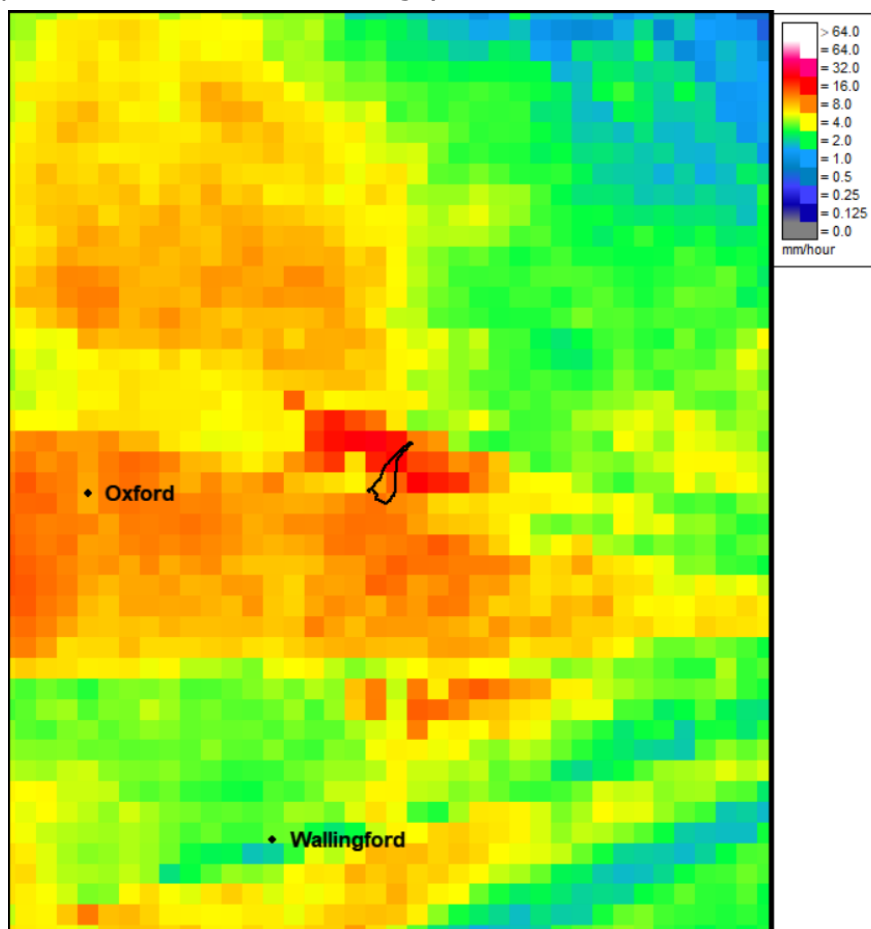
**Figure 6-2: Hyrad (radar) rainfall for the Ickford area at 20:45 3/10/2020 (time of most intense rainfall)**

The image below shows the HYRAD observed radar rainfall for the Ickford area (black boundary line in the centre of the image). Colours show rainfall rate at the time shown.

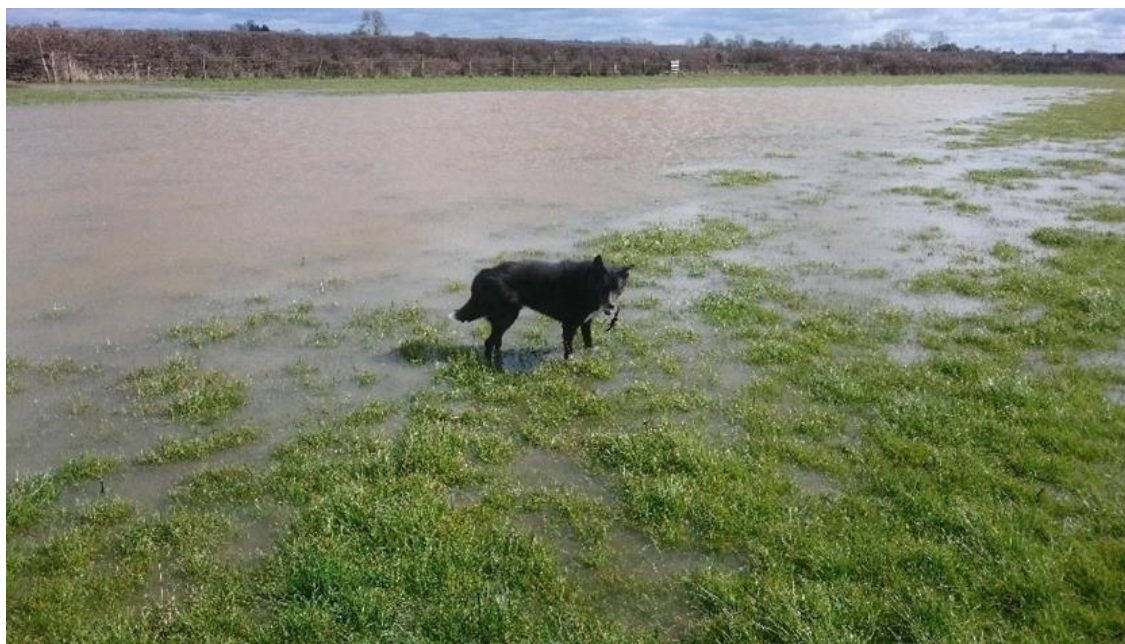
High groundwater levels in the superficial floodplain deposits were a direct source of flooding in Ickford. Groundwater levels are strongly linked to levels within the River Thame, which had risen in response to the rainfall. Groundwater ponding has been observed in the fields, particularly to the west of Worminghall Road (Figure 8-2) and south of Sheldon Road.

**Figure 8-2: Groundwater ponding in the field to the west of Worminghall Road**

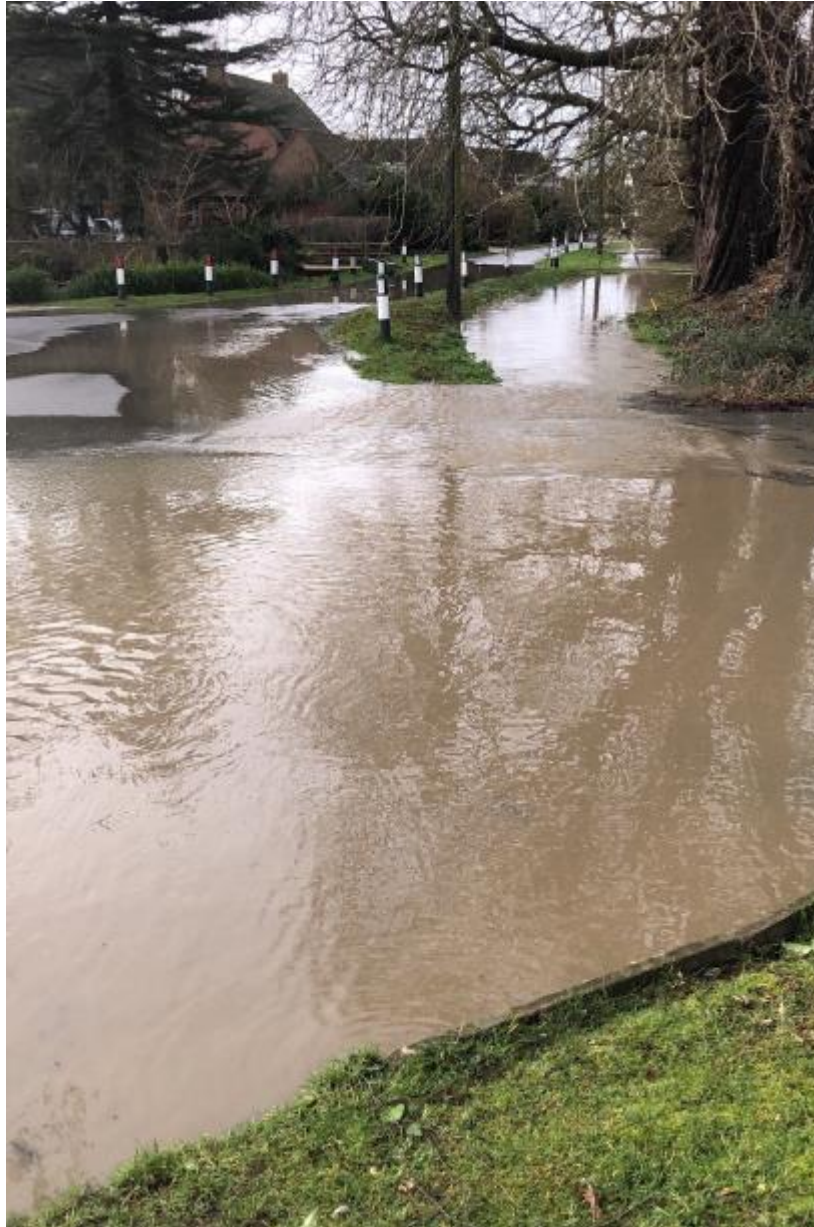
Water backed up from the River Thame in the ordinary watercourse along Church Road due to the relatively flat gradient and because it was no longer freely able to discharge into the Thame. The channel capacity was exceeded and water overtopped onto Church Road (Figure 8-3).

**Figure 8-3: Capacity of Church Road ditch exceeded, looking south down Church Road from junction (taken January 2021)**

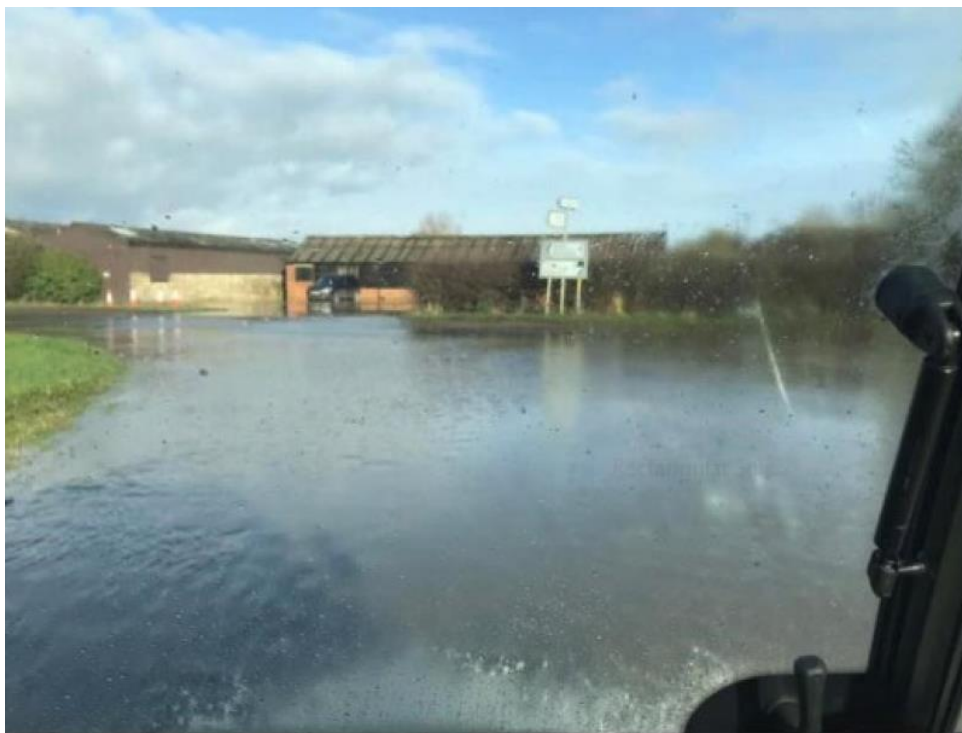
Floodwater from the main rivers of the Lappingford/Worminghall and Pepperhill Brooks flowed across the fields towards Peacehaven, at the Worminghall Road and Ickford Road junction (Figure 8-4). From here, some of this water flowed down Worminghall Road towards the village. This flood route is not shown in the Environment Agency's Risk of Flooding from Rivers and the Sea, as the flood map data is not detailed for the area.

**Figure 8-4: Flooding at the junction of Wормinghall Road and Ickford Road (taken in January 2020 but also occurred in October 2020)**

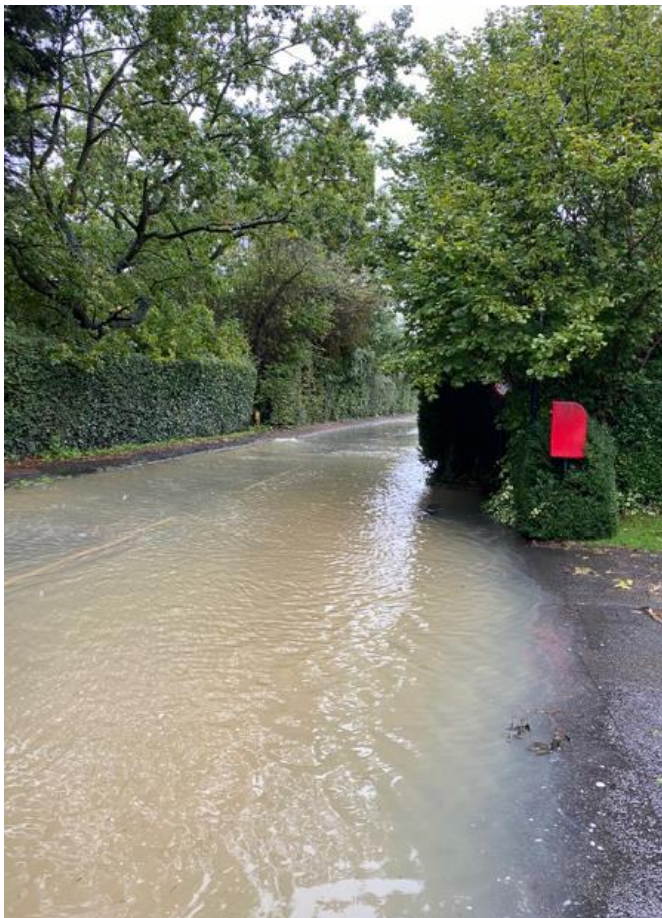
During the flood event surface water flowed down Wормinghall Road and ponded along Wормinghall Road, on Golders Close, around the Church Lane junction and along Sheldon Road (Figure 8-5, Figure 8-6, Figure 8-7). It also flowed down the road towards Little Ickford. It is noted that in the October 2020 event the lower part of Wормinghall Road reportedly flooded before river floodwater reached the junction at the northern end of the road, and residents indicated that this has also been the pattern of flooding in previous events.

**Figure 8-5: Worminghall Road, looking north towards the Rising Sun and Deanfield site (taken October 2020)**

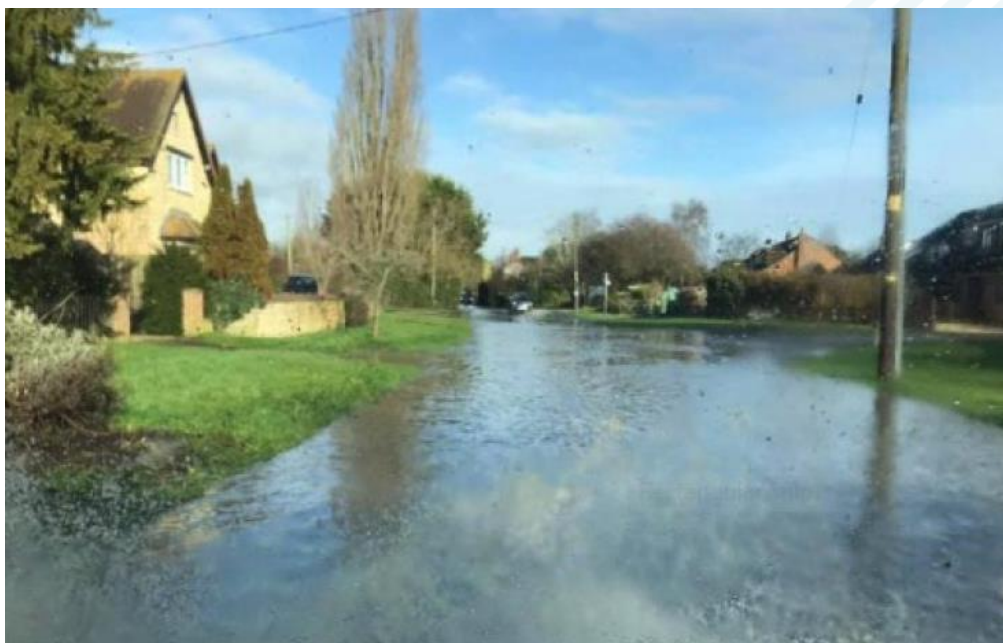
**Figure 8-6: Worminghall with Golders Close on the right (taken January 2020)**

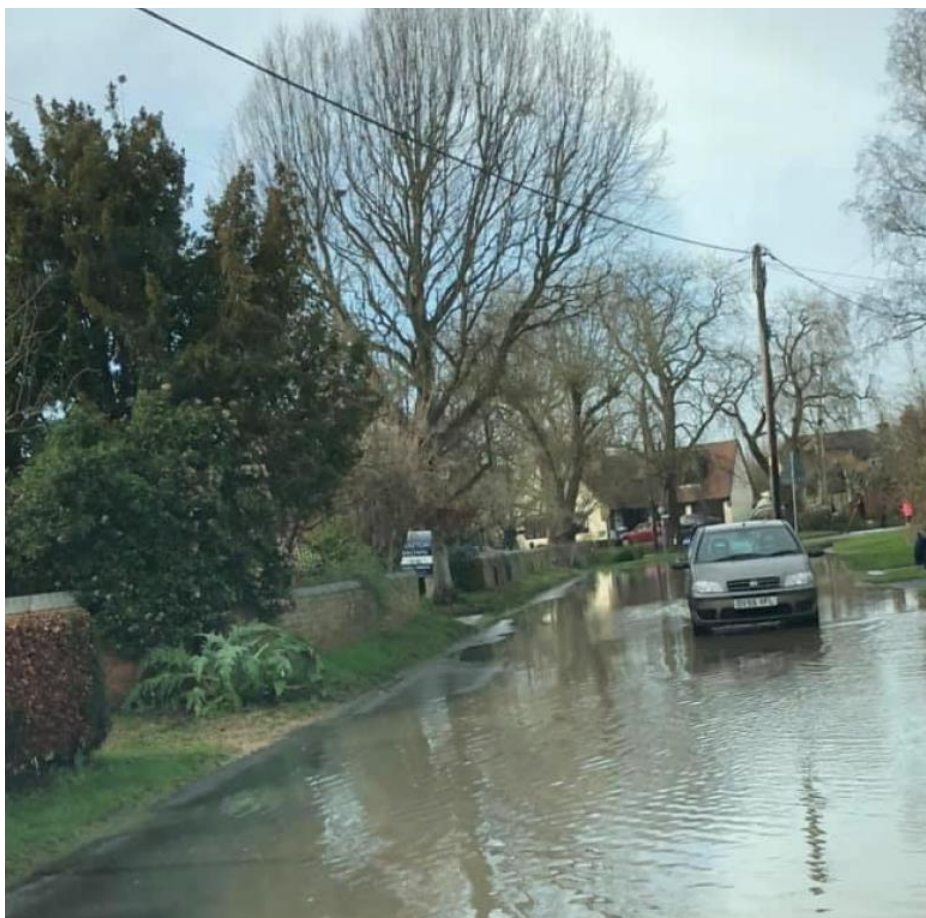
**Figure 8-7: Sheldon Road looking towards Church Road junction (taken January 2021)**

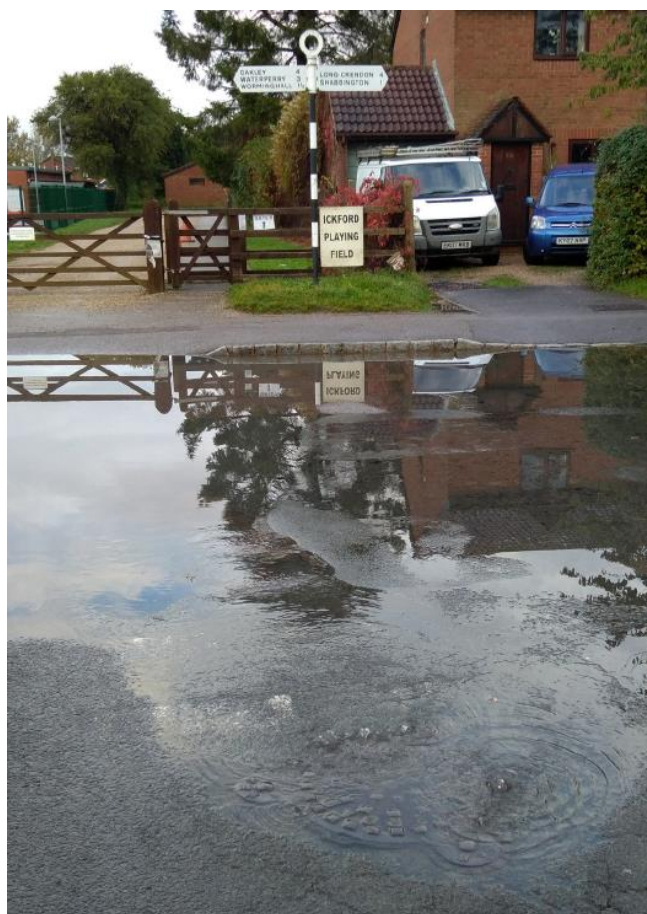
The Thames Water foul sewer network within Ickford, follows the roads to convey sewage via gravity to the Church Road pumping station. In both the October 2020 event and previous events (Figure 8-8) sewage was observed 'bubbling' out of manholes and combining with surface water along both Church Road and Sheldon Road. Thames Water had a tanker in place at the Church Road junction to remove water from the foul system for an extended period in October 2020, and this has been a regular occurrence during previous events.

Flooding of the foul sewer network occurs when additional sources of water are entering the foul sewer system. Thames Water have an ongoing investigation into the sources of the water entering the system but it is believed to be mainly caused by infiltration from groundwater when river levels are high.

**Figure 8-8: Flood water and sewage emerging from manhole on Sheldon Road outside the school (taken October 2020)**

It is recommended that all these investigations are completed as soon as possible and that the conclusions and planned actions are shared with the LLFA and stakeholders.

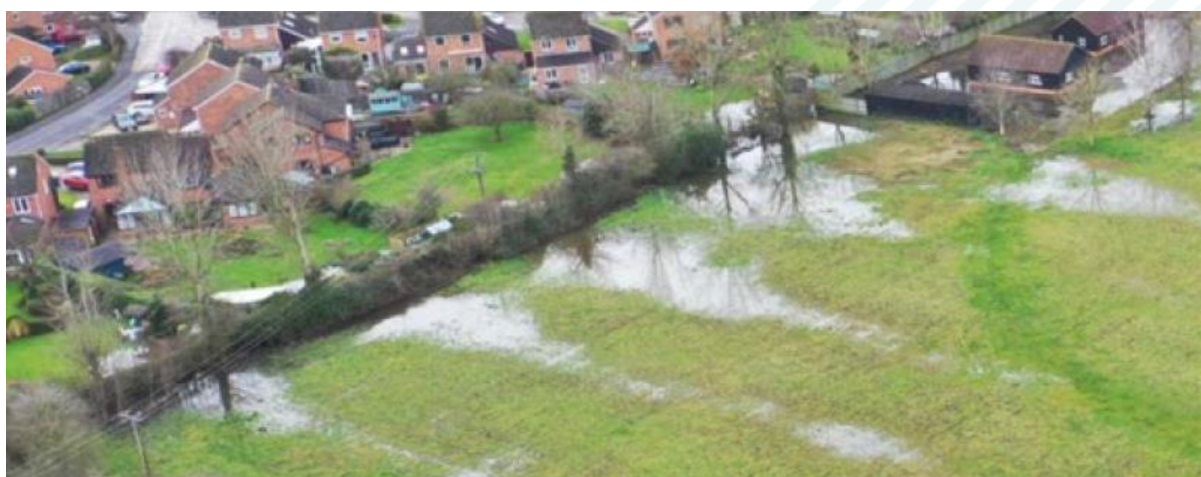
Concerns were raised to the Local Planning Authority (LPA) by both the LLFA and residents about a number of issues. These included safe access and egress from the site, as the village is at risk of being surrounded by fluvial flood water, it should be noted that safe access and egress is a matter for the LPA to consider as it is outside the remit of the LLFA. High groundwater was also raised as an issue, with residents reporting that the site was known to become waterlogged in winter (Figure 9-1). There were also concerns that flooding in the village from the foul sewer network would be made worse.

**Figure 9-1: Waterlogging on the 42 Worminghall Road development site (taken December 2020).**

Surface water runoff generated by the site will be managed via permeable paving, an attenuation basin and a geocellular tank. Infiltration is not viable at the site due to the high groundwater levels and therefore the permeable paving will provide storage and water treatment.
