Flood investigation report

High Street, Chalfont St Peter 2019

High Street, Chalfont St Peter

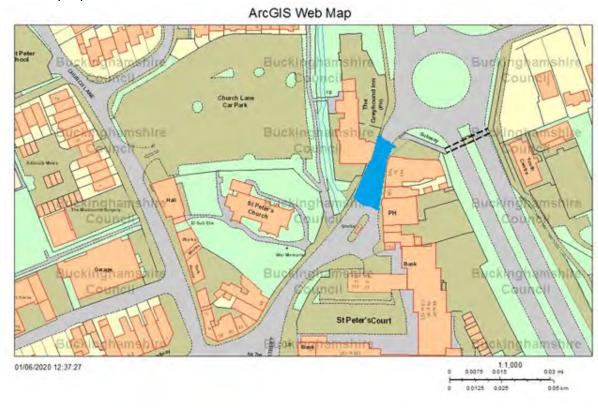
Figure 1: Location plan of flooded area.

The flooding event led to the internal flooding of 5 business properties at approximately 09:00 on the morning of the 24th of September 2019 in the location of High Street, Chalfont St Peter, figure 1. The flooding started at approximately 06:00 and started to recede early in the afternoon at approximately 14:00, the maximum depth was approximately 18 inches deep.

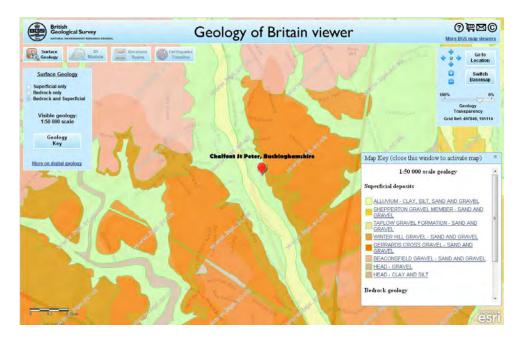
Figure 7 – Geology map of Chalfont St Peter - BGS

Chalfont St Peter is situated on alluvium (clay, silt, sand and gravel) along the line of the Misbourne, with sand and gravel superficial deposits on the more hilly parts of the village. The solid geology is chalk along the A413 and the line of the River Misbourne, but is Lambeth group (clay, silt and sand) on the more hilly parts of the village either side of the river, as shown in figure 8. Low lying areas underlain by permeable strata such as chalk, such as Chalfont St Peter along the line of the River Misbourne, are particularly susceptible to groundwater flooding.

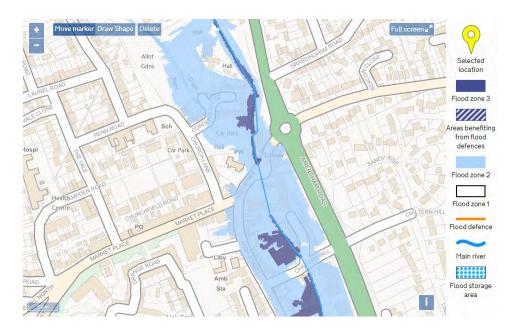
Figure 8 - Flood zone map

River – The river Misbourne runs under High Street, Chalfont St Peter. The River Misbourne is a main river that flows through Chalfont St Peter, as shown in Figure 8. It is a chalk stream that flows for 17 miles (27 km) from Mobwell Pond just north of Great Missenden to its confluence with the River Colne, which itself is a tributary of the River Thames. Apart from a small section in Great Missenden, the River Misbourne is classed as a main river and the environment agency would be responsible for the continued overseeing of the maintenance of the River Misbourne.

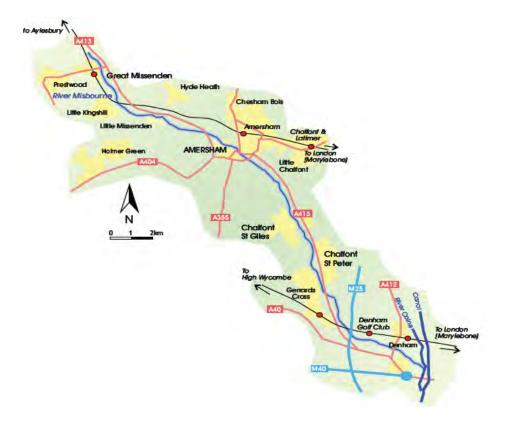
Figure 9 – River Misboure plan

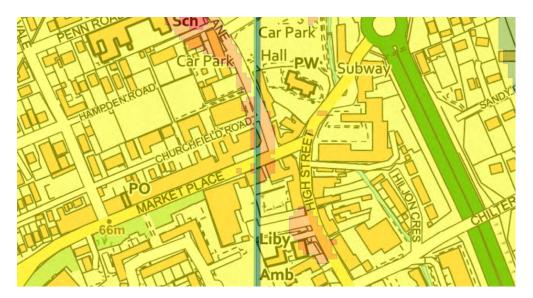
Groundwater – The groundwater was at normal levels for the time of year and it is not believed that groundwater played a part in this flooding event. Please see the below groundwater mapping and this shows the area is generally not effected by groundwater throughout normal periods of the year.

Figure 10 – Ground water map
