Buckinghamshire County Council

Flood Investigation Report

The Willows, Aylesbury, 7th February 2014

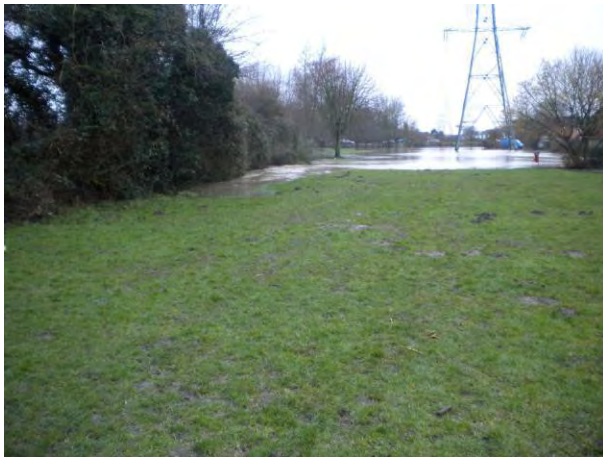
07/02/2014 08:20 Looking from the brook at Stratford Drive over towards Oxford Road (A418) Chris Spreadborough

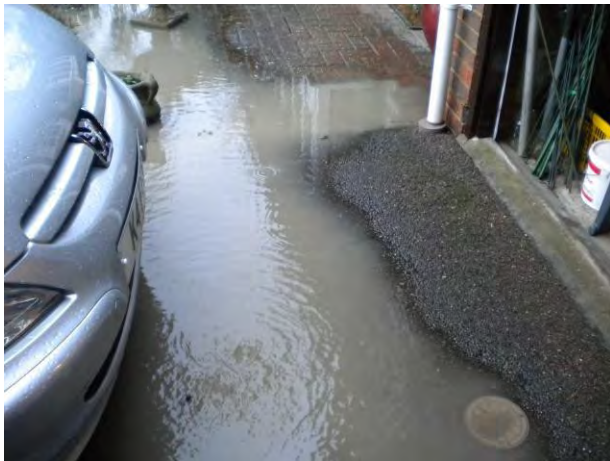
07/02/2014 12:30 The damp patch shows where
it got close to the front door and garage before
we could stop it Chris Spreadborough

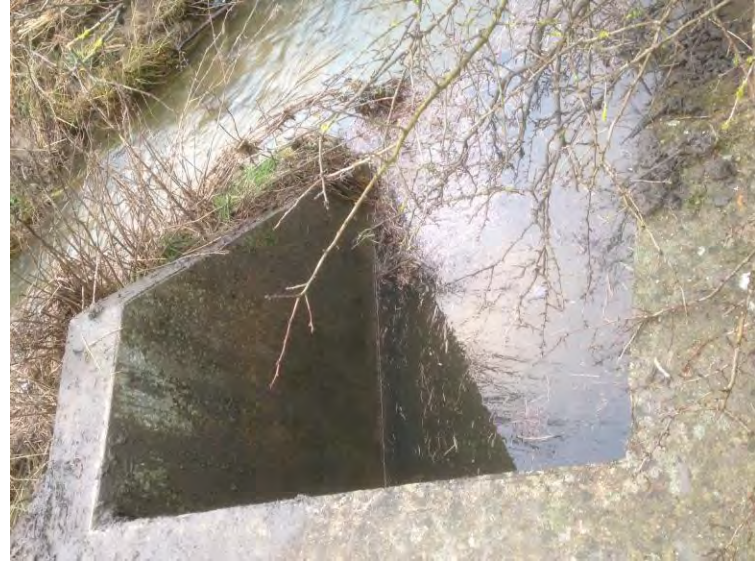
There was some siltation of the outfalls into Stoke Brook from the road drainage pipes. This siltation would have caused some backing up at lower flow levels but as the water levels in Stoke Brook would have been high these would have been the primary reason for backing up of water into the drainage pipes and gullies.

10/02/2014 16:47 Gully outfall - Councillor Steven Lambert

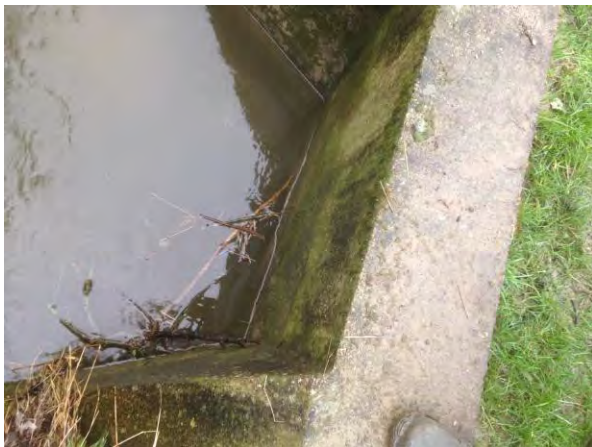
10/02/2014 16:31 Gully outfall - Councillor Steven Lambert

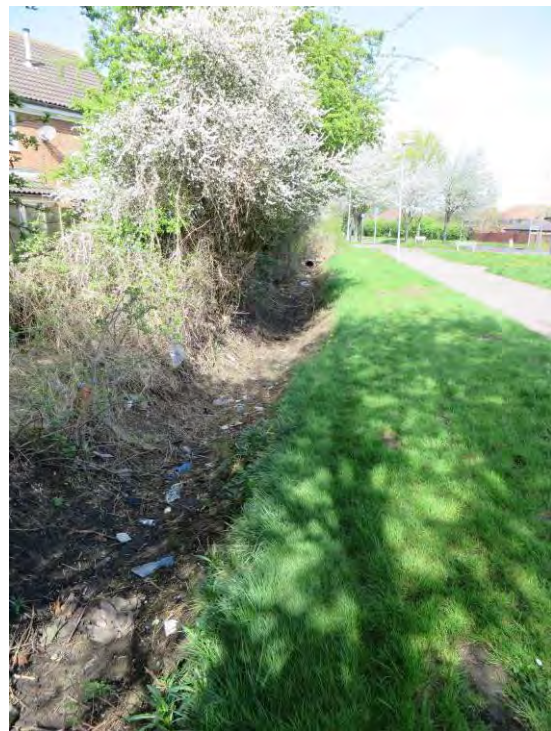
Ellen Road ditch after clearance
