Thornborough Section 19 Flood Investigation

Final Technical Report

July 2022

Buckinghamshire
Council

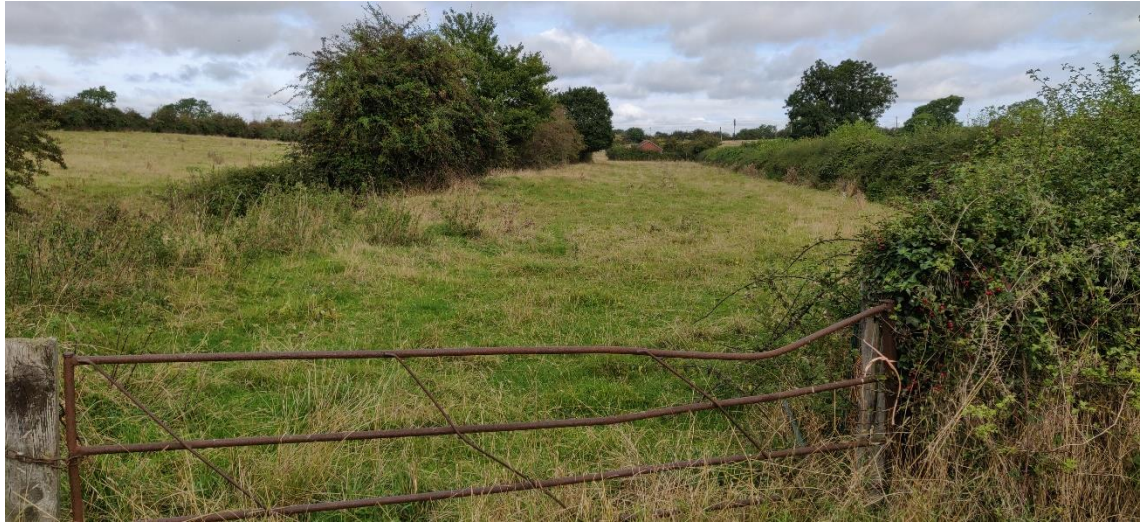
Flood risk is currently managed locally by residents and riparian owners, by way of maintaining ditches, watercourses and drains. The Buckingham and Ouzel IDB maintains Cowerde Brook downstream of the village, below the bridge on Lower End. Here, a section of the watercourse flows to a pumping station alongside Lower Road.

Figure 5-2: The section of IDB maintained watercourse. The watercourse flows within the ditch to the left, whilst Lower Road is behind the hedge to the right

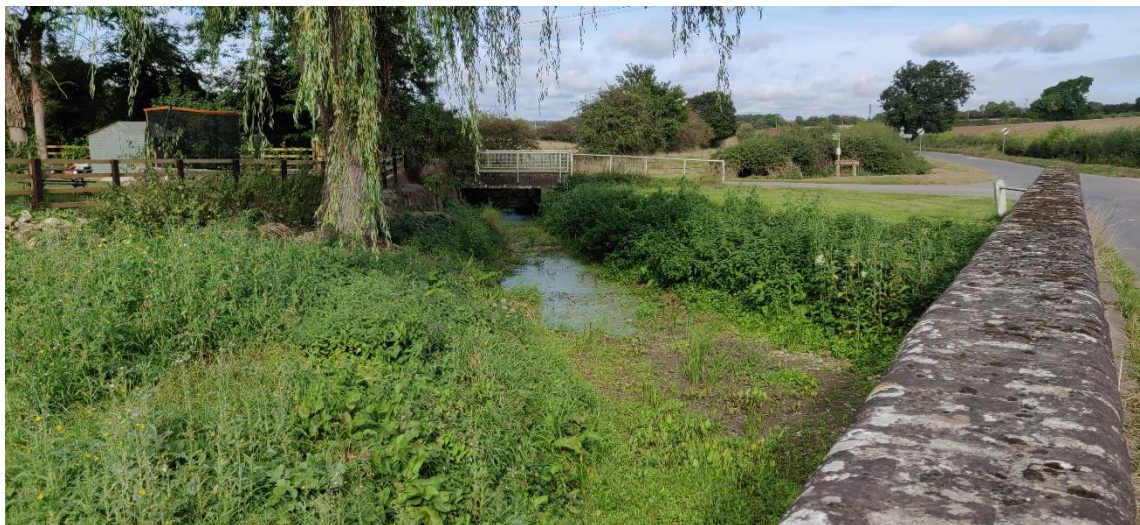
Figure 5-3: The watercourse between Lower End and Hatchet Leys Bridges, just upstream of the location of Figure 5-2 above
