# Thornton Section 19 Flood Investigation

## Final Technical Report

14 July 2022

Buckinghamshire  
Council

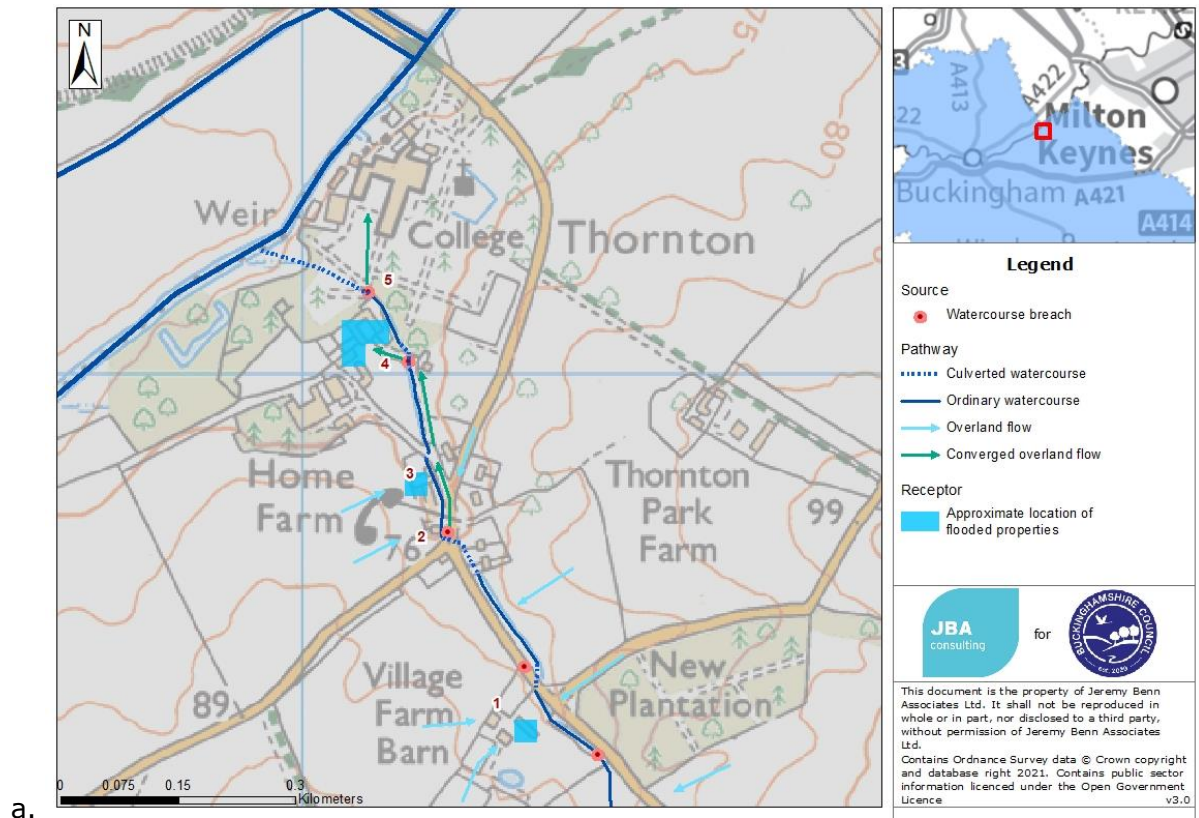
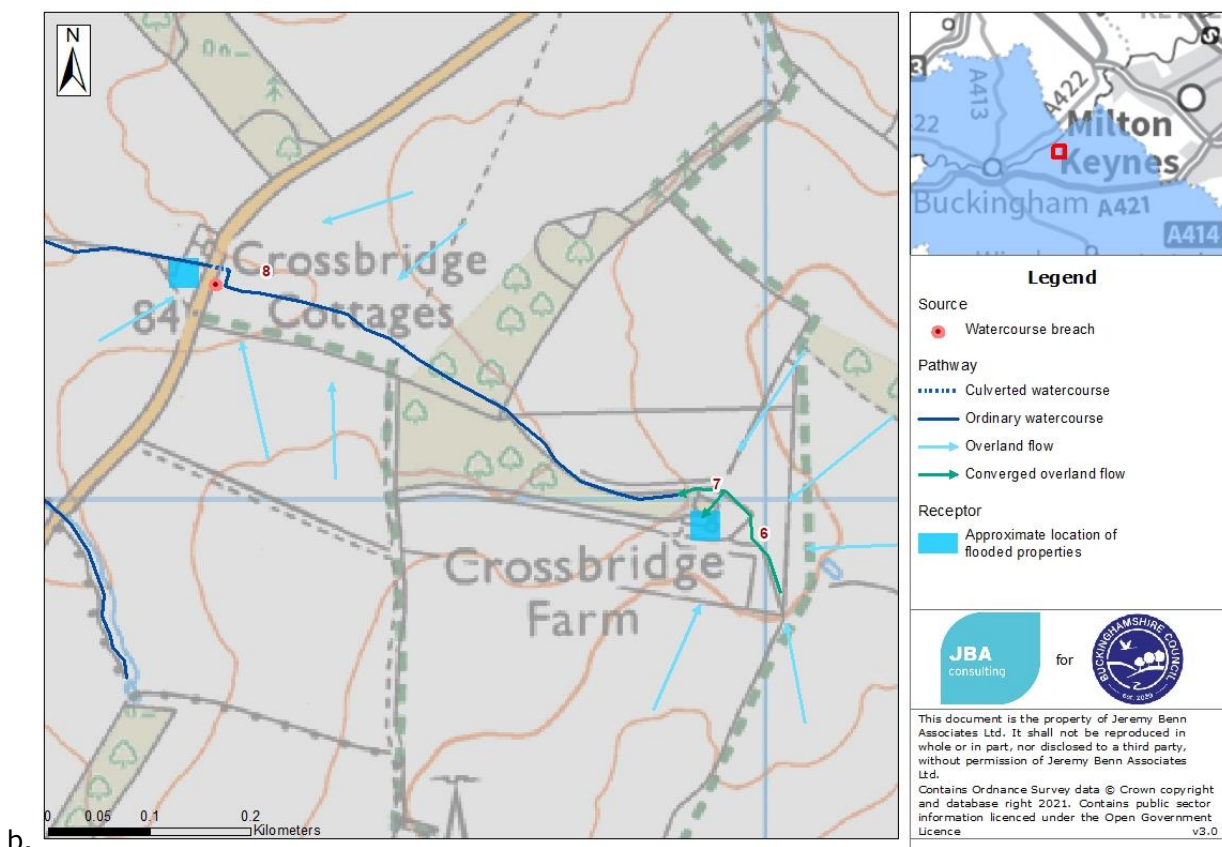
**Figure 8-1: Map of sources, pathways and receptors in Thornton village (a) and the Crossbridge area (b).**

The sources, pathways and receptors in these areas are summarised in Figure 8-1a and Figure 8-1b, and discussed in detail in the following sections.

At Thornton College it enters a final culvert and runs below the school playing fields before discharging to the Great Ouse. During the event, water levels in the channel rose rapidly in response to rainfall falling on the saturated catchment, and the banks were overtopped at the locations shown in Figure 8-1a in locations 1, 2, 4 and 5. A photo of the watercourse overtopping during the event at location 2 is shown in Figure 8-2 below.

adjacent to Crossbridge Barn before returning to its original course towards the Great Ouse. There was one reported overtopping of the watercourse, shown in Figure 8-1b at location 8, where the watercourse spilled out across the road rather than following the diversion channel.

Following the heavy rainfall overland flow was observed on several fields surrounding the village. This ran towards the rear of the properties at locations 1 and 3 on Figure 8-1a, submerging the rear gardens and subsequently entered the properties via the rear doors and walls.

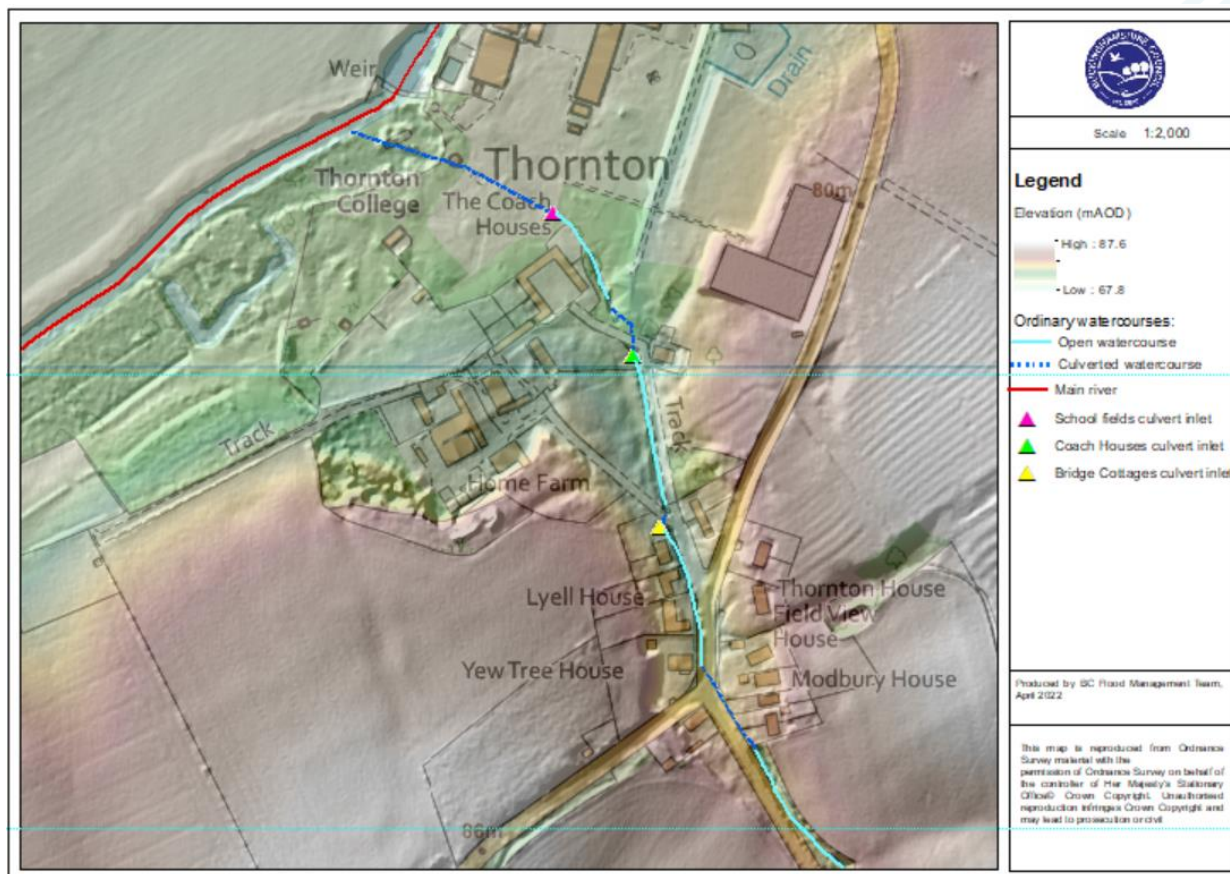
**Figure 9-1: Approximate locations of the culverts in Thornton village**

We reviewed existing data on the drainage infrastructure and completed a high-level assessment of the capacity of the three culverts in Thornton village due to concerns that these may have been a factor in the cause and severity of the flooding.

The culverts at Bridge Cottages, Coach Houses and the School Fields were assessed as shown in Figure 9-1 above. The culvert inlet dimensions, channel gradient and surface conditions were recorded, then the culverts were modelled within InfoWorks ICM<sup>13</sup> to calculate the capacity. This value was compared against the estimated flows of the event, to check whether the culvert capacity was likely to have contributed to the flooding.

Table 10-1. The inspection of the condition of the watercourse was carried out at three locations during a site visit on 2 July 2021 (as shown in Figure 9-1). The locations correspond to the upstream ends of the culverts at Bridge Cottages, Coach Houses and the School Fields as shown in Figure 8-1a.
