Buckinghamshire County Council

Flood Investigation Report

The Willows, Aylesbury, 7th February 2014

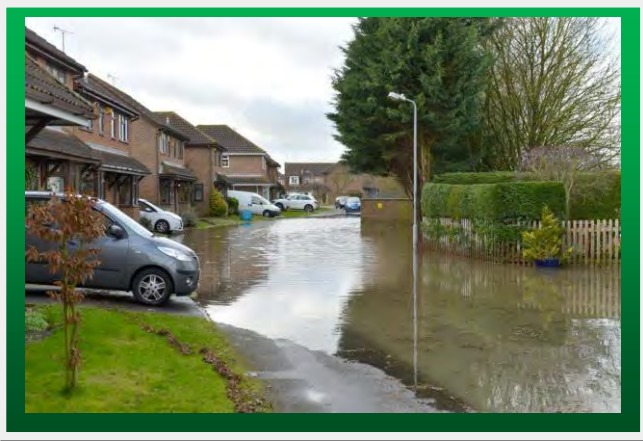
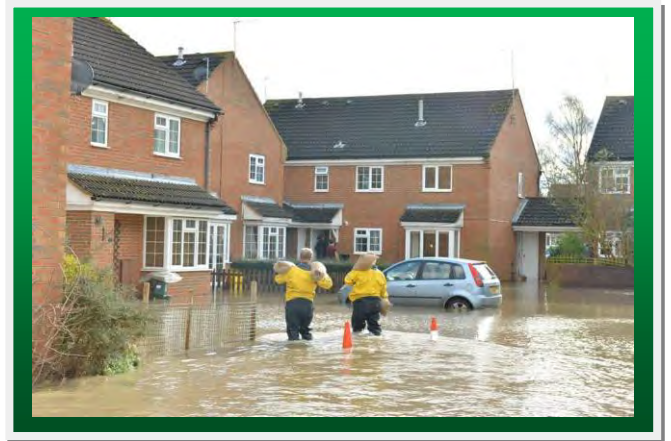
Photos from the Bucks Herald – 7th February 2014

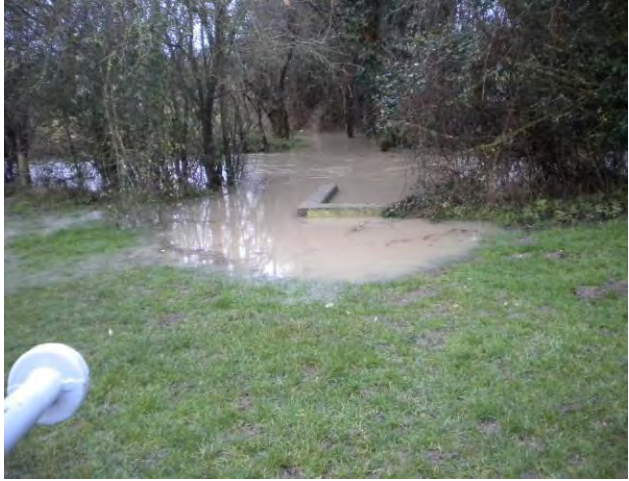
07/02/2014 08:15 Stoke Brook from the end of Stratford Drive Chris Spreadborough

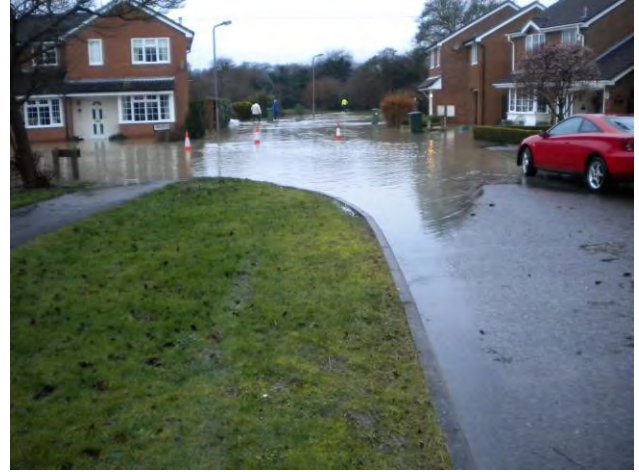
07/02/2014 08:40 Junction of Stratford Drive/Miles End Chris Spreadborough

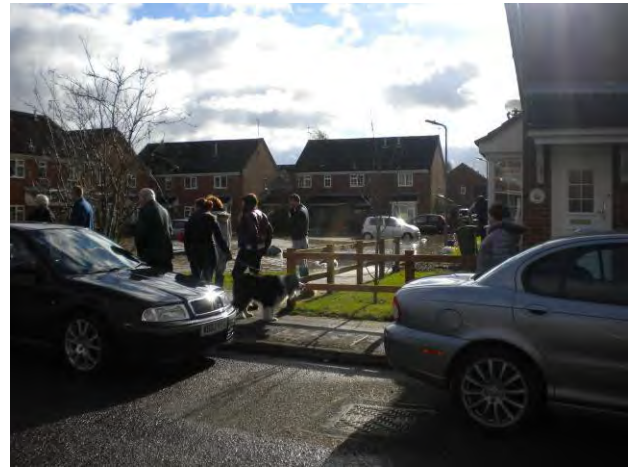
07/02/2014 10:00 Brotheridge Court flooding Chris Spreadborough

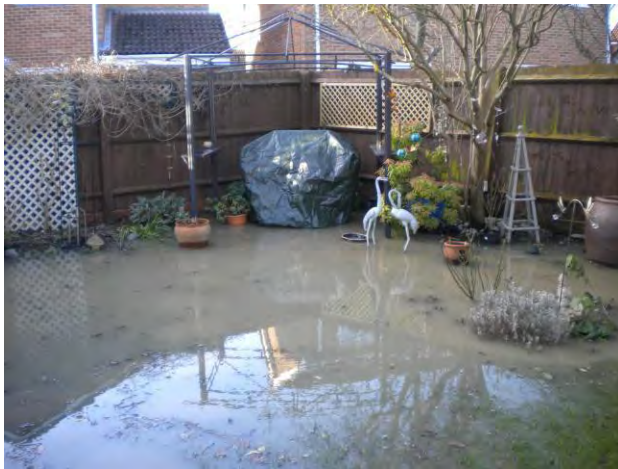
07/02/2014 12:15 Our back garden is starting to flood Chris Spreadborough

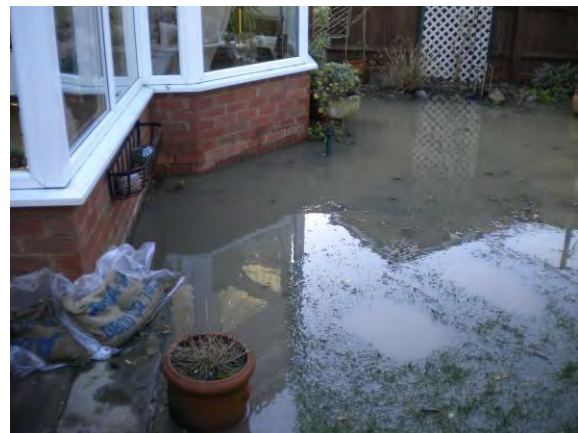
07/02/2014 12:30 Getting closer to our back
door Chris Spreadborough

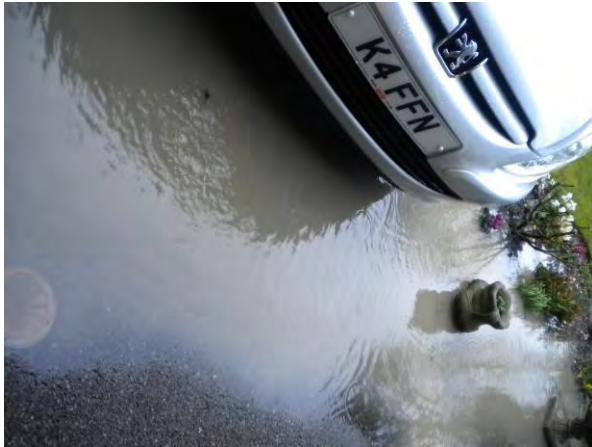
07/02/2014 12:30 Just inches from the garage
Chris Spreadborough

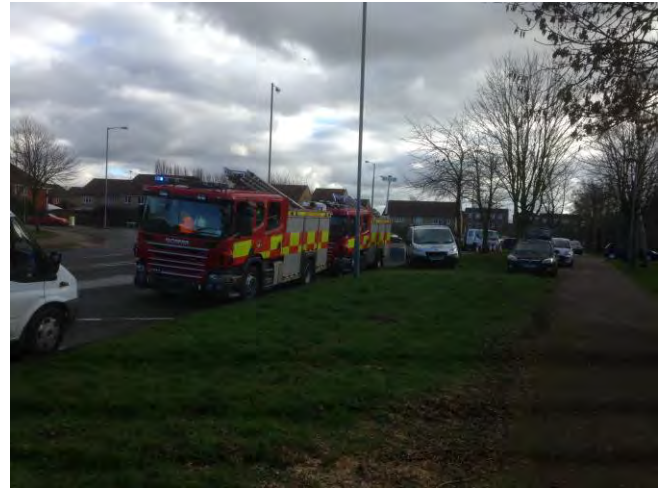
07/02/2014 13:08 Numerous responding
agencies on site - Councillor Steven Lambert

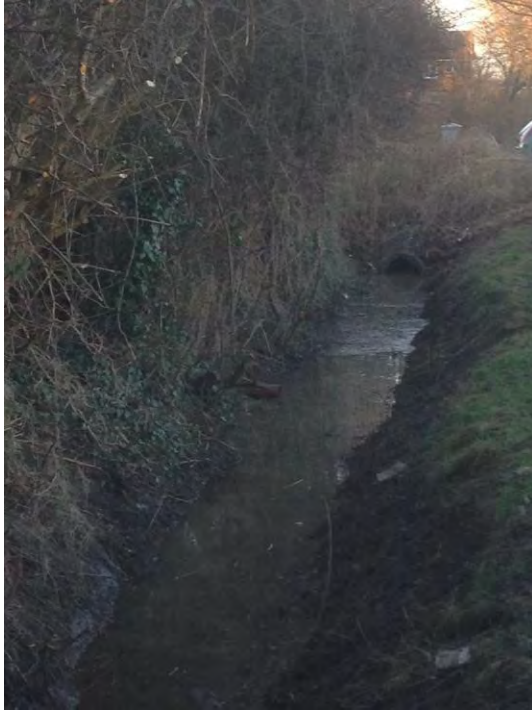
11/02/2014 16:36 Ellen Road ditch post flooding - Councillor Steven Lambert

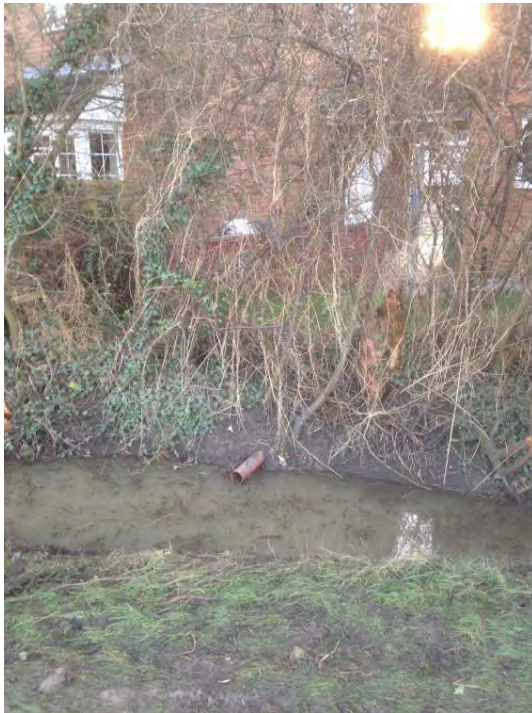
11/02/2014 16:37 Ellen Road ditch post flooding - Councillor Steven Lambert

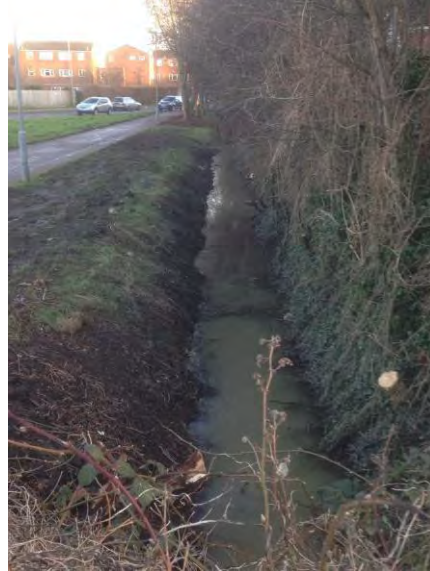
11/02/2014 16:37 Ellen Road ditch post flooding - Councillor Steven Lambert

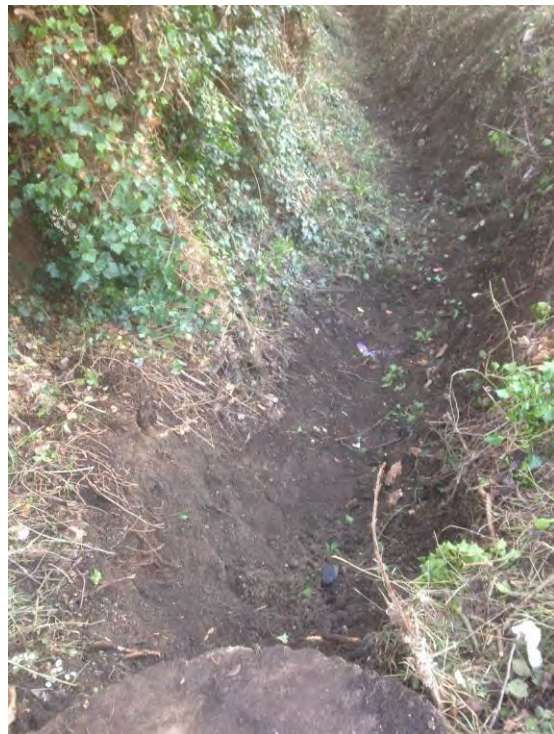
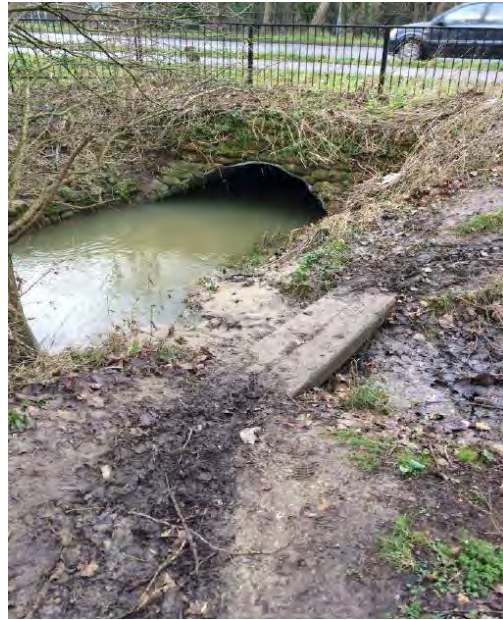
25/02/2014 17:30 Two photos (above) of the
Oxford Road Culvert post the flood event

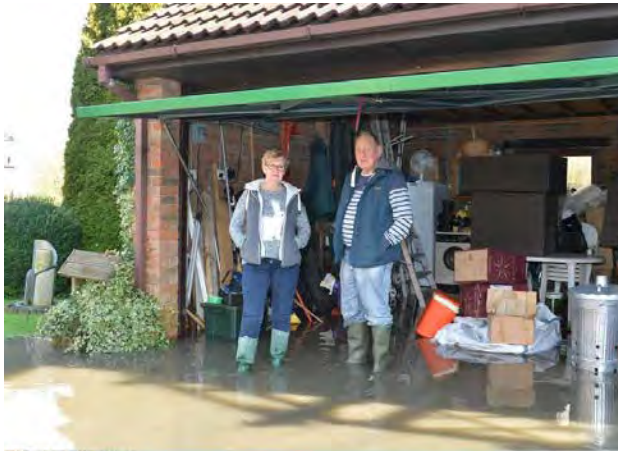
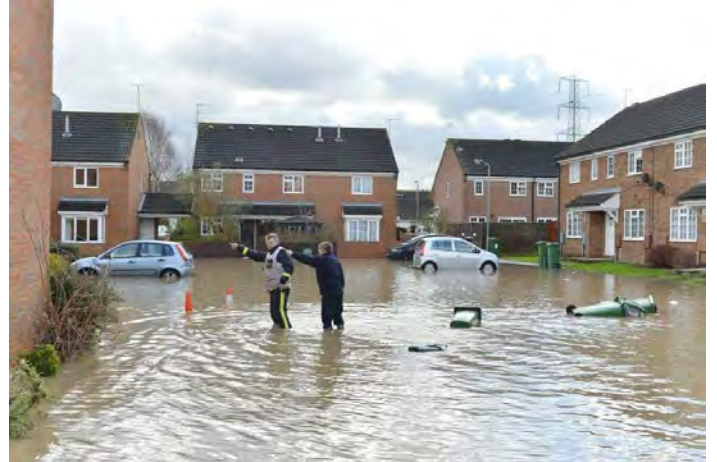
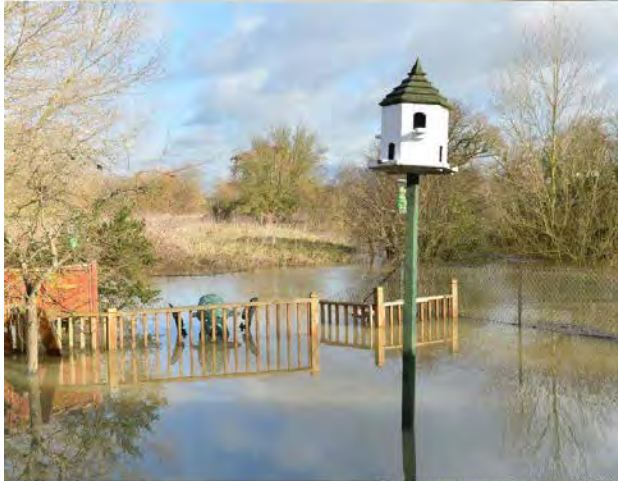
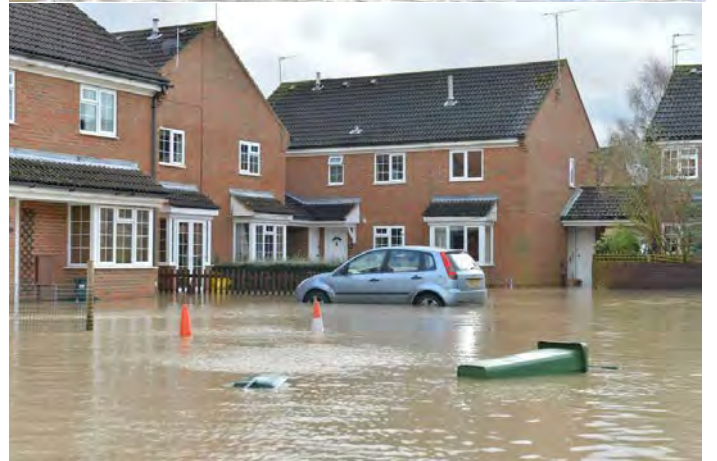
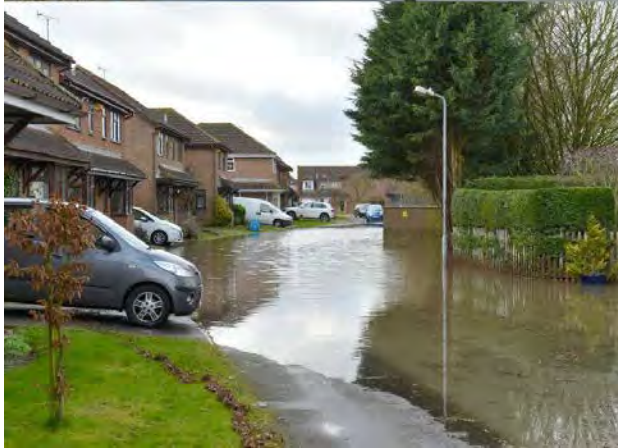
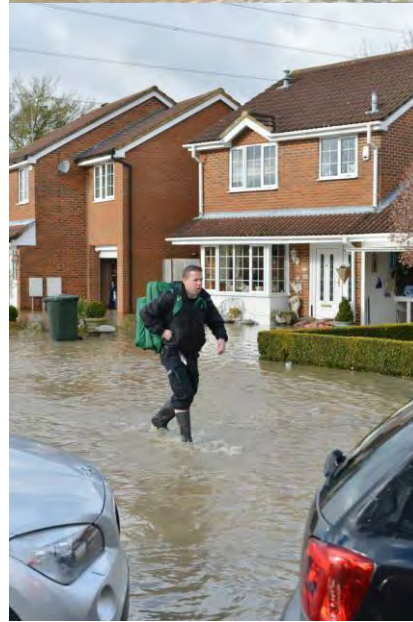
Bucks Herald Photographs – 07/02/2014

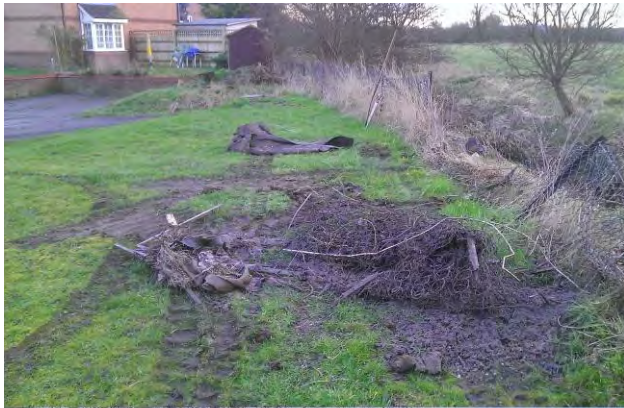
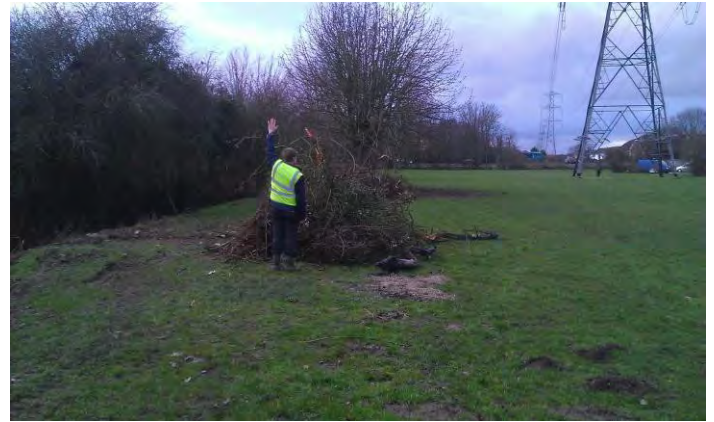
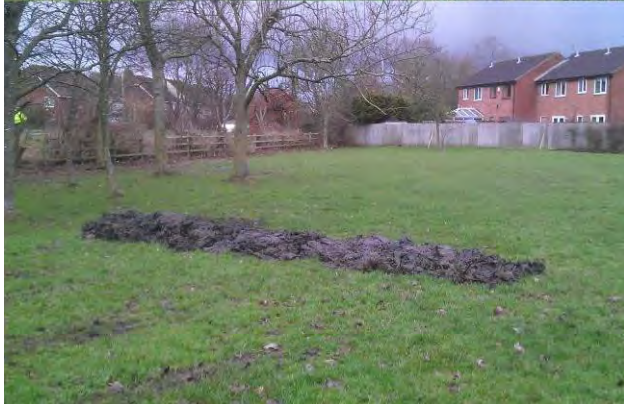
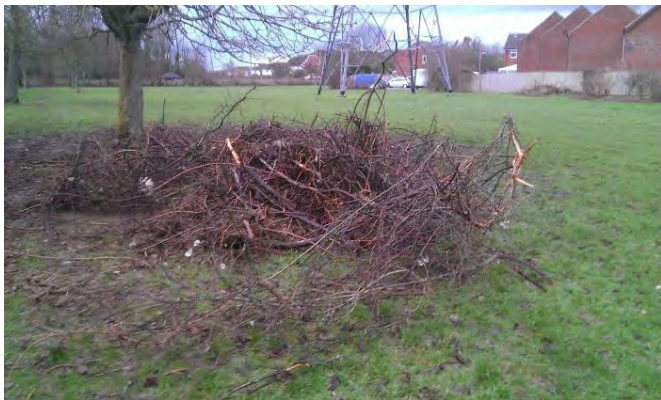
10/02/2014 Rubbish removed from Stoke Brook
– Councillor Steven Lambert

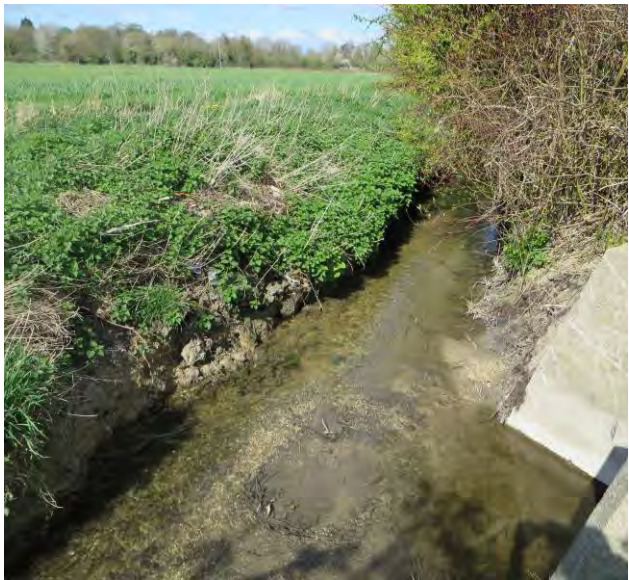
Ellen Road ditch after clearance
